I-10 | LOOP 202 TO SR-387
WILD HORSE PASS CORRIDOR

Design Concept Report Appendices

Interstate 10 Corridor: State Route 202L
to State Route 387

*ADOT Project Nos. F0252 01L and F0252 02L
Federal Aid No. 010-C(222)S*

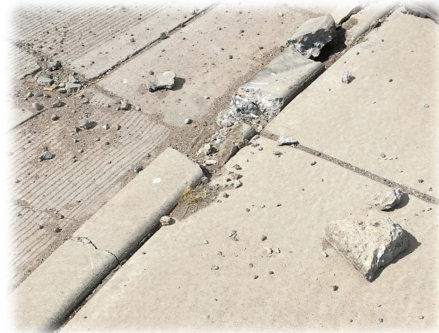
1028011
Sidwalk
Broken Concrete

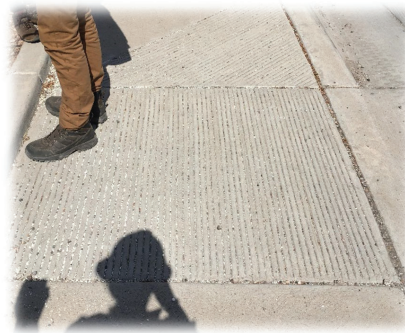
1383462
Curb Ramp
No Truncated Domes

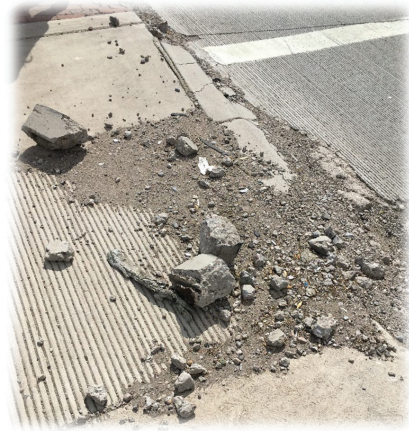
1383470
Traffic Island
Cracked Concrete

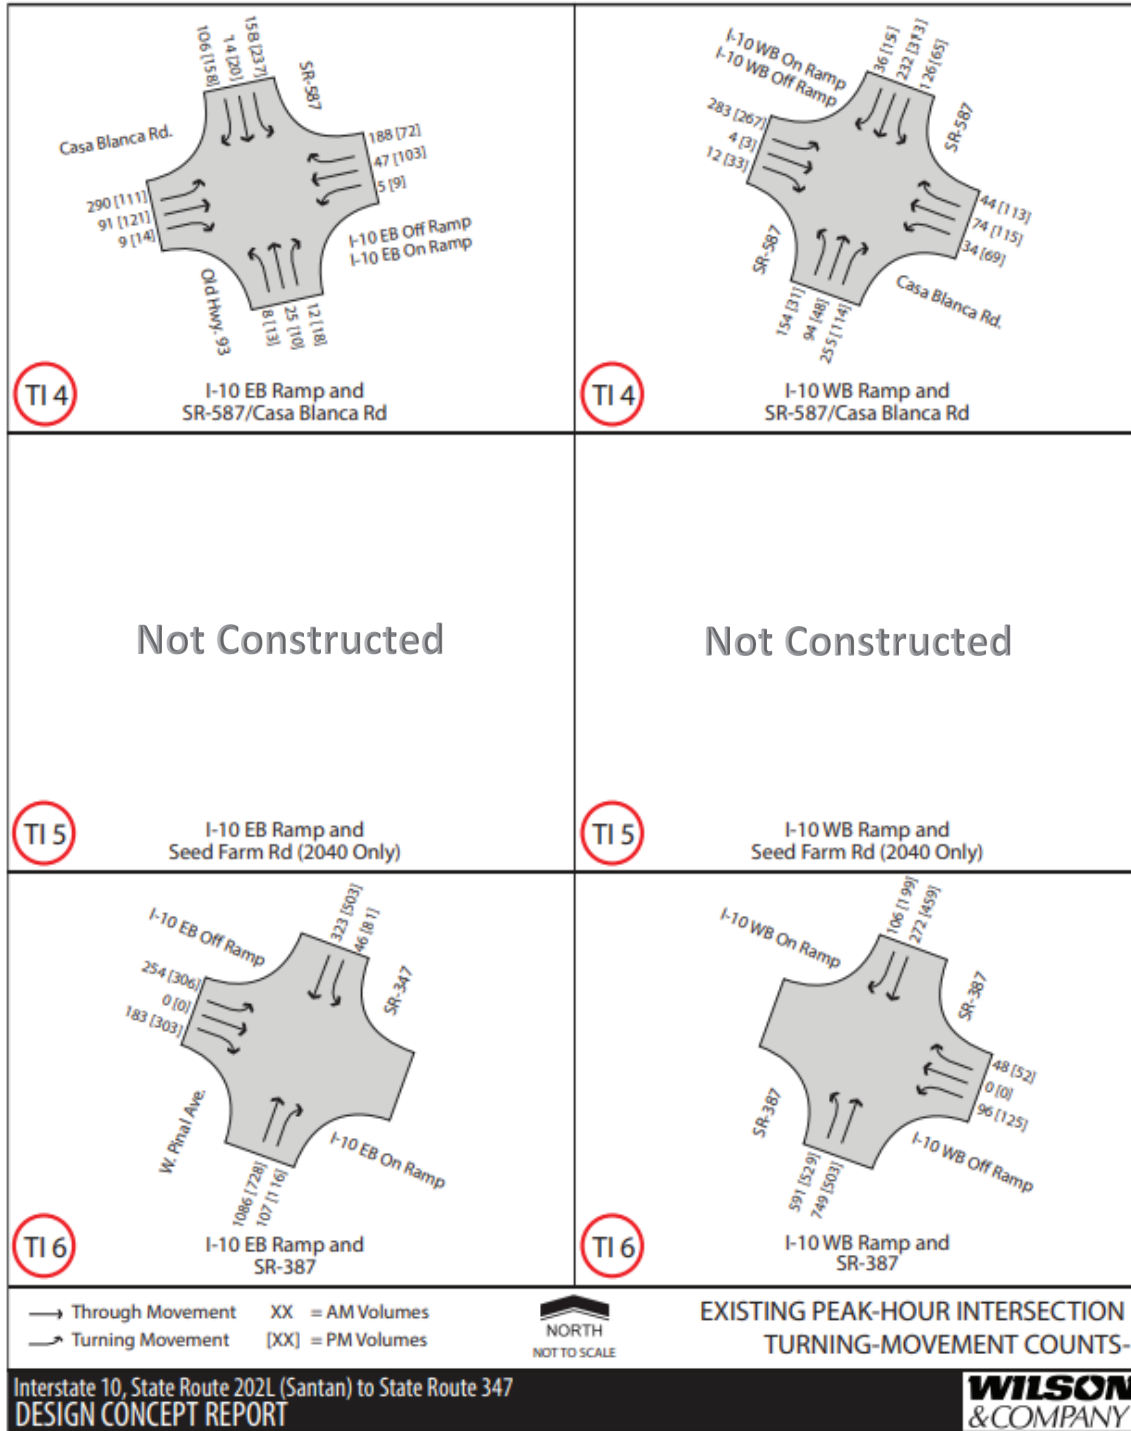
Figure 3: Existing Turning Movement Counts Continued

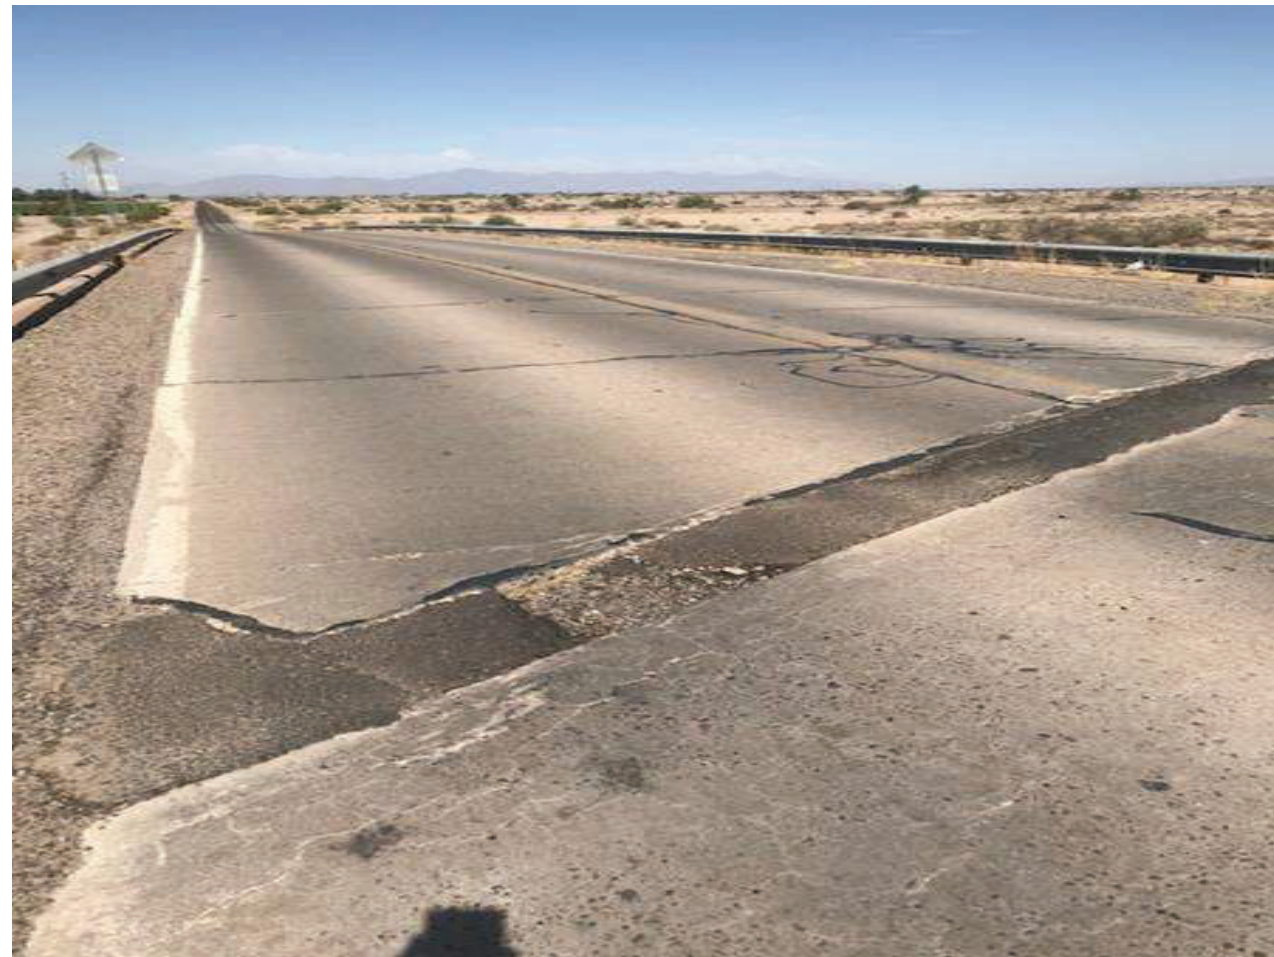
File Name : 01213-2021-05-18-Photo-7.jpg
 Description : AC deterioration, east approach, with settlement

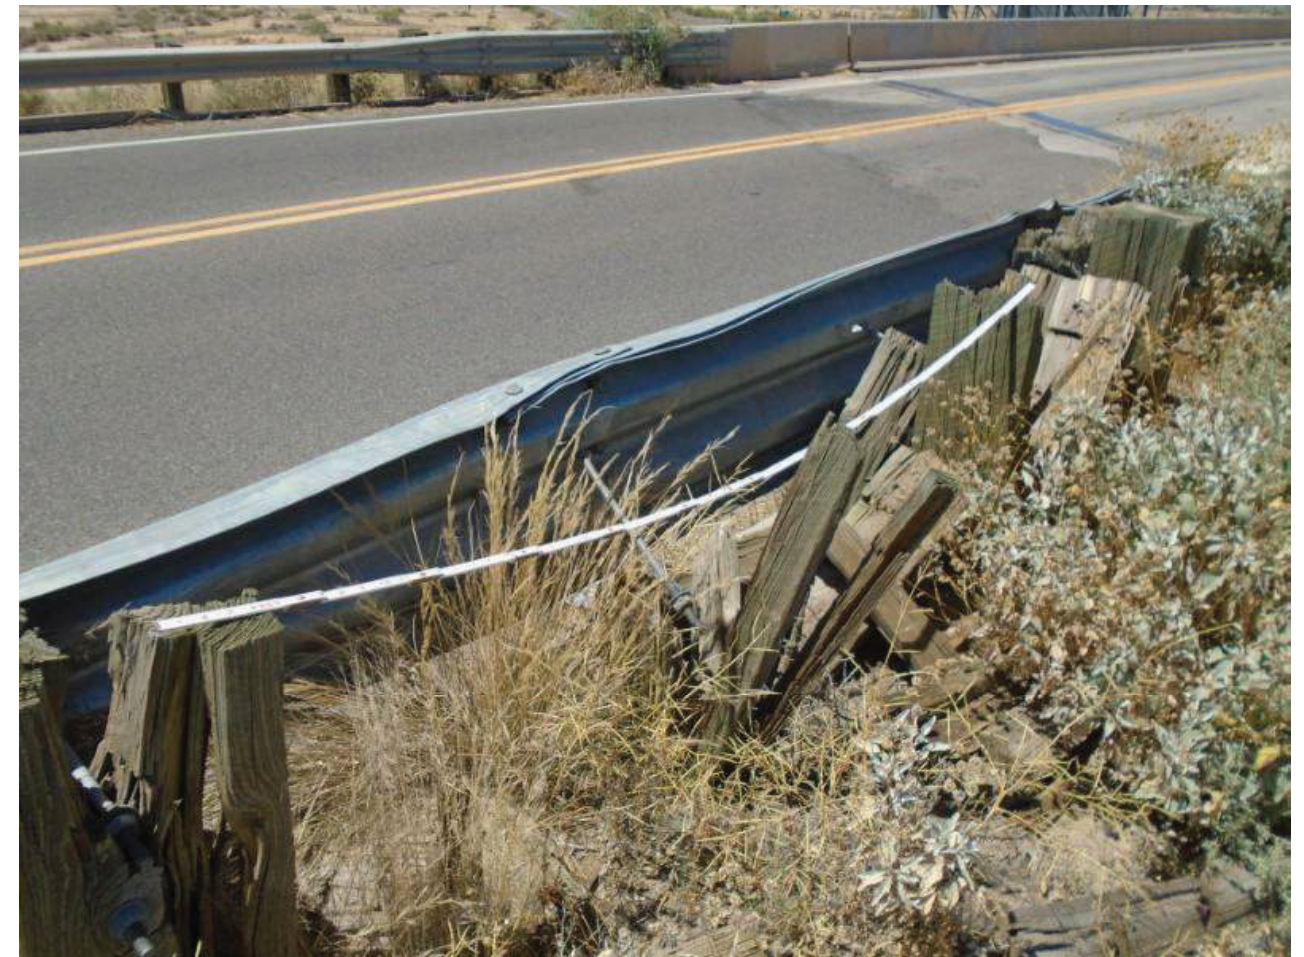
File Name : 01214-2020-05-31-Photo-9.JPG
 Description : Impact Damage, SE Approach Transition, LN

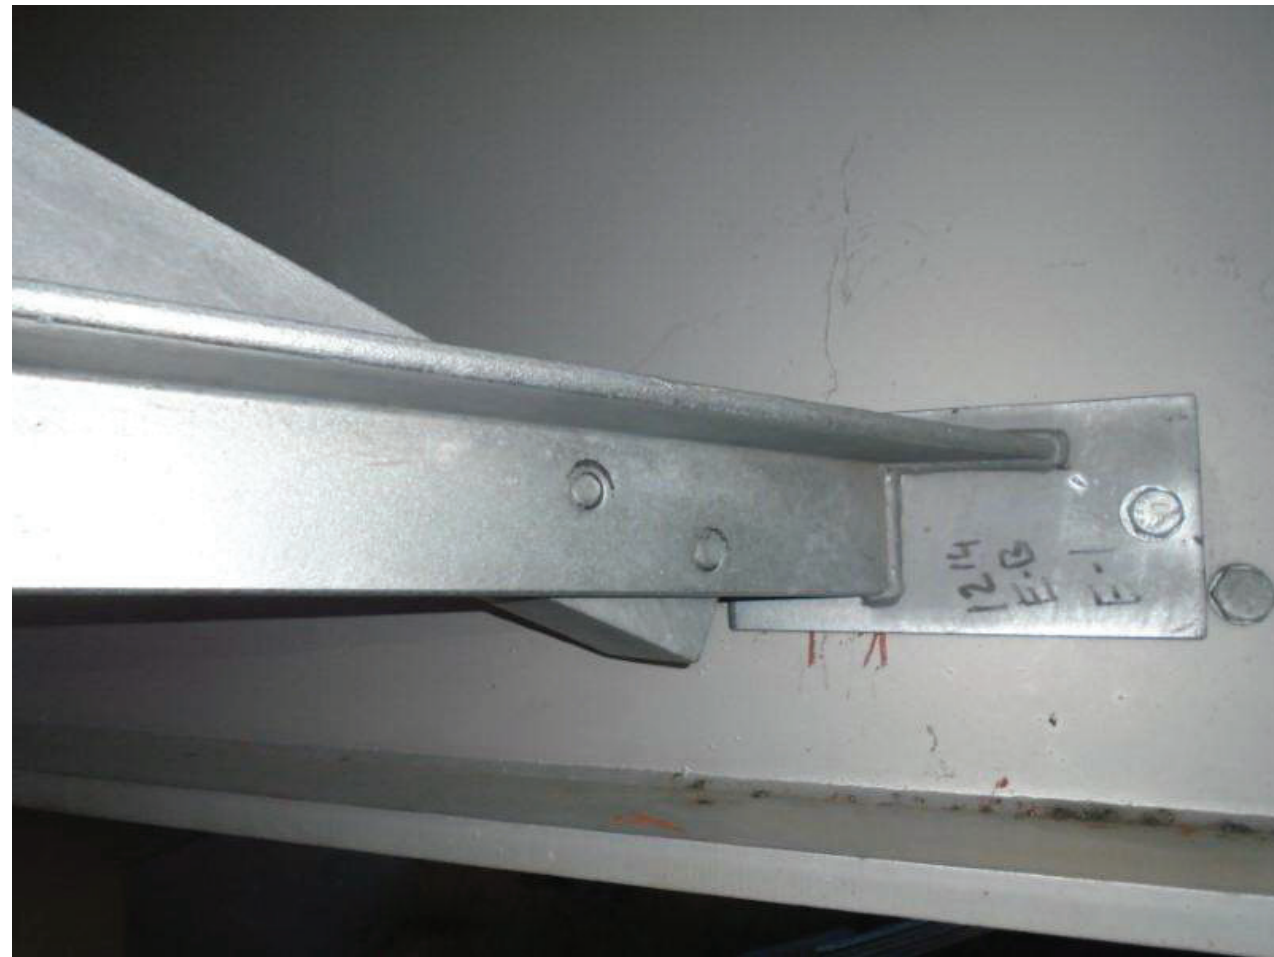
File Name : 01214-2020-05-31-Photo-24.JPG
 Description : Loose Connection, Wrong Way Sign Support, Span 3, LSW

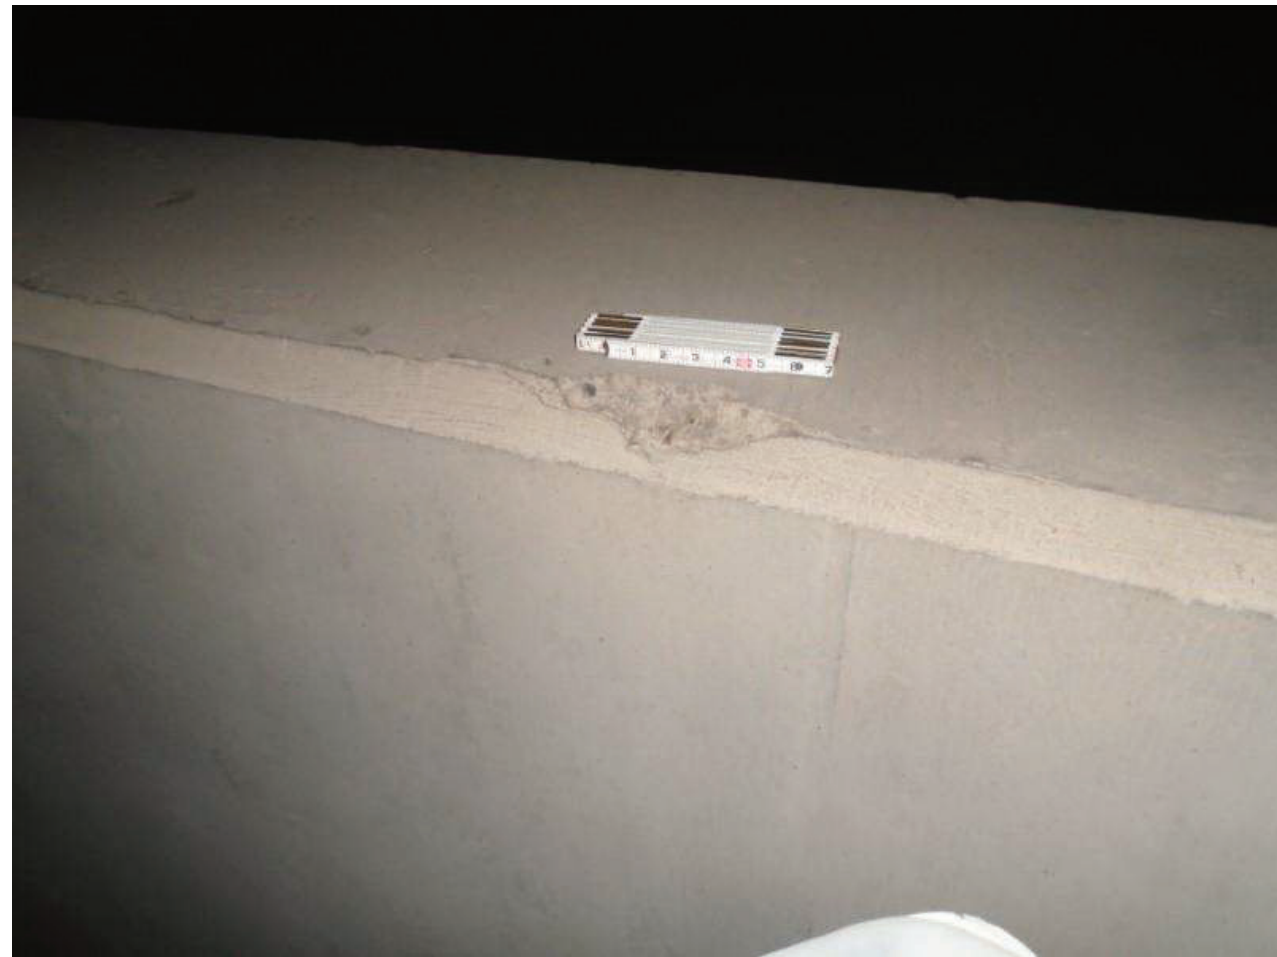
File Name : 01214-2020-05-31-Photo-26.JPG
 Description : Edge Spall, Pier 1 Cap, Bay 2, South Side, LN

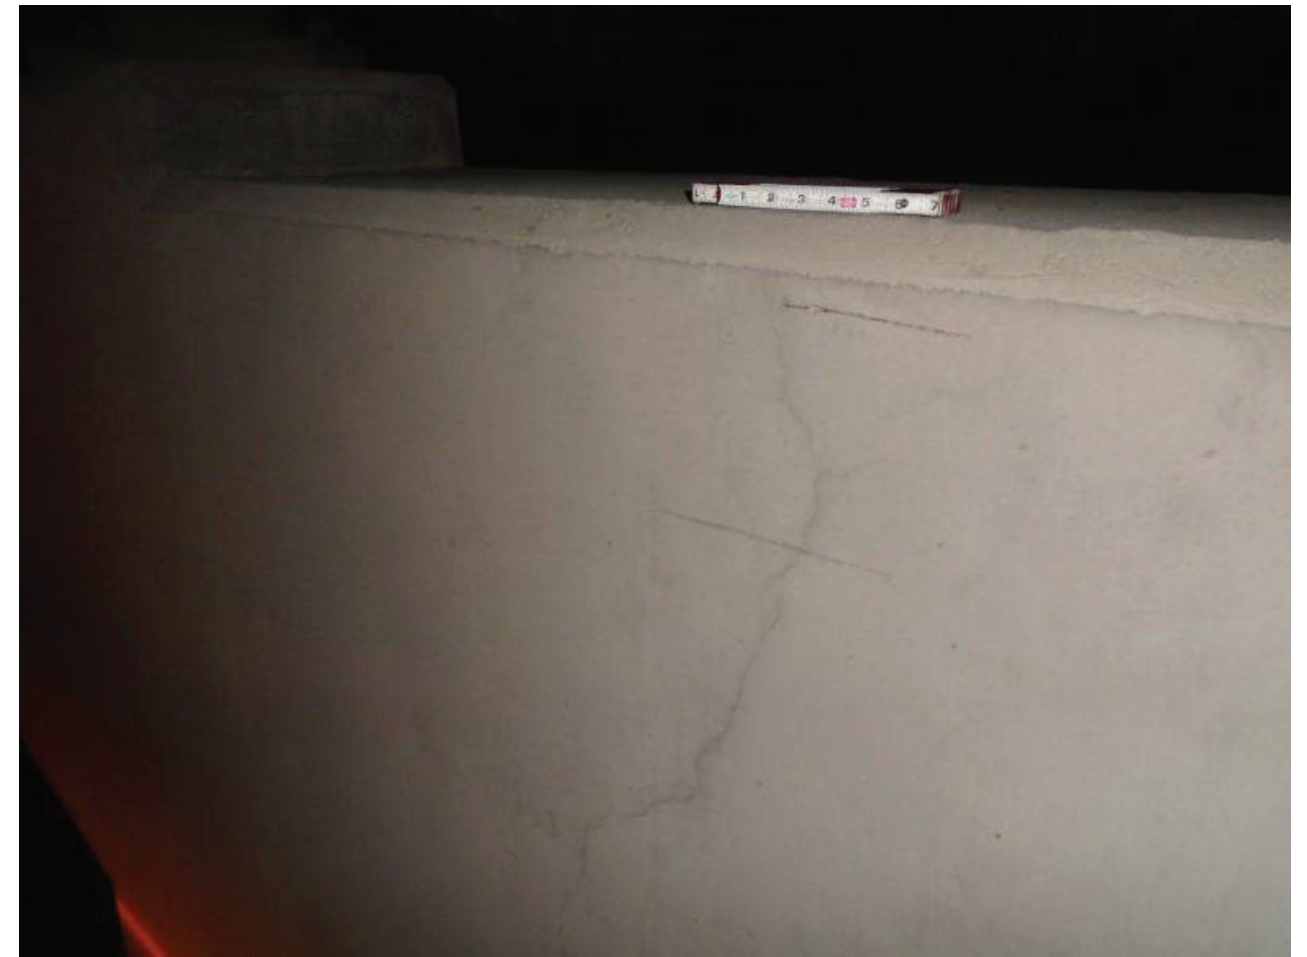
File Name : 01214-2020-05-31-Photo-27.JPG
 Description : Typical Pier Cap Cracks

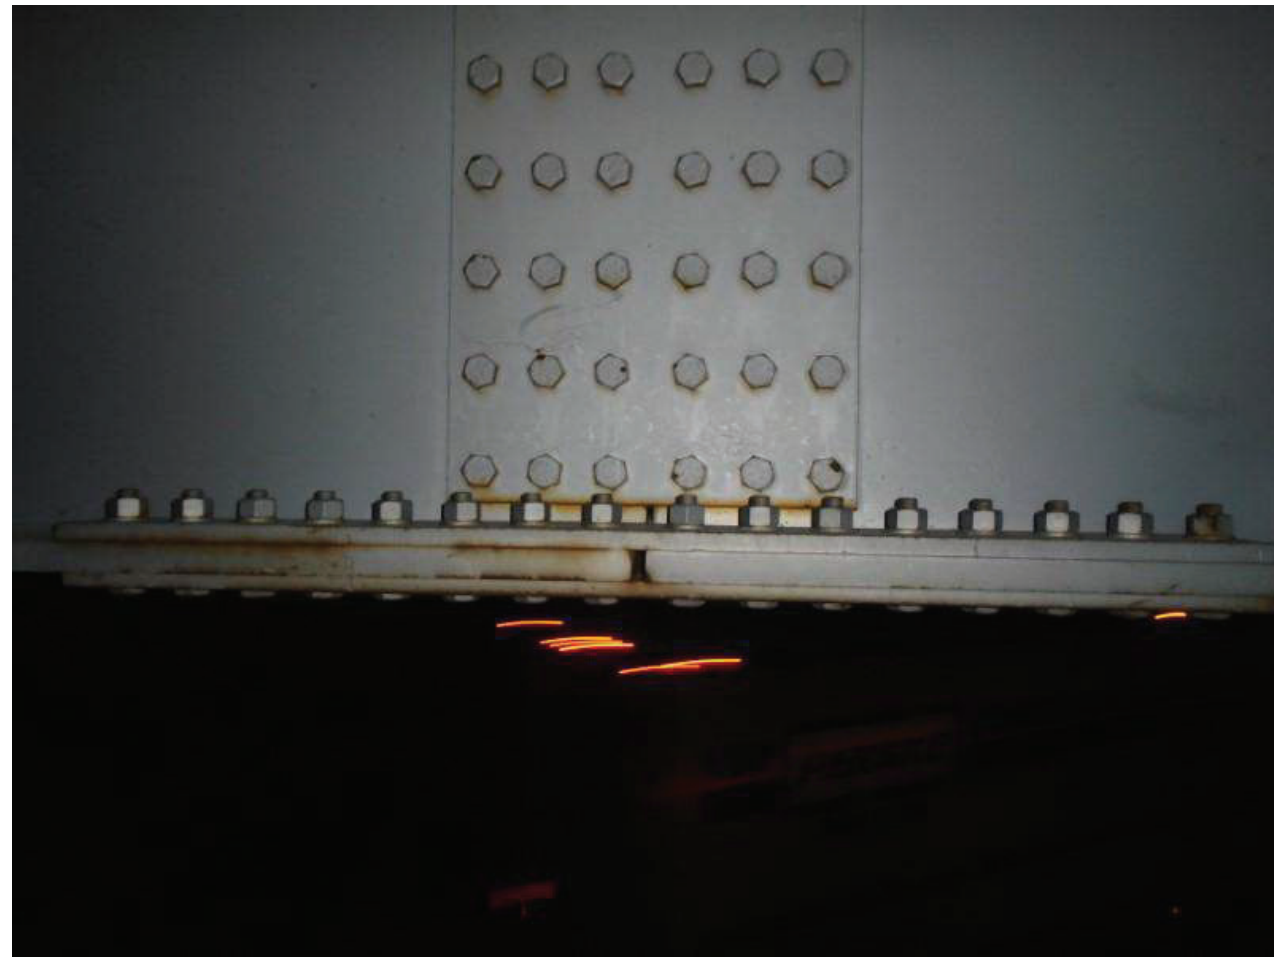
File Name : 01215-2020-05-31-Photo-18.JPG
 Description : Splice Plate Corrosion, Span 4, Girder 4, LSE

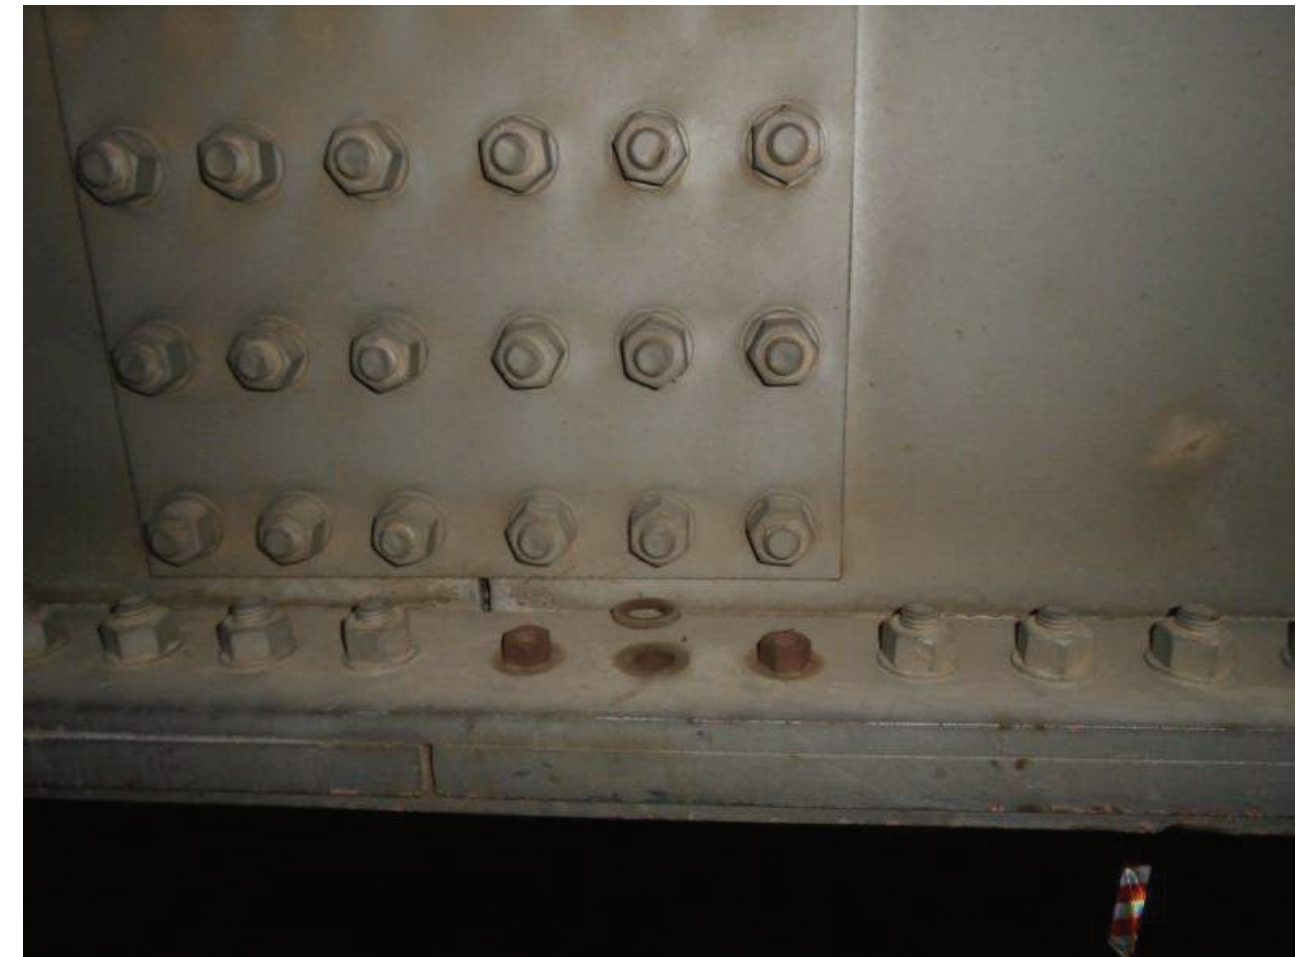
File Name : 01215-2020-05-31-Photo-25.JPG
 Description : Missing Bolt, Span 2, Girder 4, South Splice Plate, LE

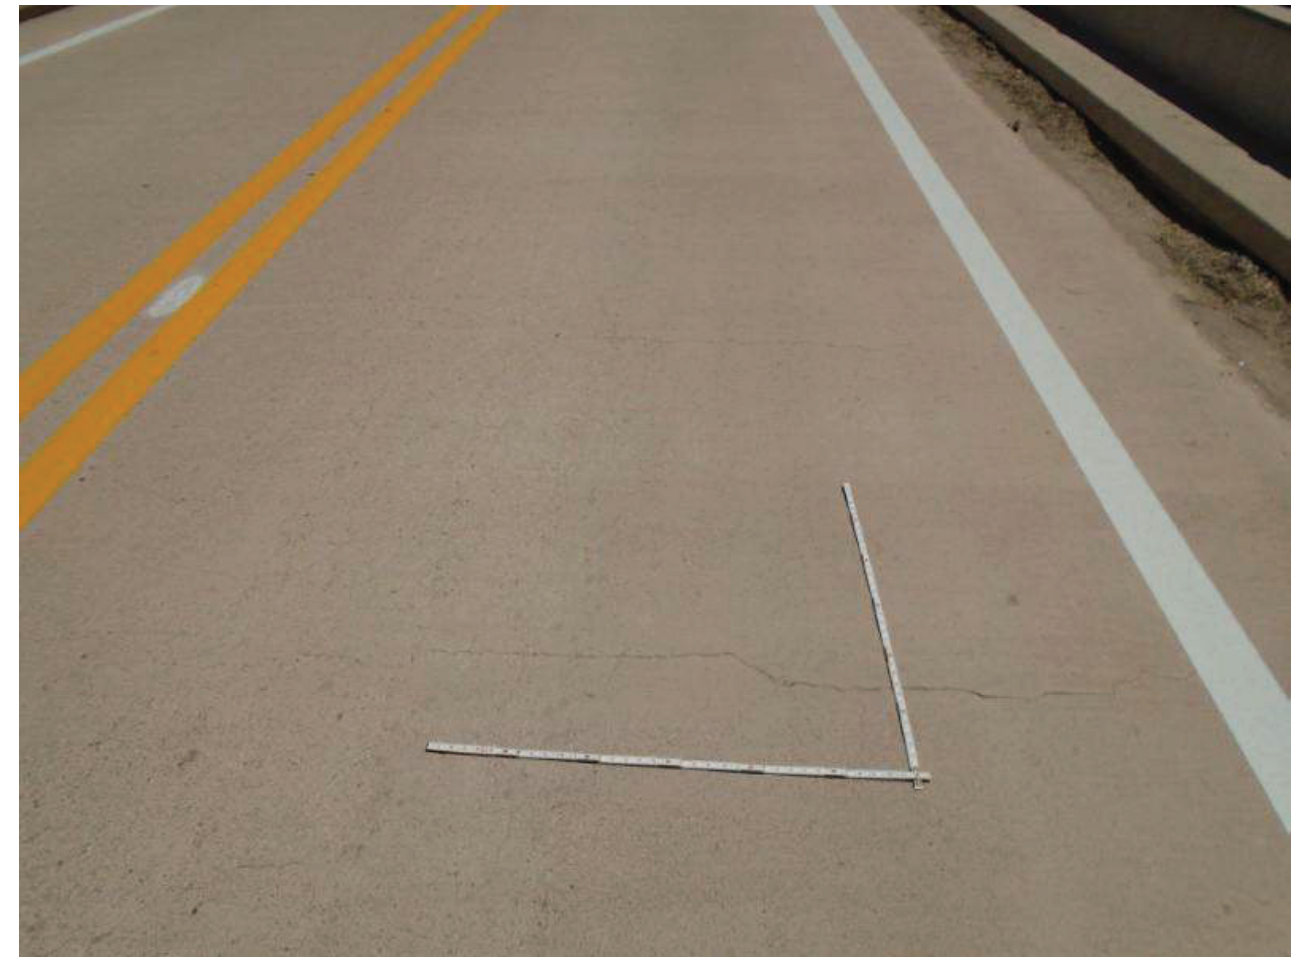
File Name : 01216-2020-05-31-Photo-6.JPG
 Description : Typical Deck Cracking

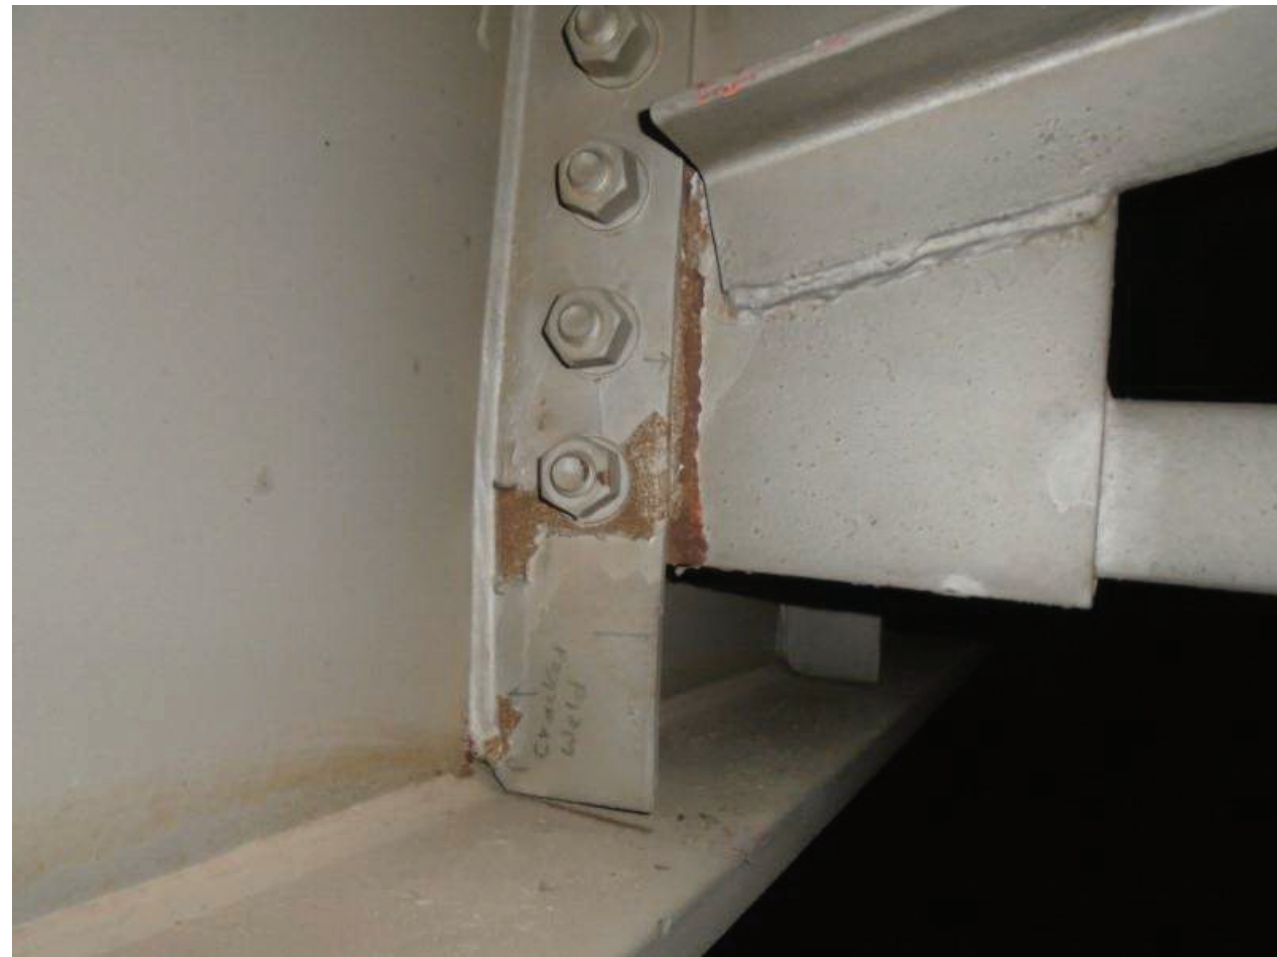
File Name : 01216-2020-05-31-Photo-21.JPG
 Description : Cracked Weld, Span 2, Girder 1, Diaphragm 1, LSW

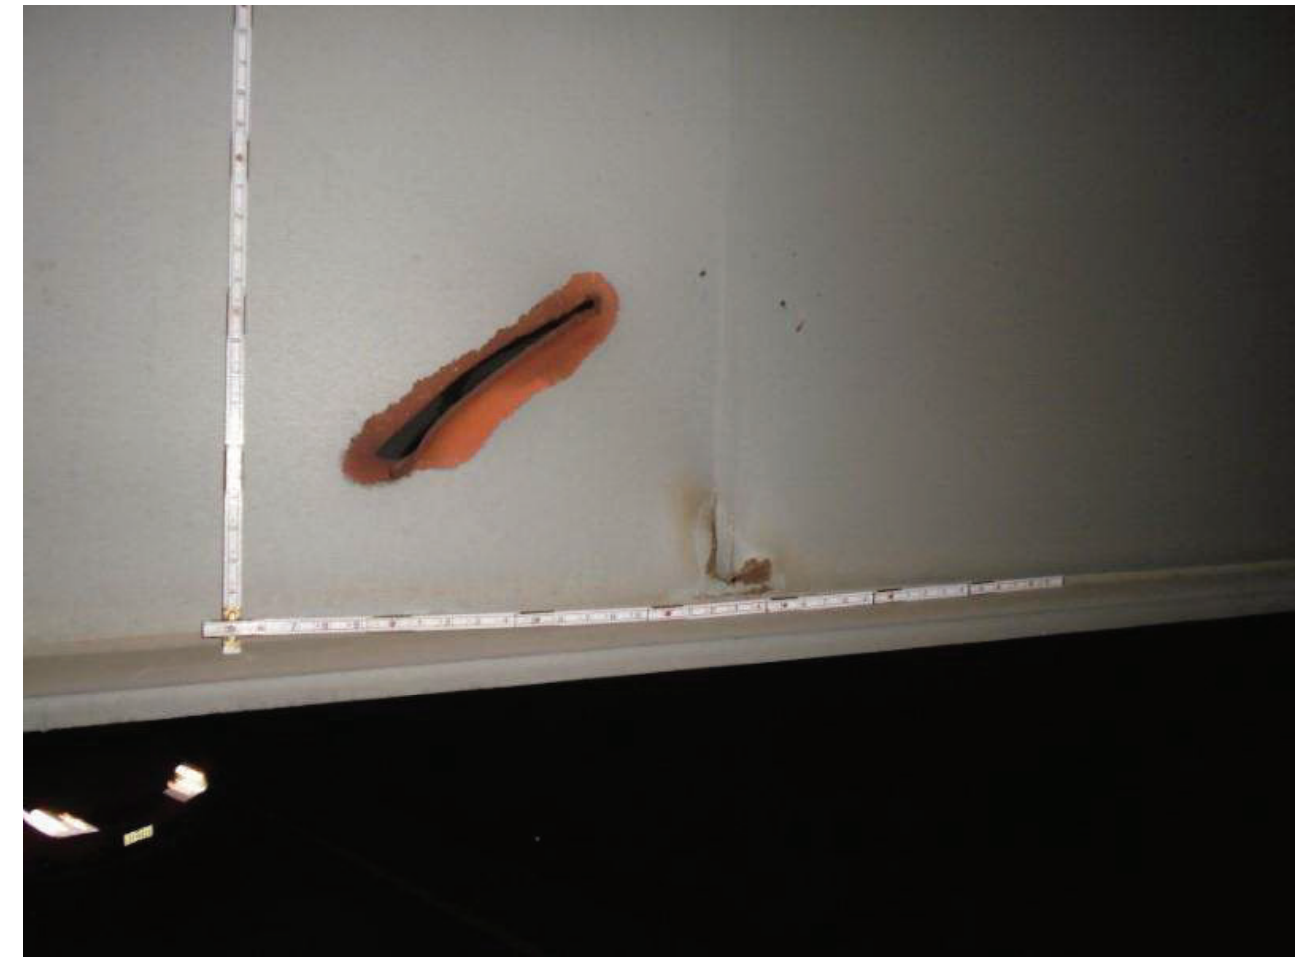
File Name : 01216-2020-05-31-Photo-22.JPG
 Description : Impact Damage, Span 2, Girder 2, Diaphragm 1, LS

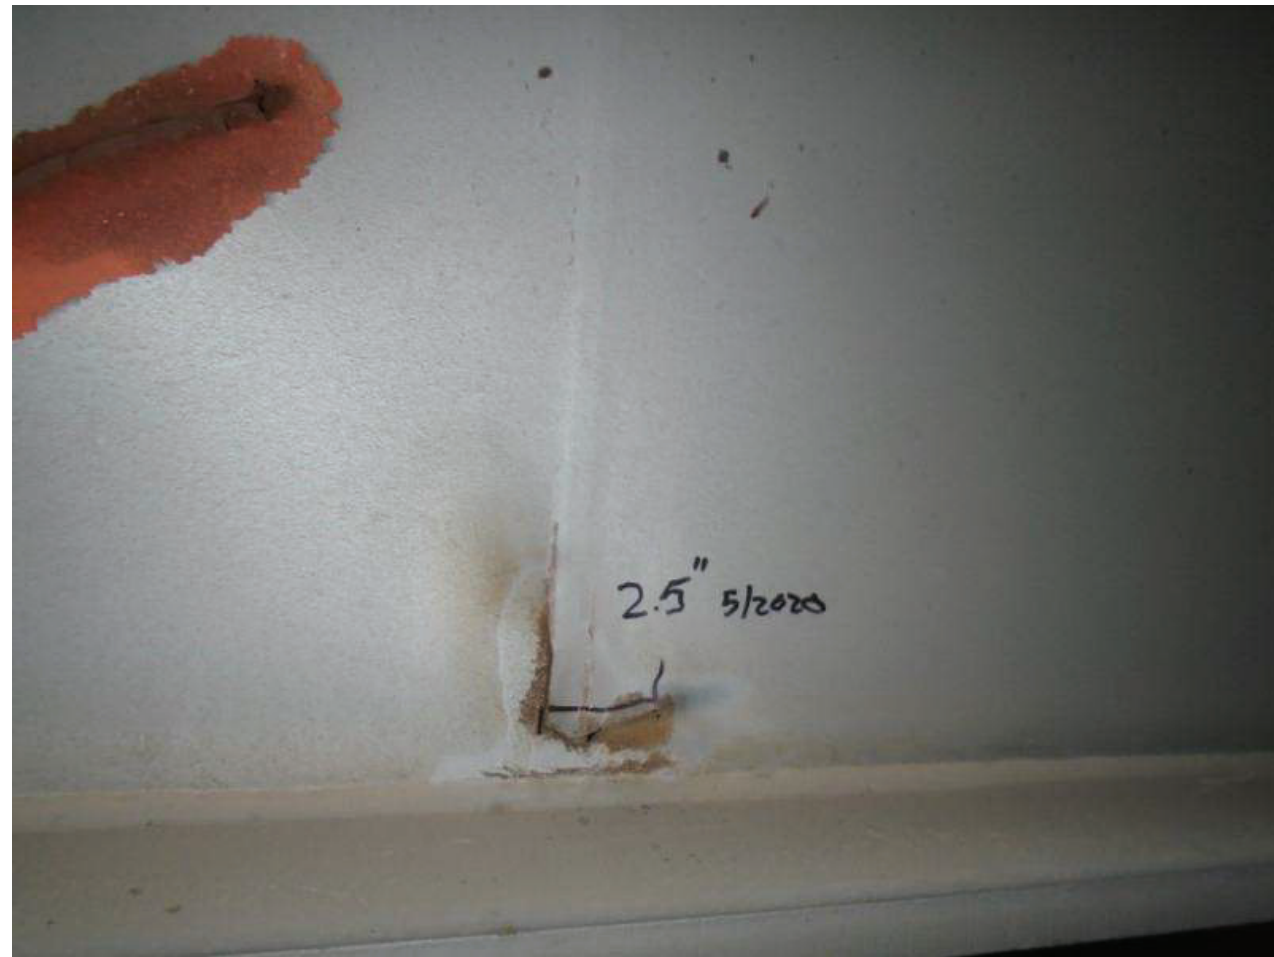
File Name : 01216-2020-05-31-Photo-25.JPG
 Description : Horizontal Tear/Crack Span 2, Girder 2, Diaphragm 1, LS

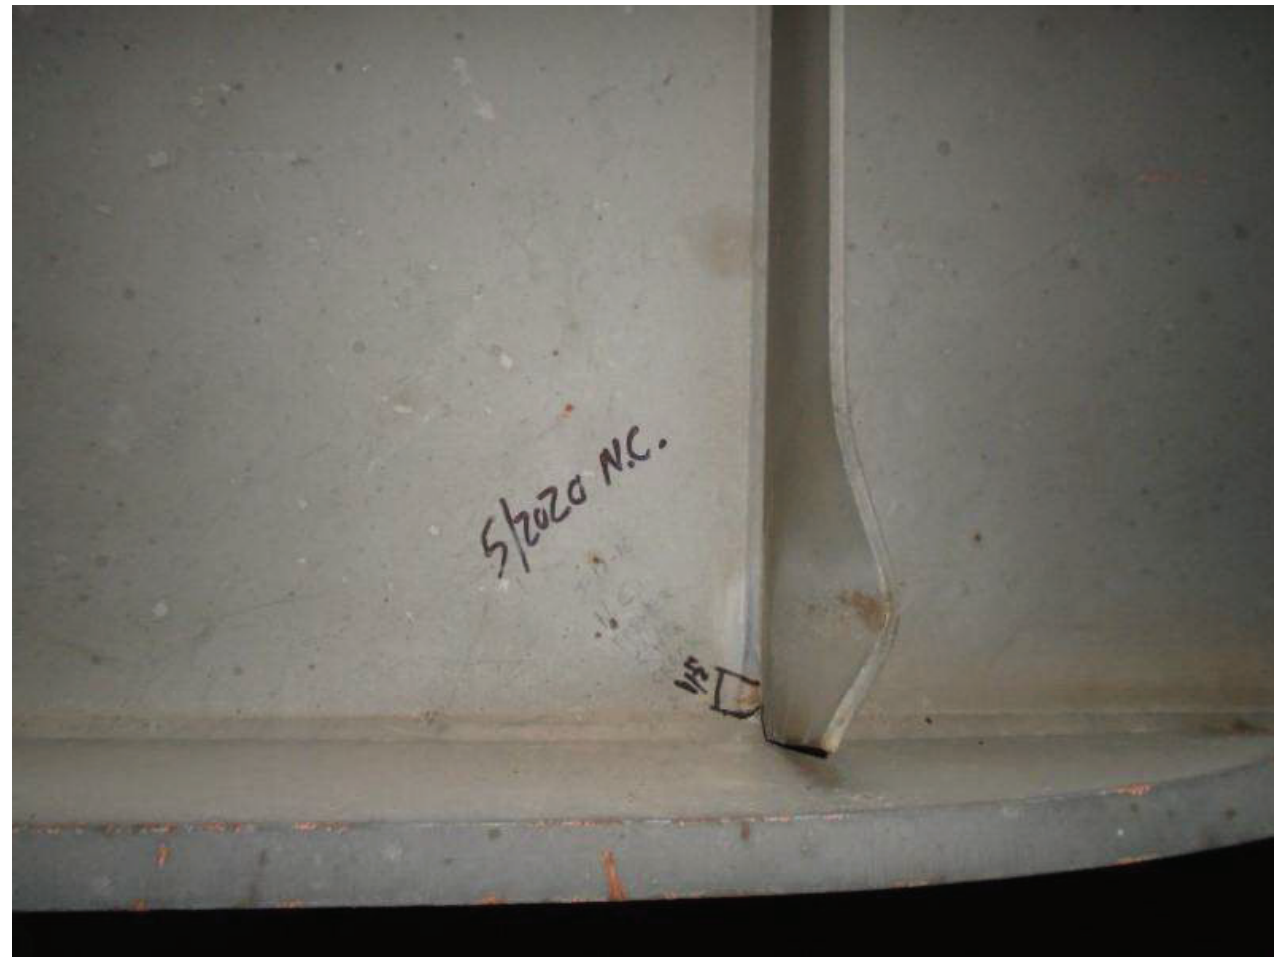
File Name : 01216-2020-05-31-Photo-27.JPG
 Description : Crack in Vertical Stiffener, Span 2, Girder 4, at East Splice Plate, LN

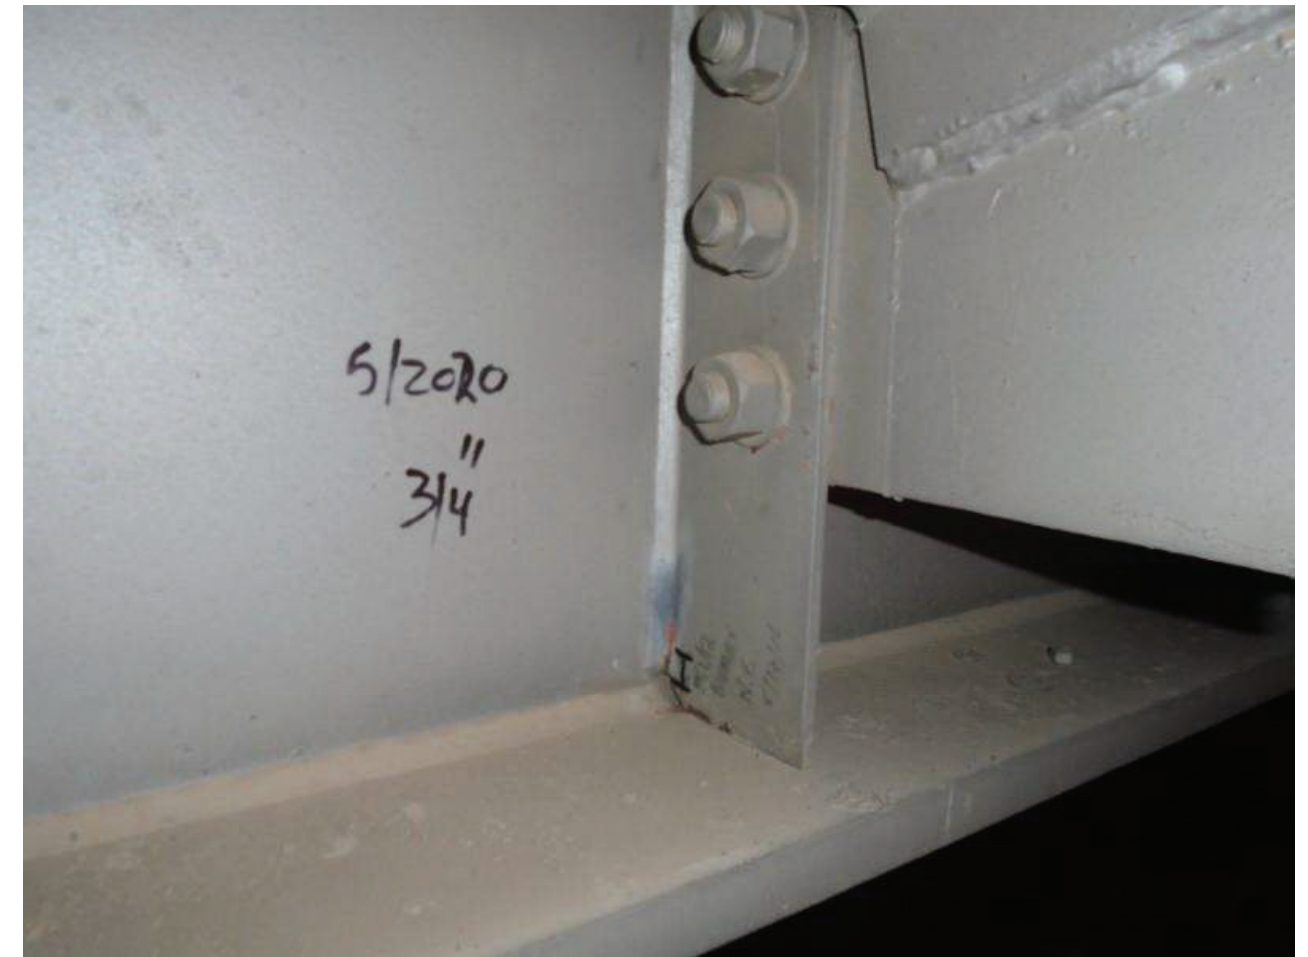
File Name : 01216-2020-05-31-Photo-28.JPG
 Description : Crack in Vertical Stiffener, Span 2, Girder 1, Diaphragm 2, LS

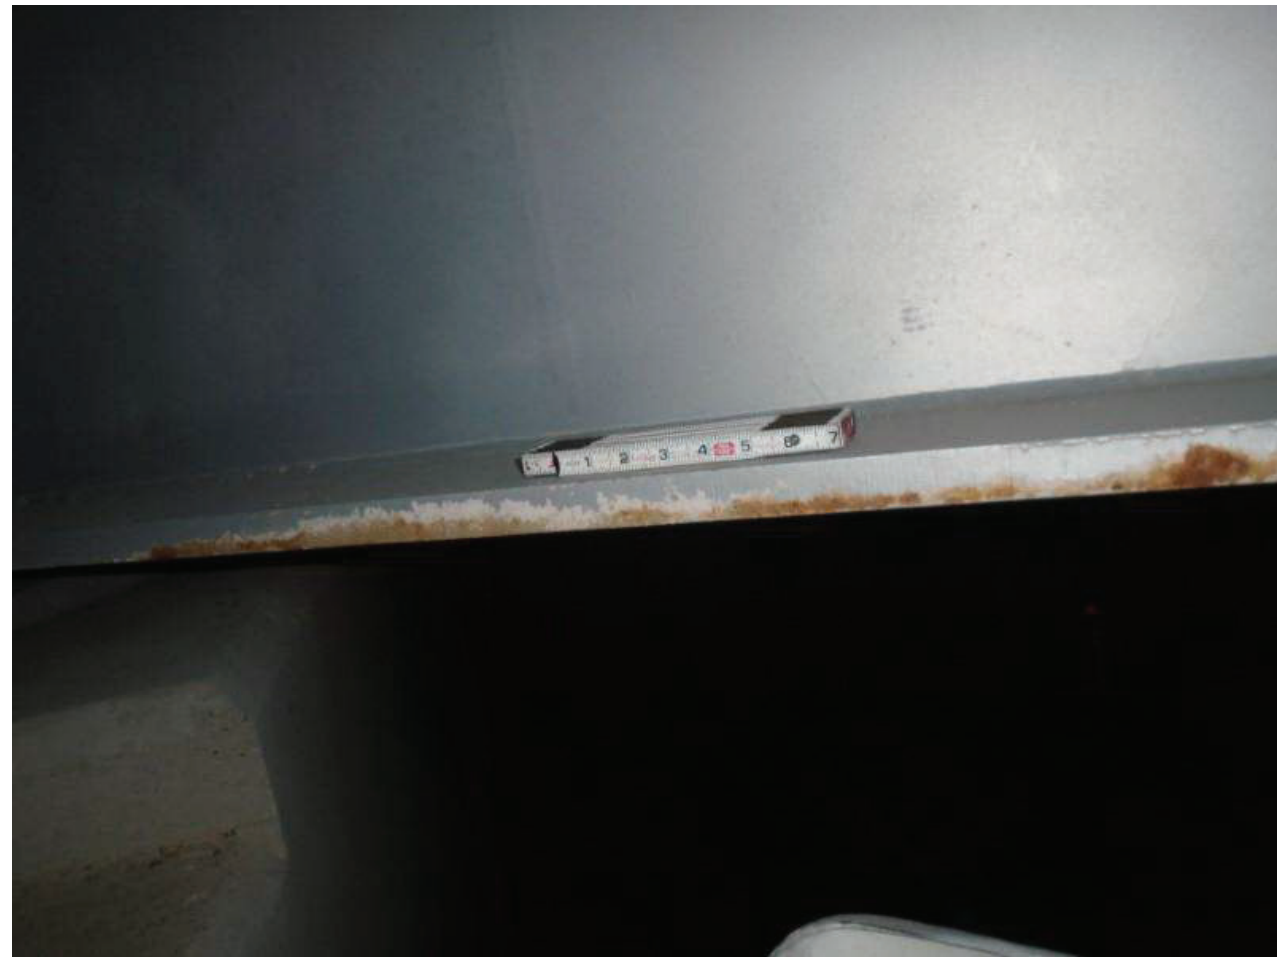
File Name : 01216-2020-05-31-Photo-29.JPG
 Description : Failing Paint, Span 3, Girder 1, Near Pier 3, LN

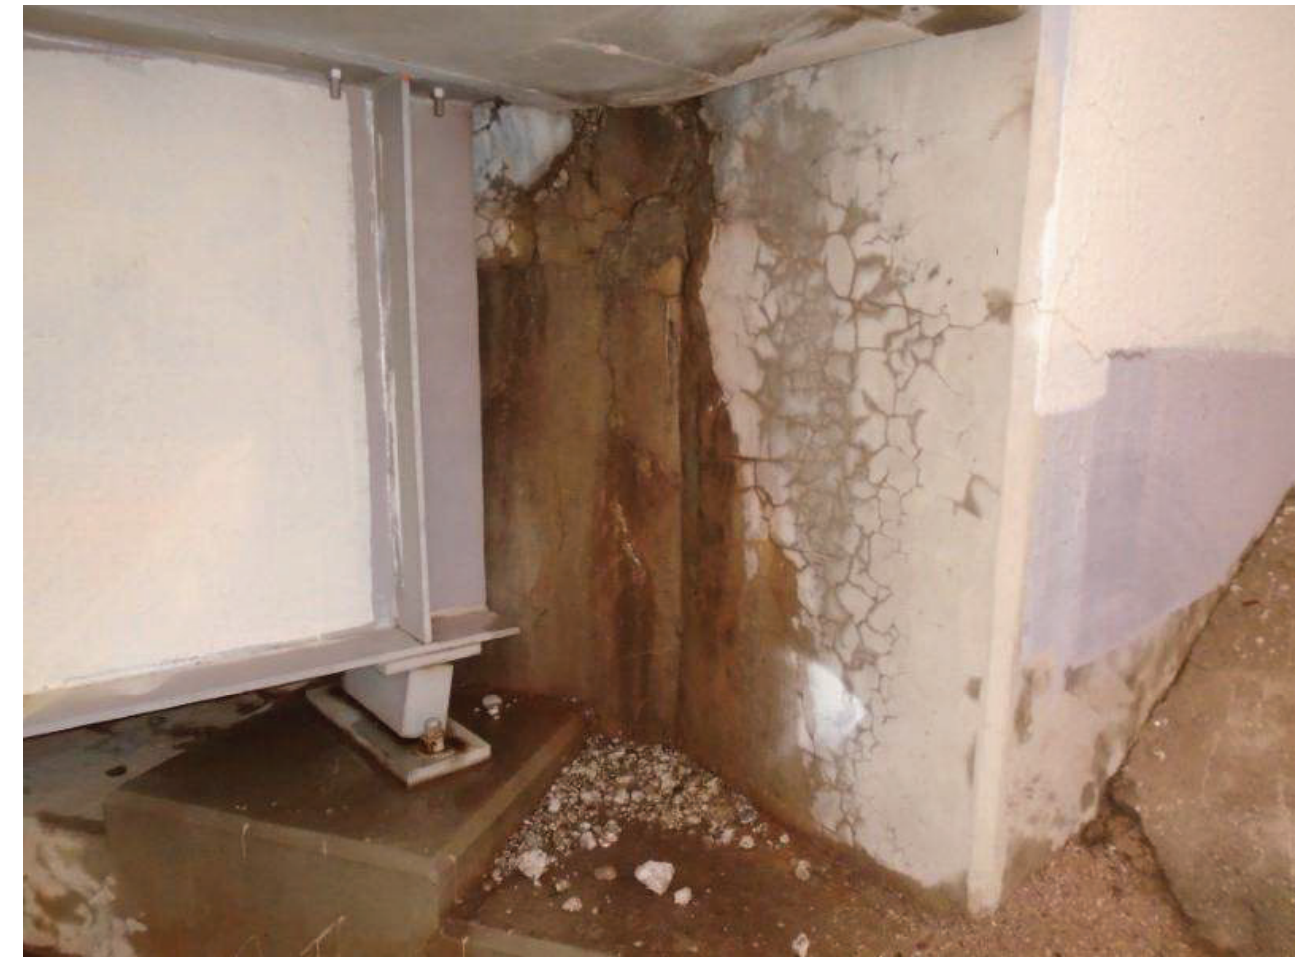
File Name : 01216-2020-05-31-Photo-30.JPG
 Description : Spalls & Map Cracks, Southeast Abutment Backwall, LNE

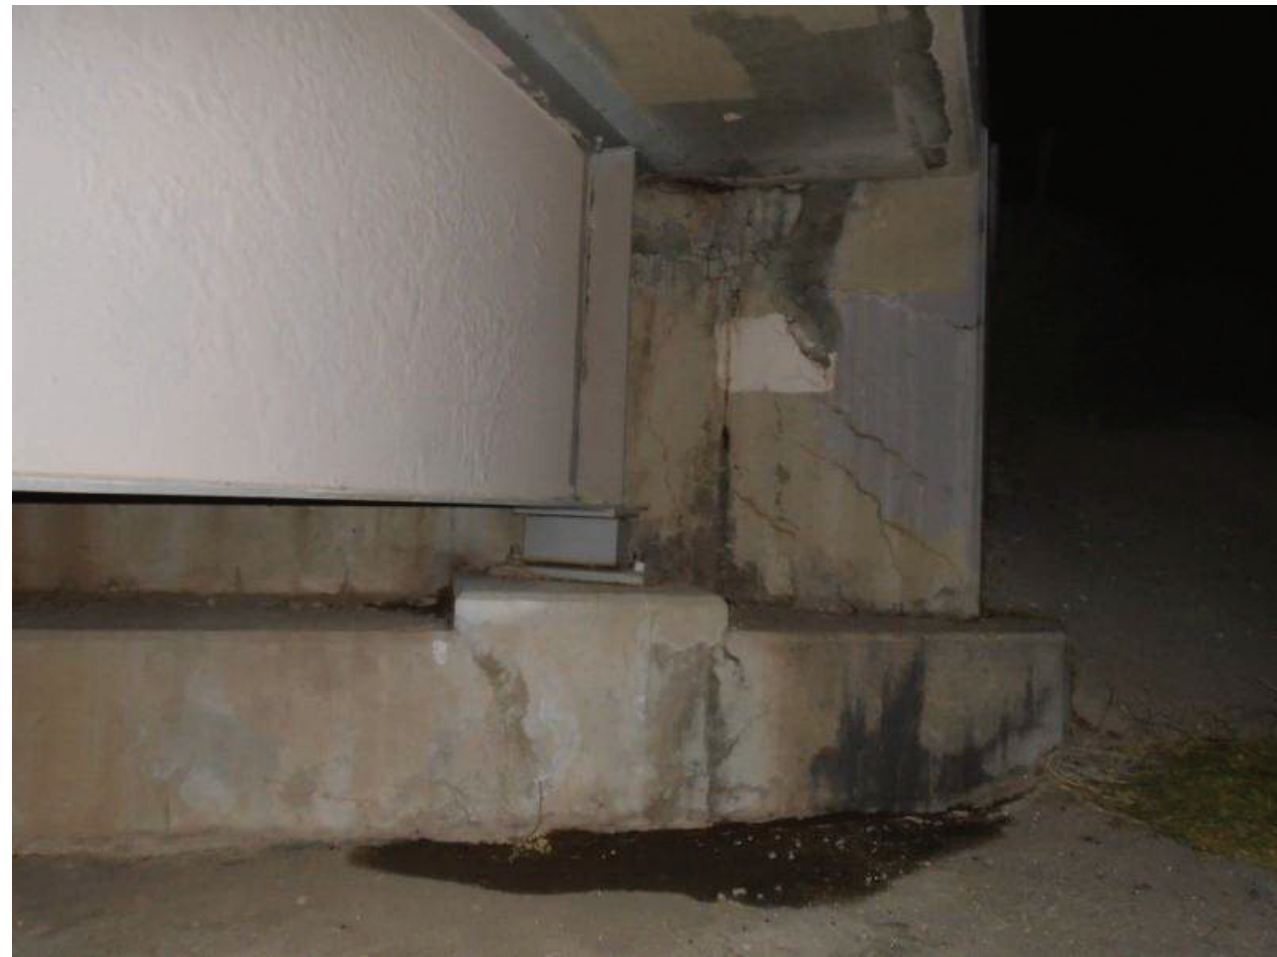
File Name : 01216-2020-05-31-Photo-31.JPG
 Description : Spalls & Map Cracks, Southwest Abutment Backwall, LW
