I-10 | LOOP 202 TO SR-387
WILD HORSE PASS CORRIDOR

Design Concept Report Appendices

Interstate 10 Corridor: State Route 202L
to State Route 387

*ADOT Project Nos. F0252 01L and F0252 02L
Federal Aid No. 010-C(222)S*

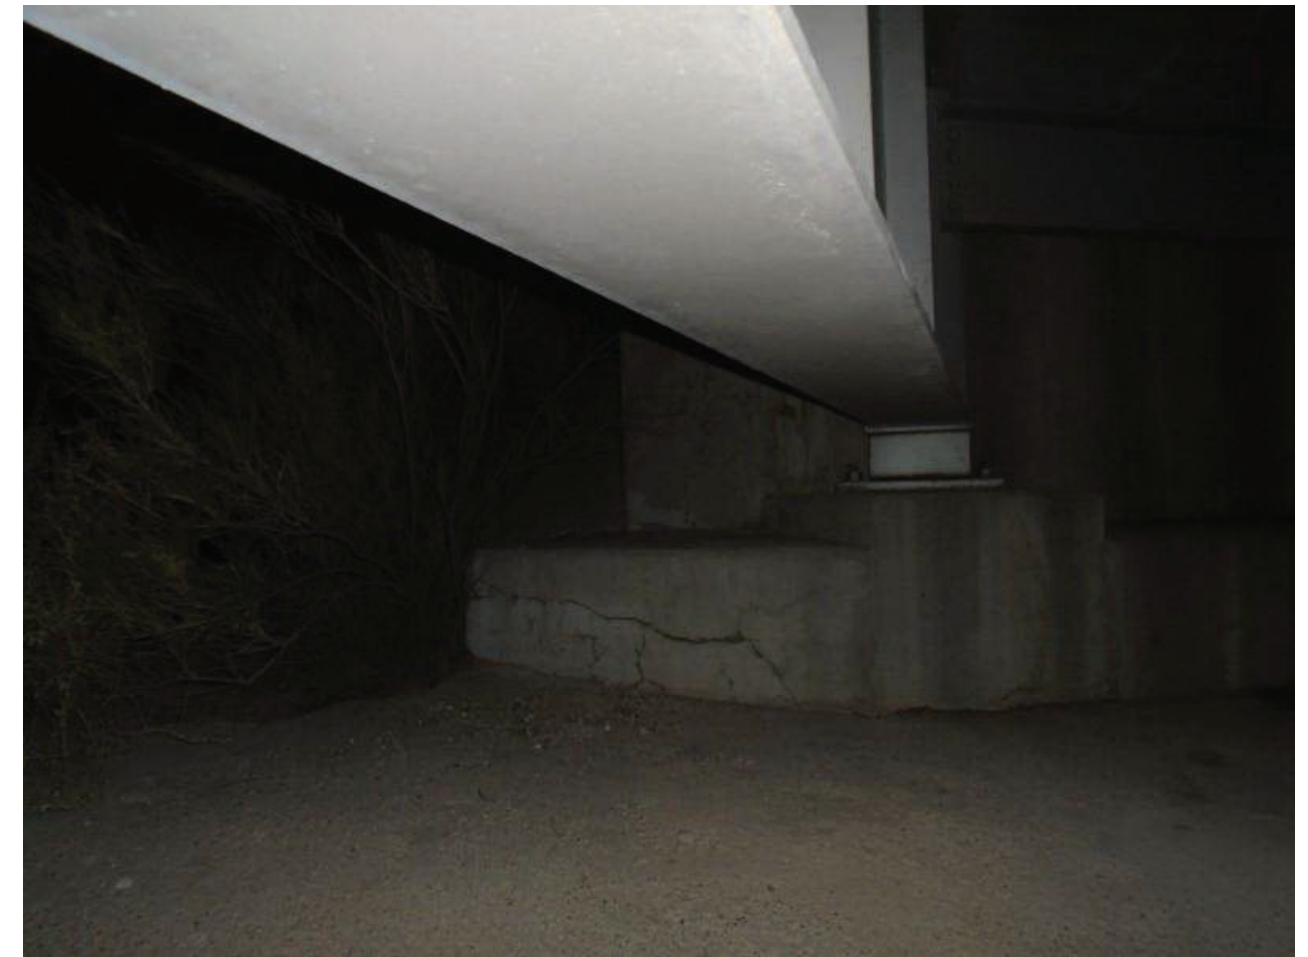
File Name : 01216-2020-05-31-Photo-32.JPG
 Description : Wide Crack, Northwest Abutment Backwall, LW

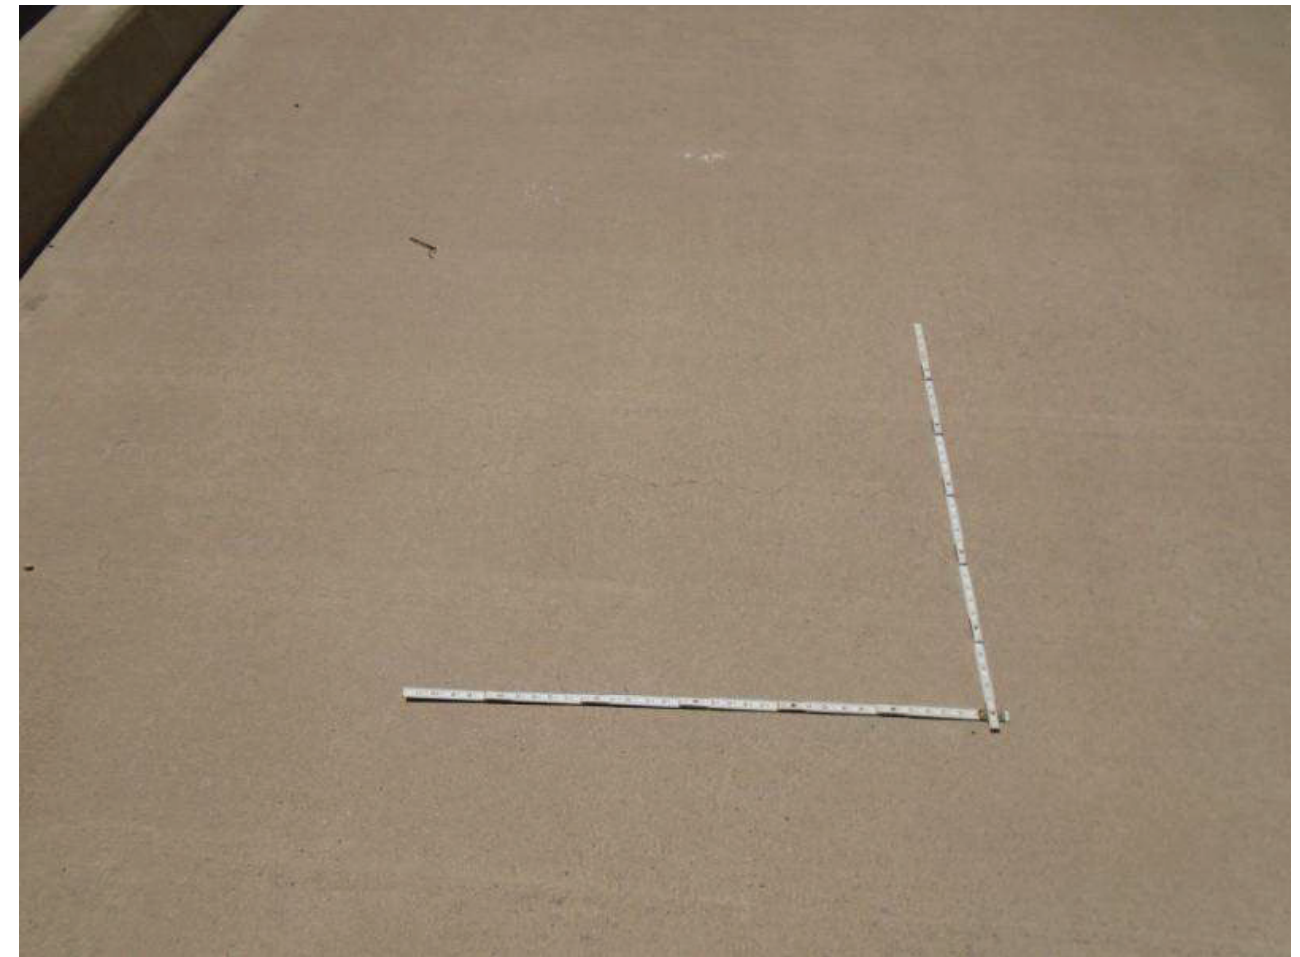
File Name : 01150-2020-05-31-Photo-6.JPG
 Description : Typical Deck Cracking

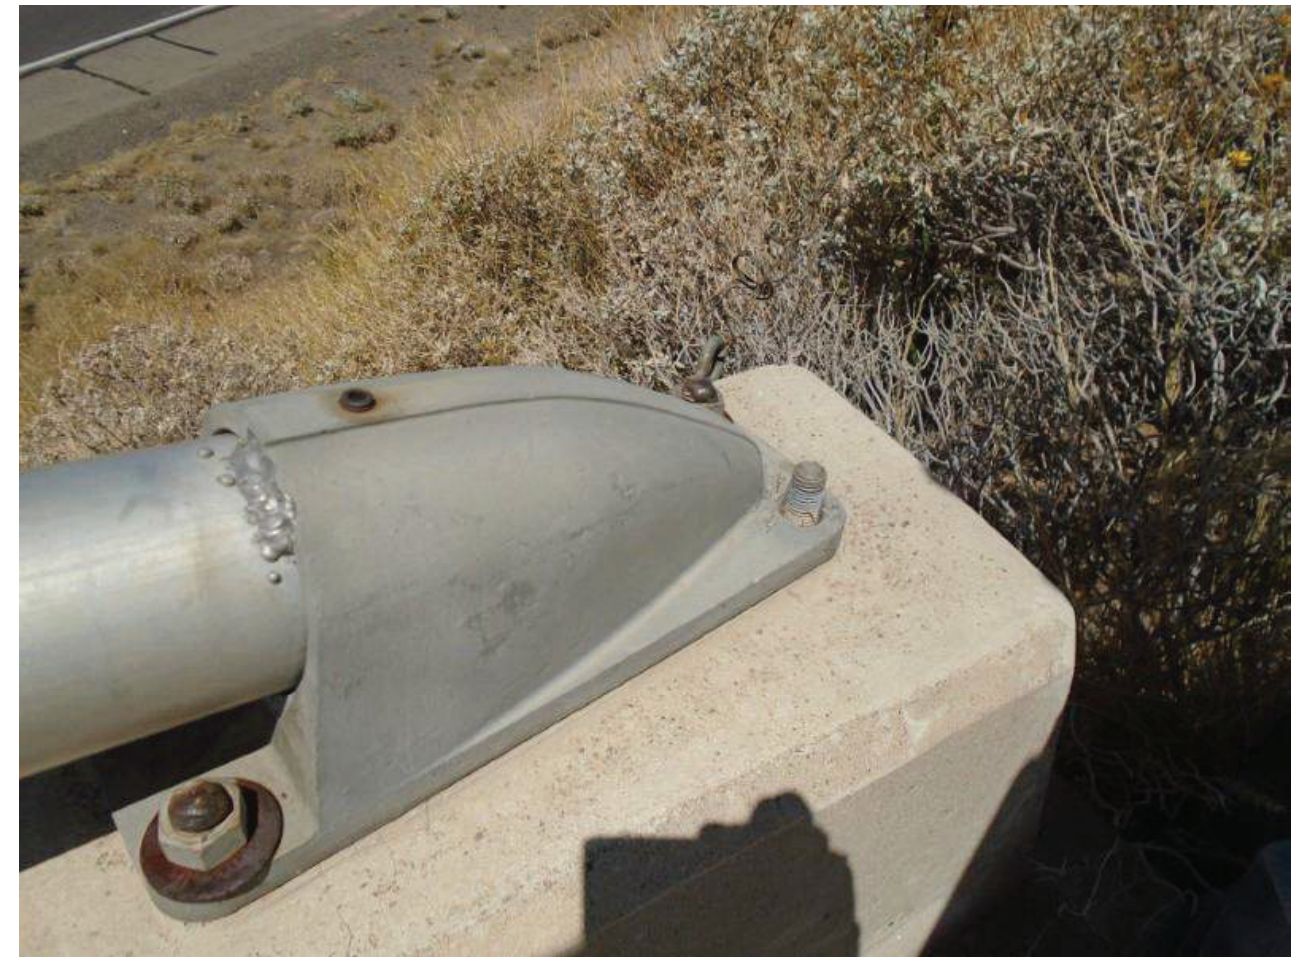
File Name : 01150-2020-05-31-Photo-8.JPG
 Description : Typical Missing Nuts, End of Metal Railing

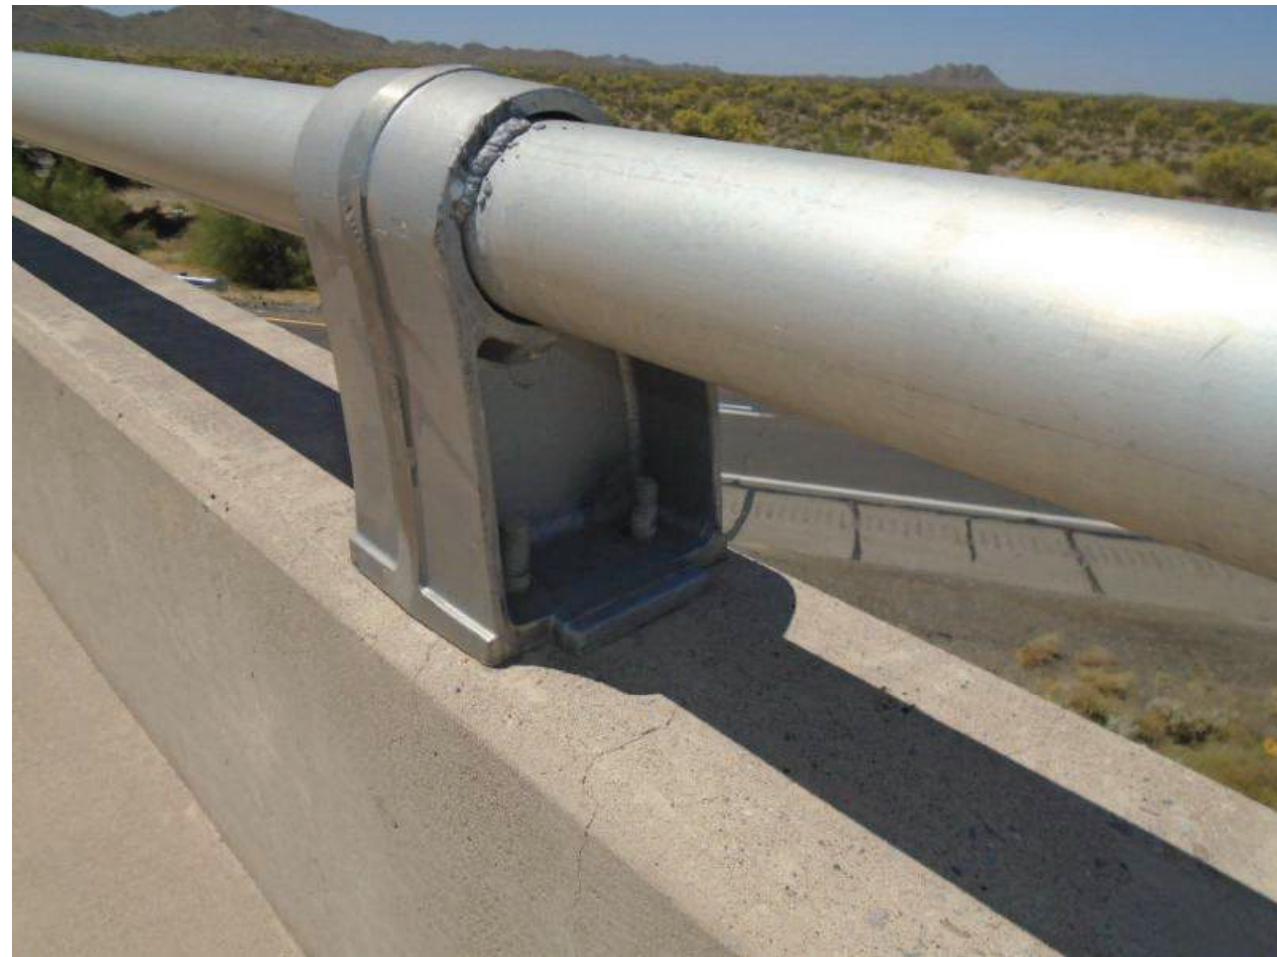
File Name : 01150-2020-05-31-Photo-9.JPG
 Description : Typical Missing Nuts, Intermediate Metal Railing Support

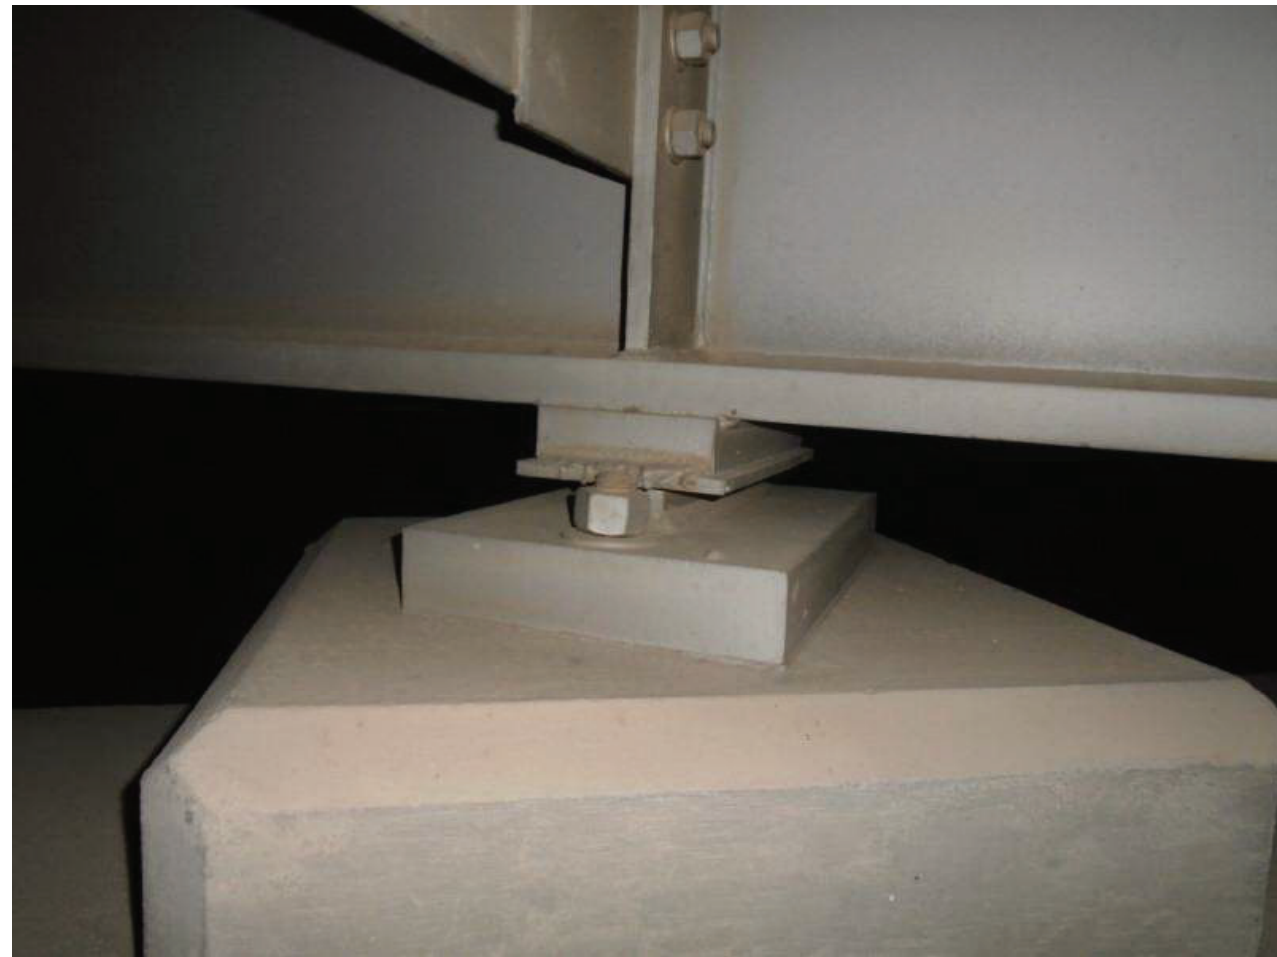
File Name : 01150-2020-05-31-Photo-13.JPG
 Description : Pier 3, Typical Bearing Condition, LSW

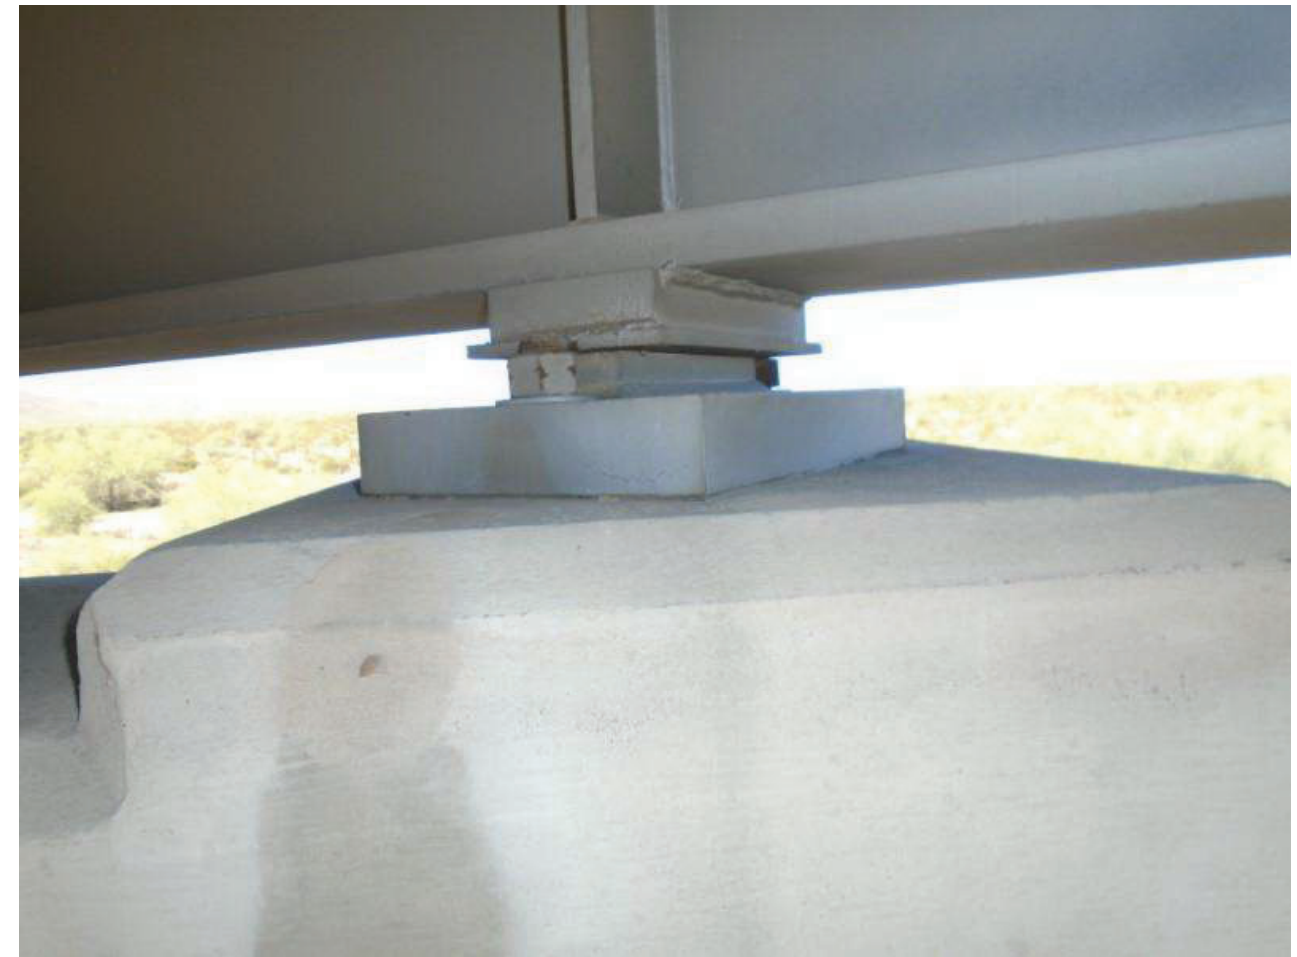
File Name : 01150-2020-05-31-Photo-14.JPG
 Description : Pier 2, Typical Bearing Condition, LSW

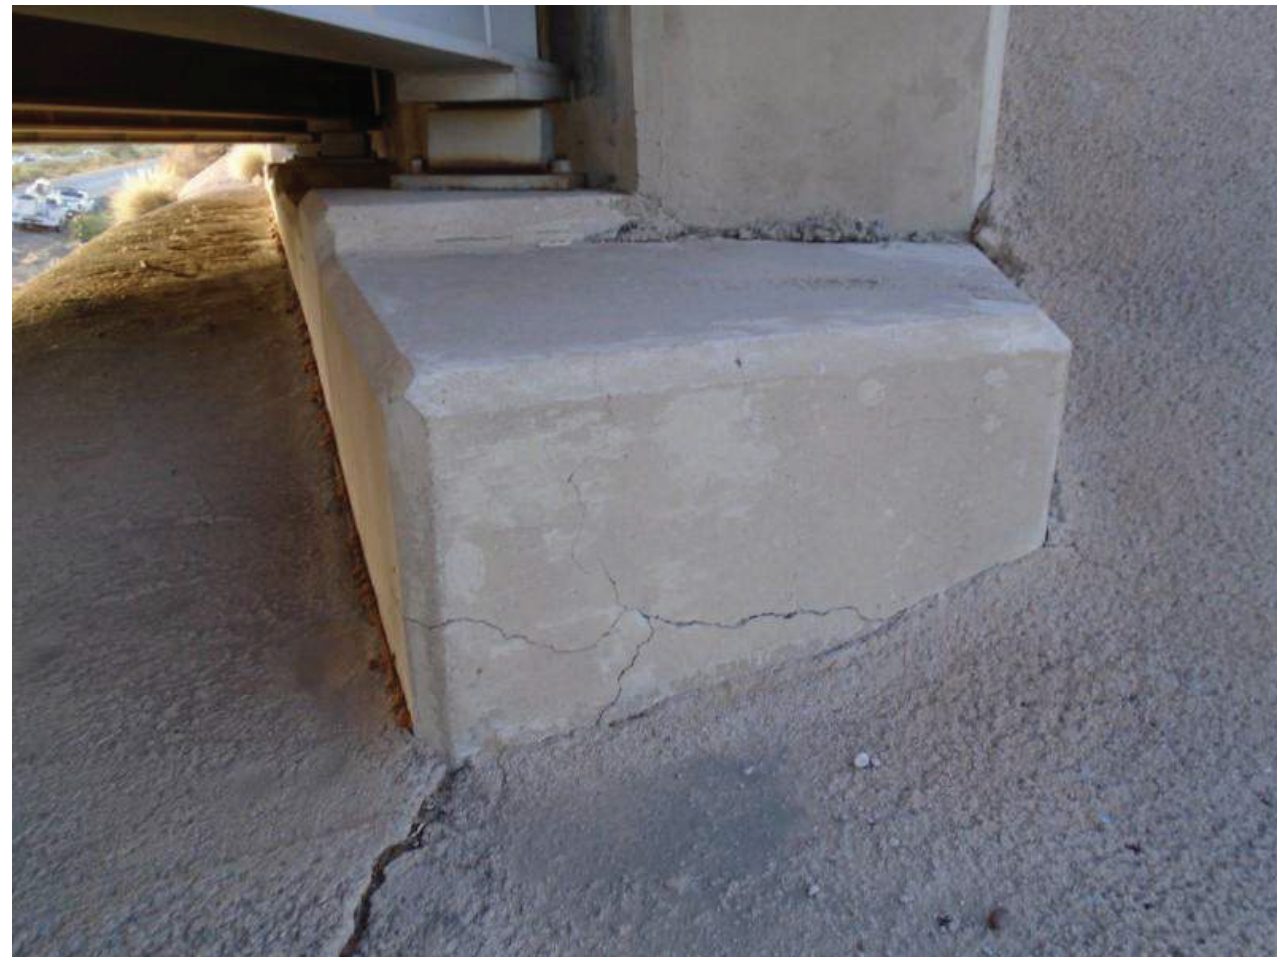
File Name : 01150-2020-05-31-Photo-19.JPG
 Description : Wide Map Cracks, East End of North Abutment, LNW

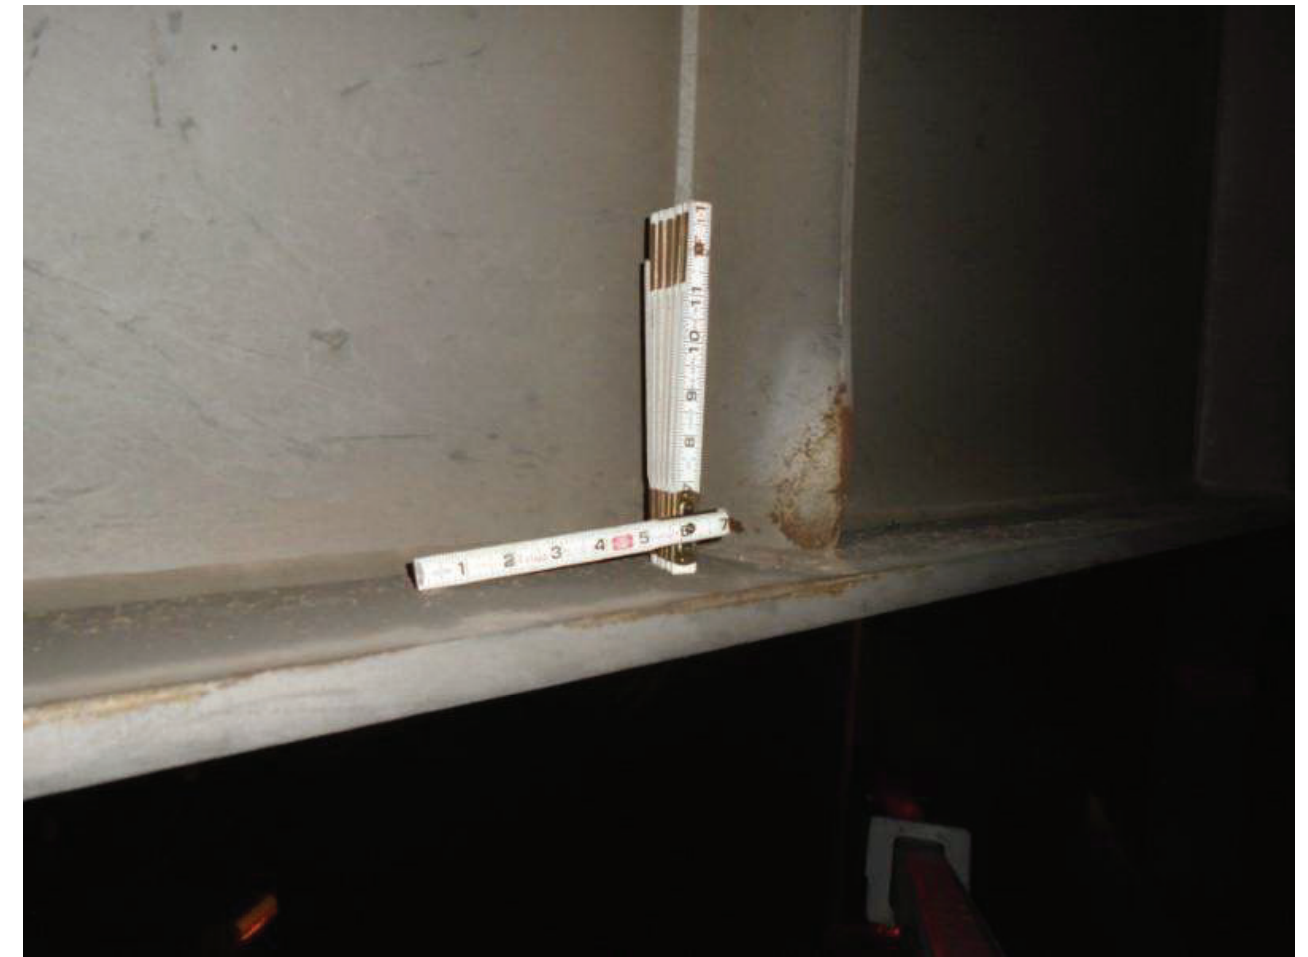
File Name : 01150-2020-05-31-Photo-24.JPG
 Description : Cracked Diaphragm Stiffener, Span 4, Girder 2, Bay 2, LW

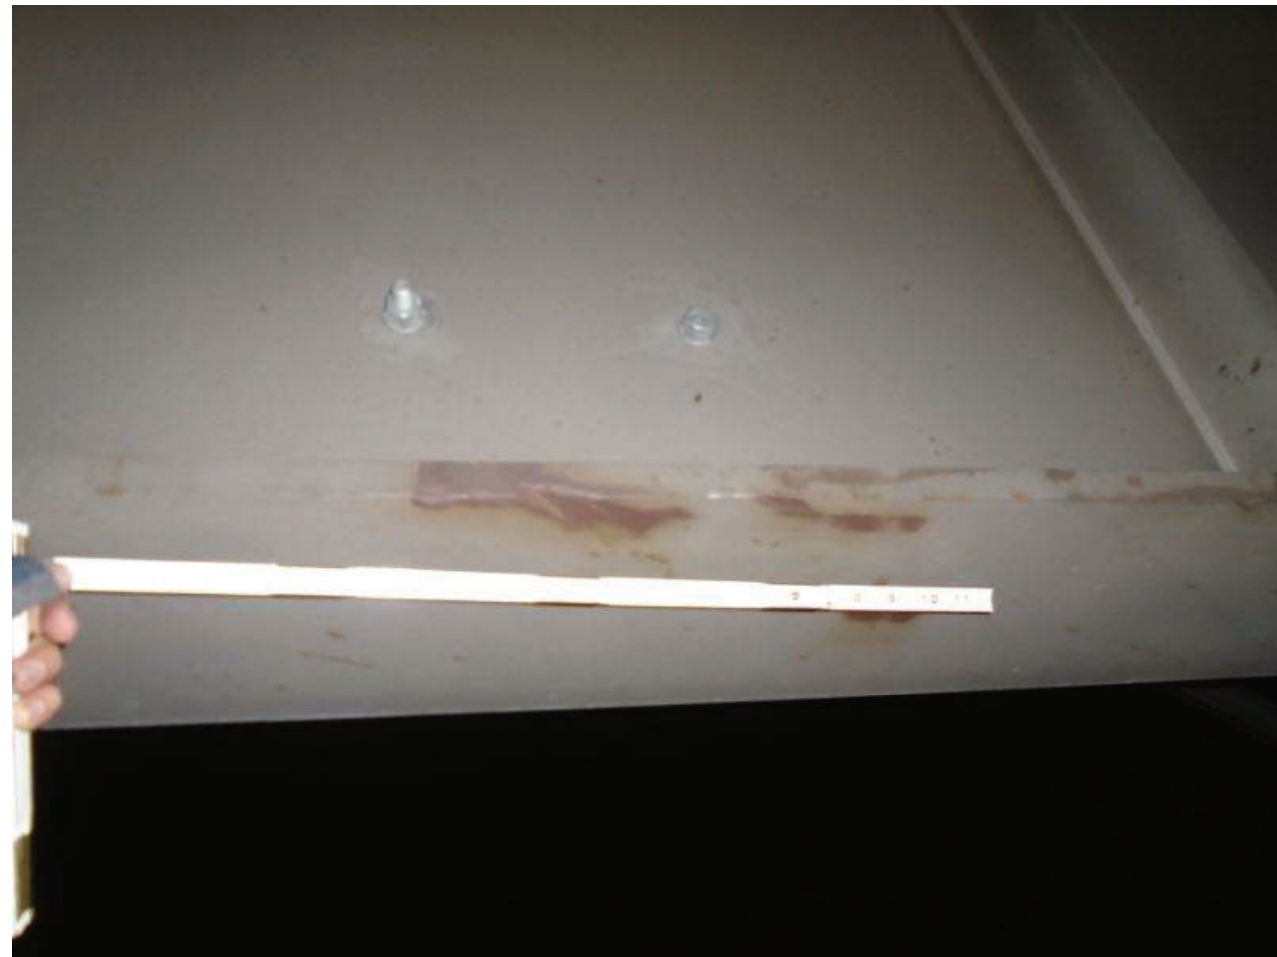
File Name : 01150-2020-05-31-Photo-25.JPG
 Description : Impact Damage, Span 2, Girder 4, Over Left Lane, LE

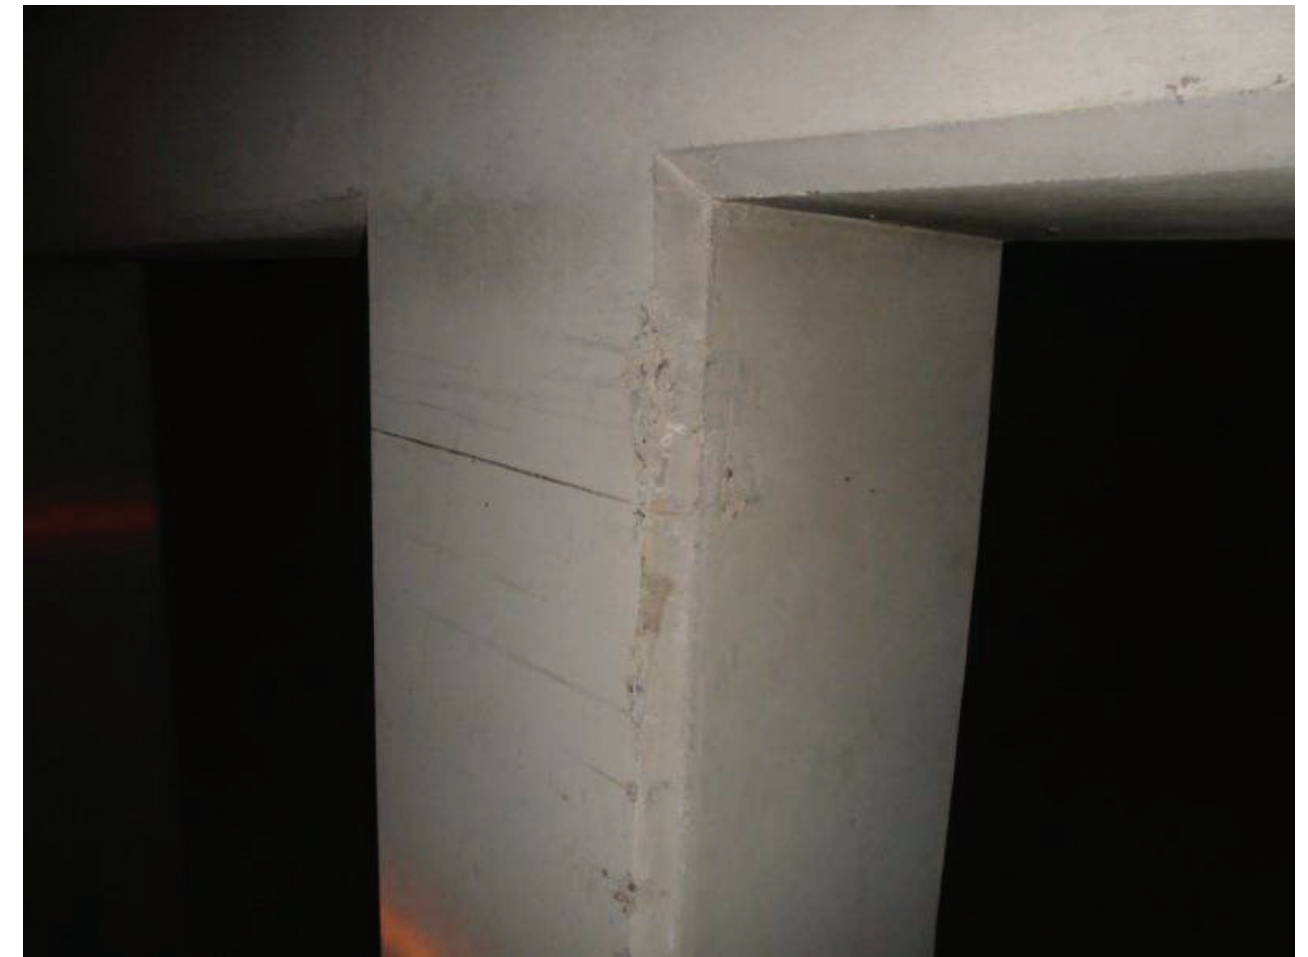
File Name : 01150-2020-05-31-Photo-26.JPG
 Description : Spall with Scrape Marks, Pier 2, Second Column from East, LE

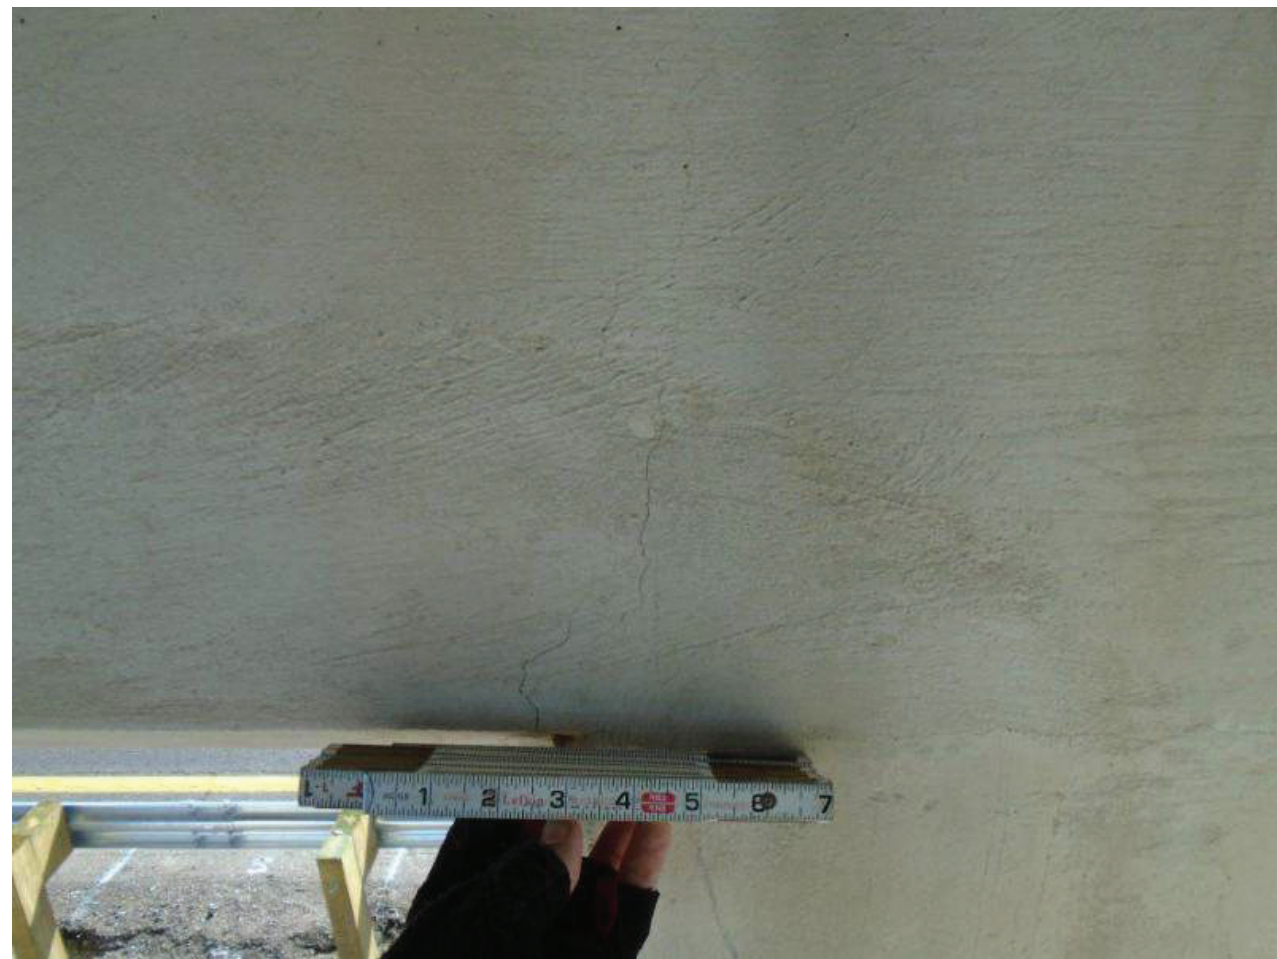
File Name : 01150-2020-05-31-Photo-27.JPG
 Description : Vertical Cracks, Pier 3 Cap, at Column 4, LN

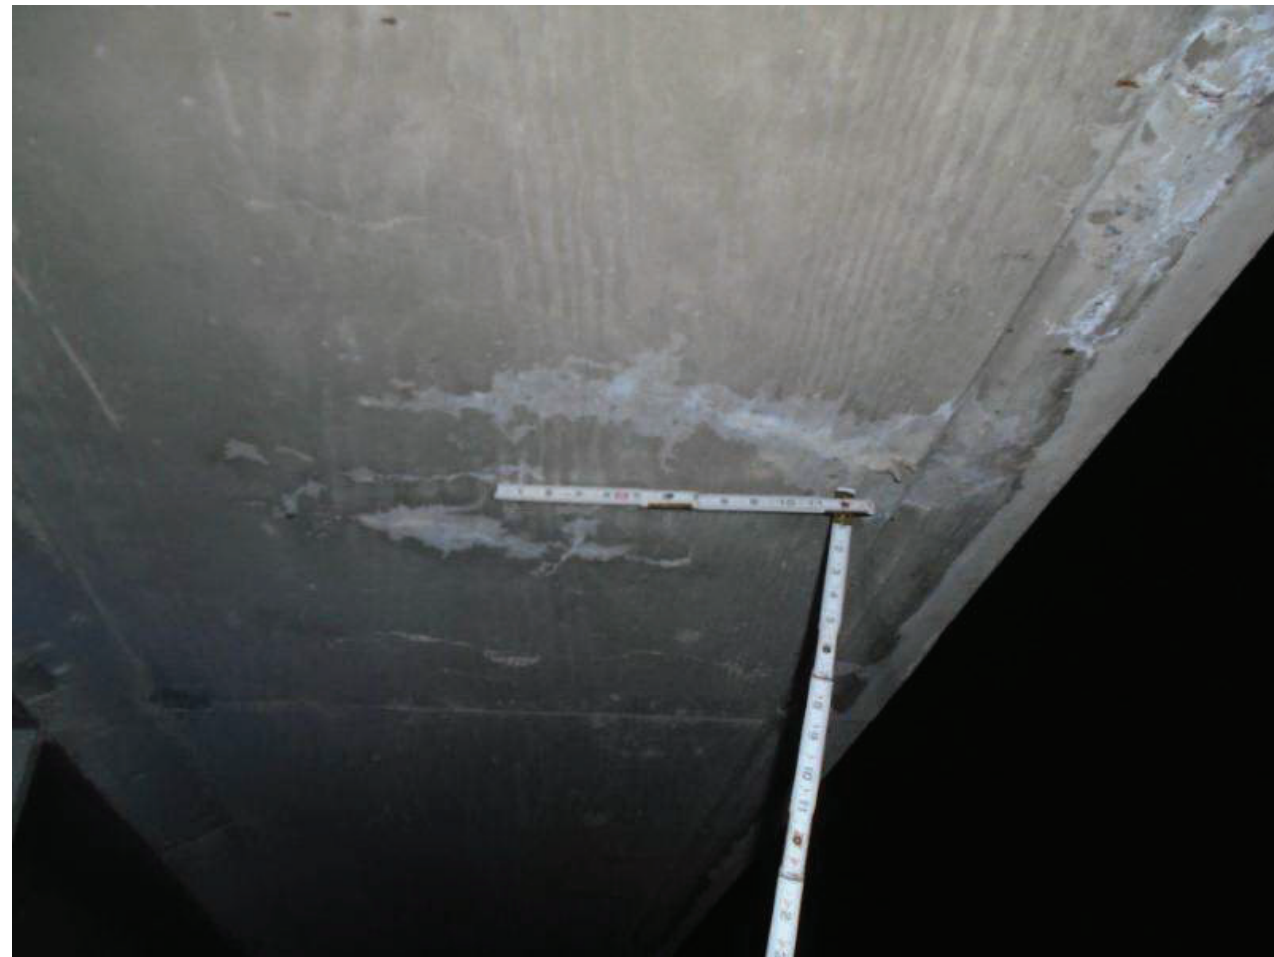
File Name : 01151-2020-05-22-Photo-22.JPG
 Description : Typical Cracks with Efflorescence, Soffit Overhang

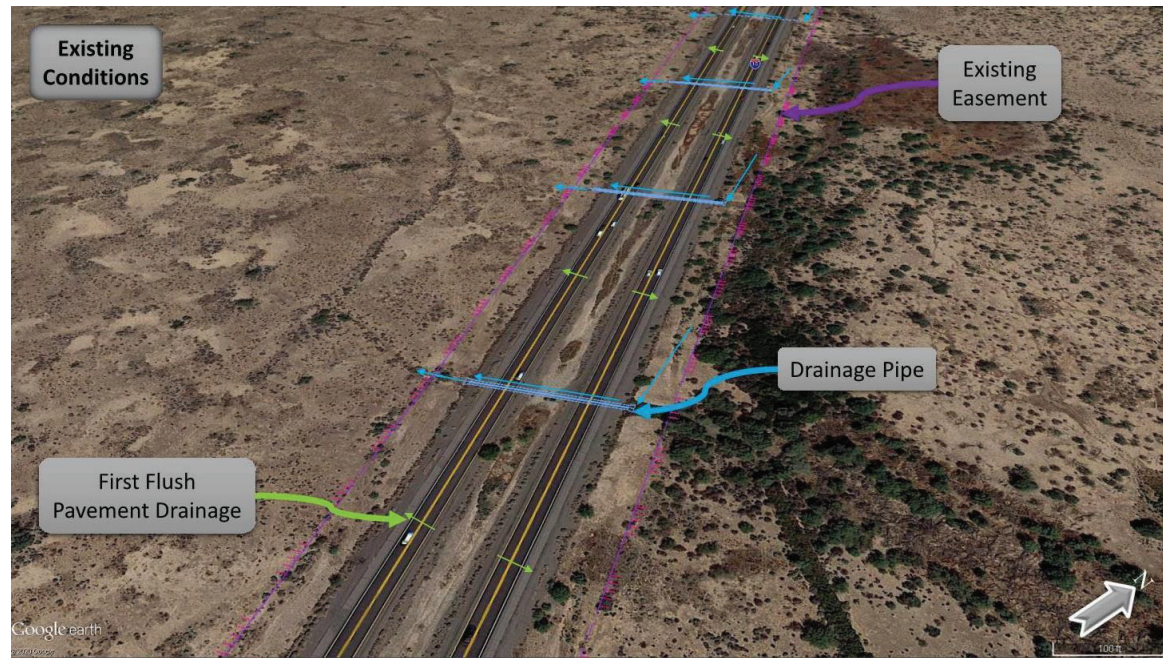
Exhibit 1a: SR-202L to Gila River – Existing Condition

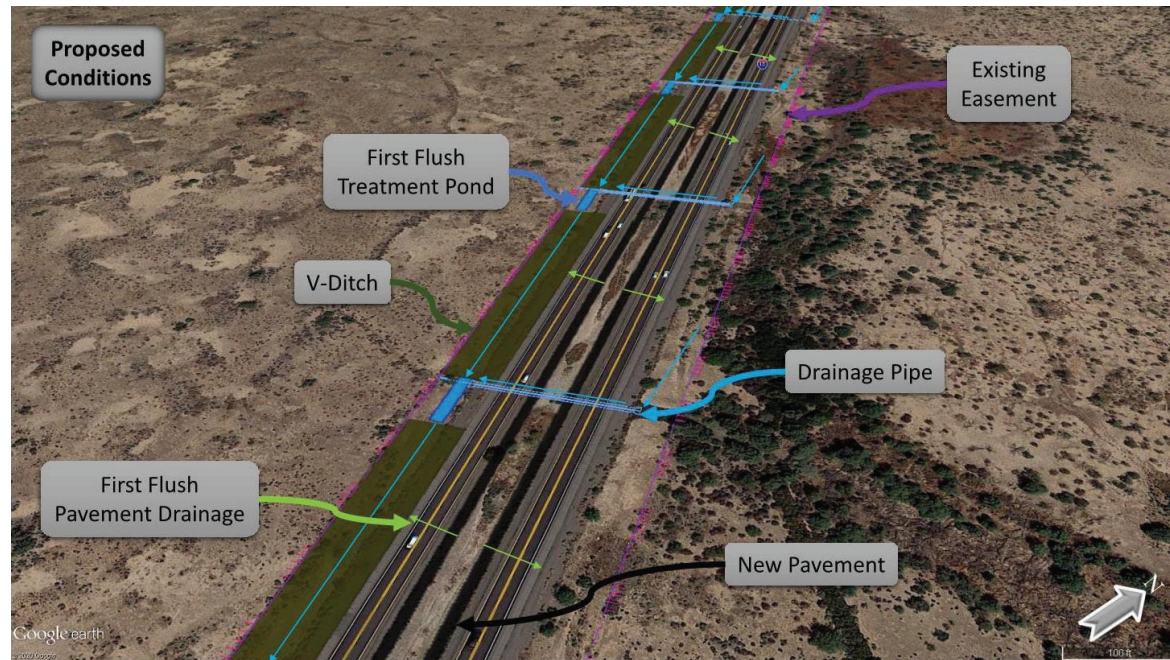
Exhibit 1b: SR-202L to Gila River – Proposed First Flush Water Quality Solution

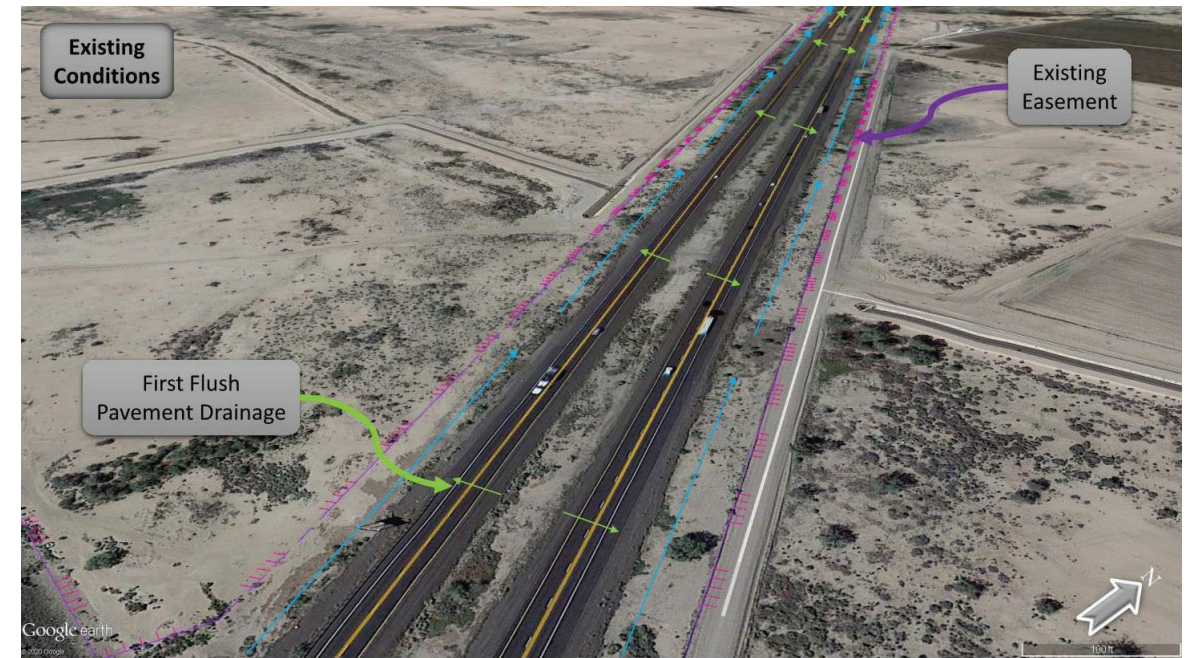
Exhibit 2a: Gila River to SR-587 – Existing Condition

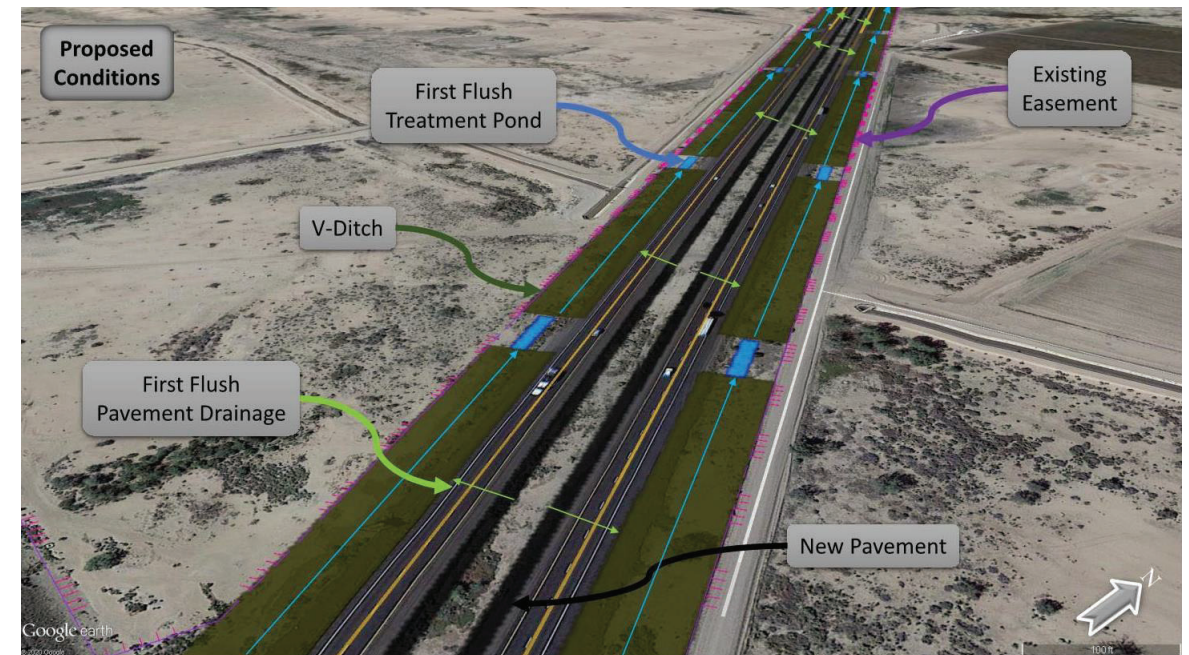
Exhibit 2b: Gila River to SR-587 – Proposed First Flush Water Quality Solution

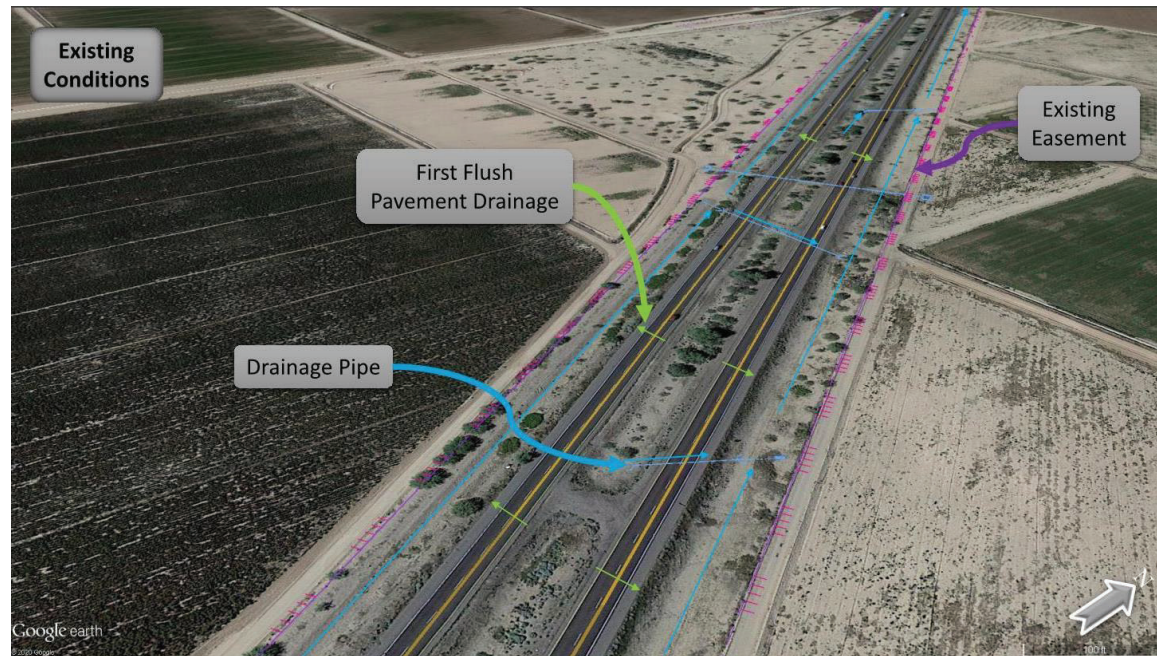
Exhibit 3a: SR-587 to South of SR-387 – Existing Condition

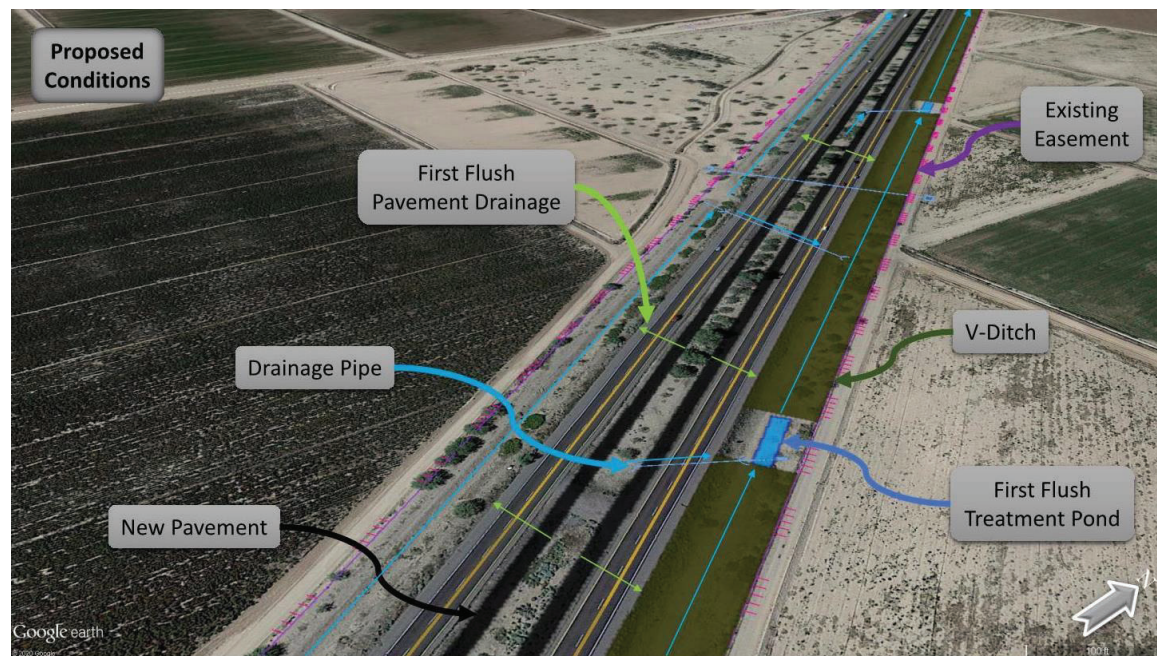
Exhibit 3b: SR-587 to South of SR-387 – Proposed First Flush Water Quality Solution
