I-10 | LOOP 202 TO SR-387
WILD HORSE PASS CORRIDOR

Draft Design Concept Report Appendix Volume

Interstate 10 Corridor: State Route 202L
to State Route 387

*ADOT Project Nos. F0252 01L and F0252 02L
Federal Aid No. 010-C(222)S*

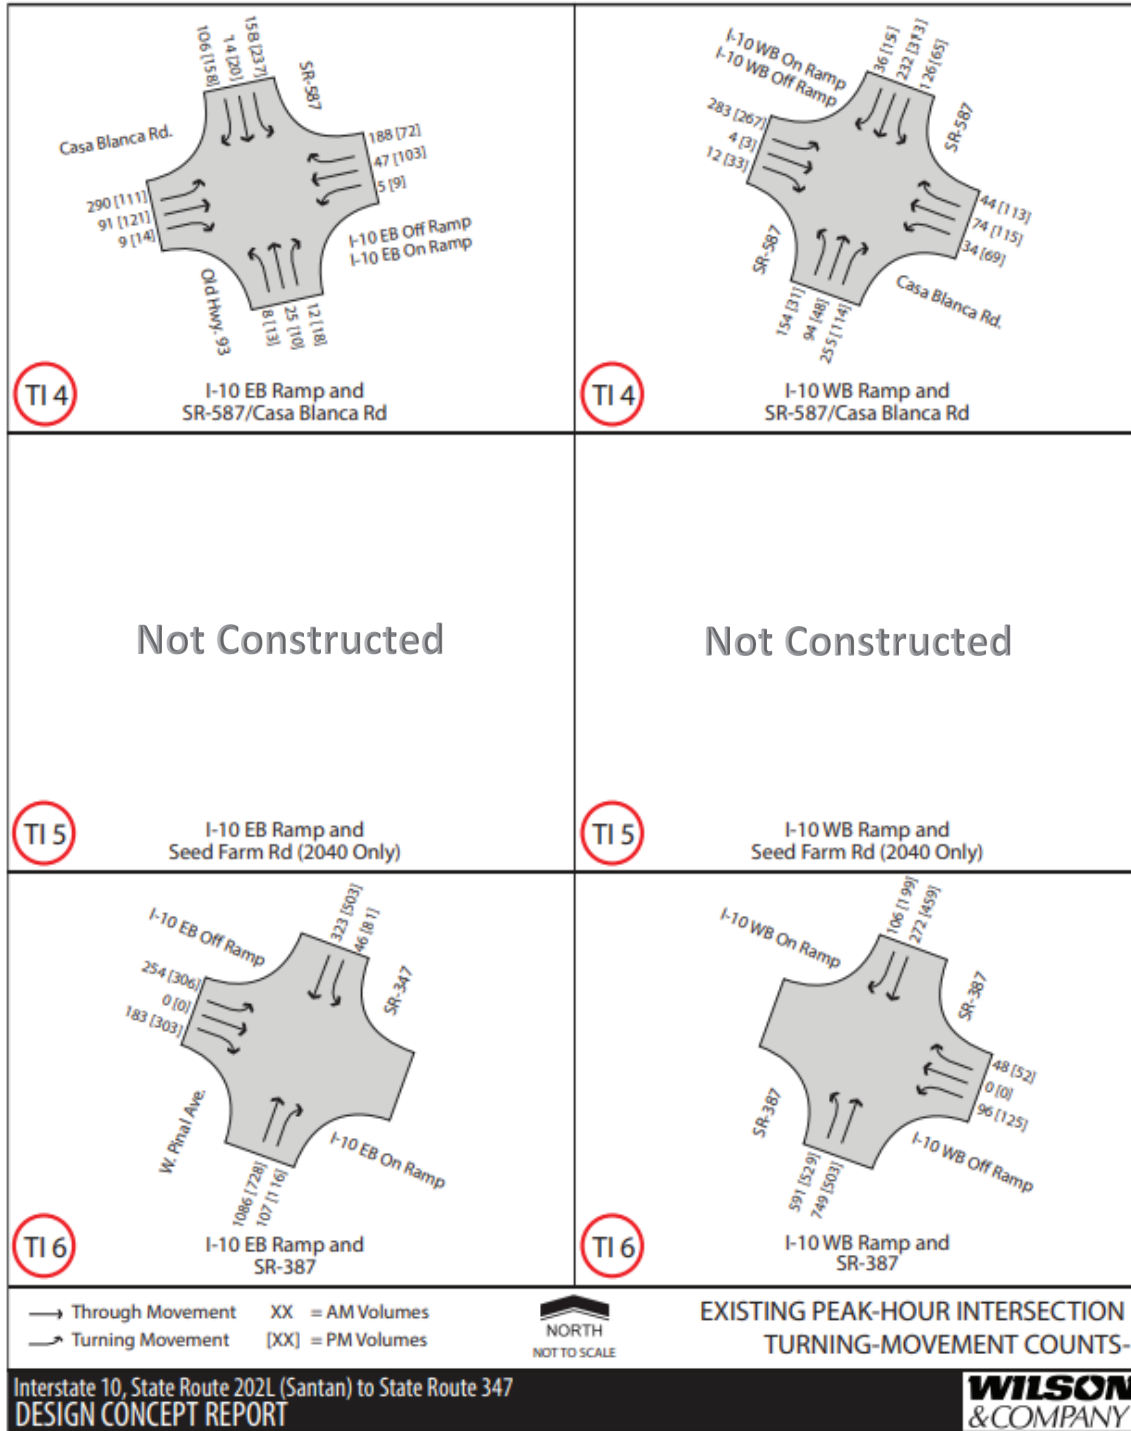
Figure 3: Existing Turning Movement Counts Continued

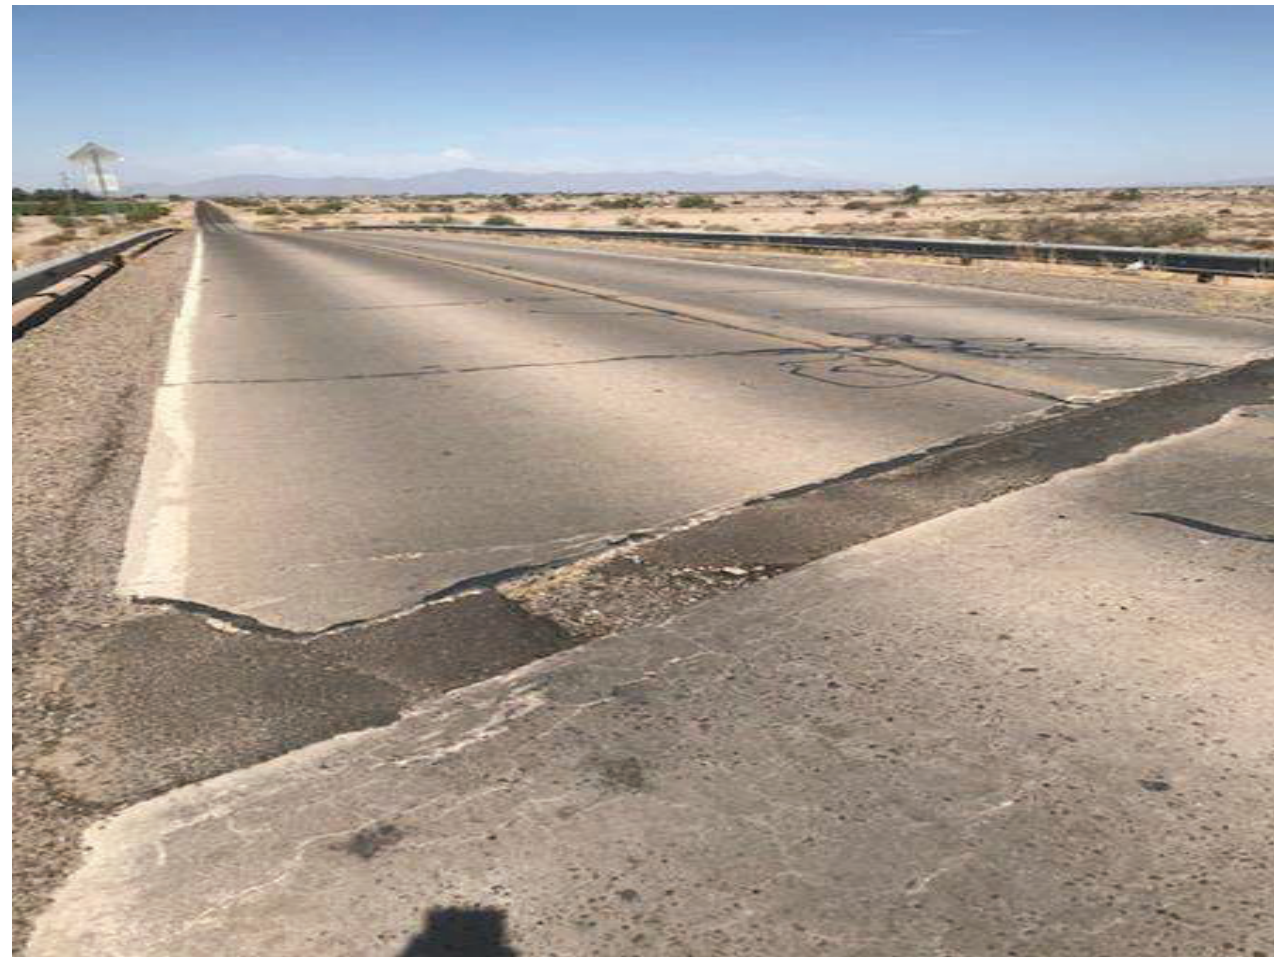
File Name : 01213-2021-05-18-Photo-7.jpg
 Description : AC deterioration, east approach, with settlement

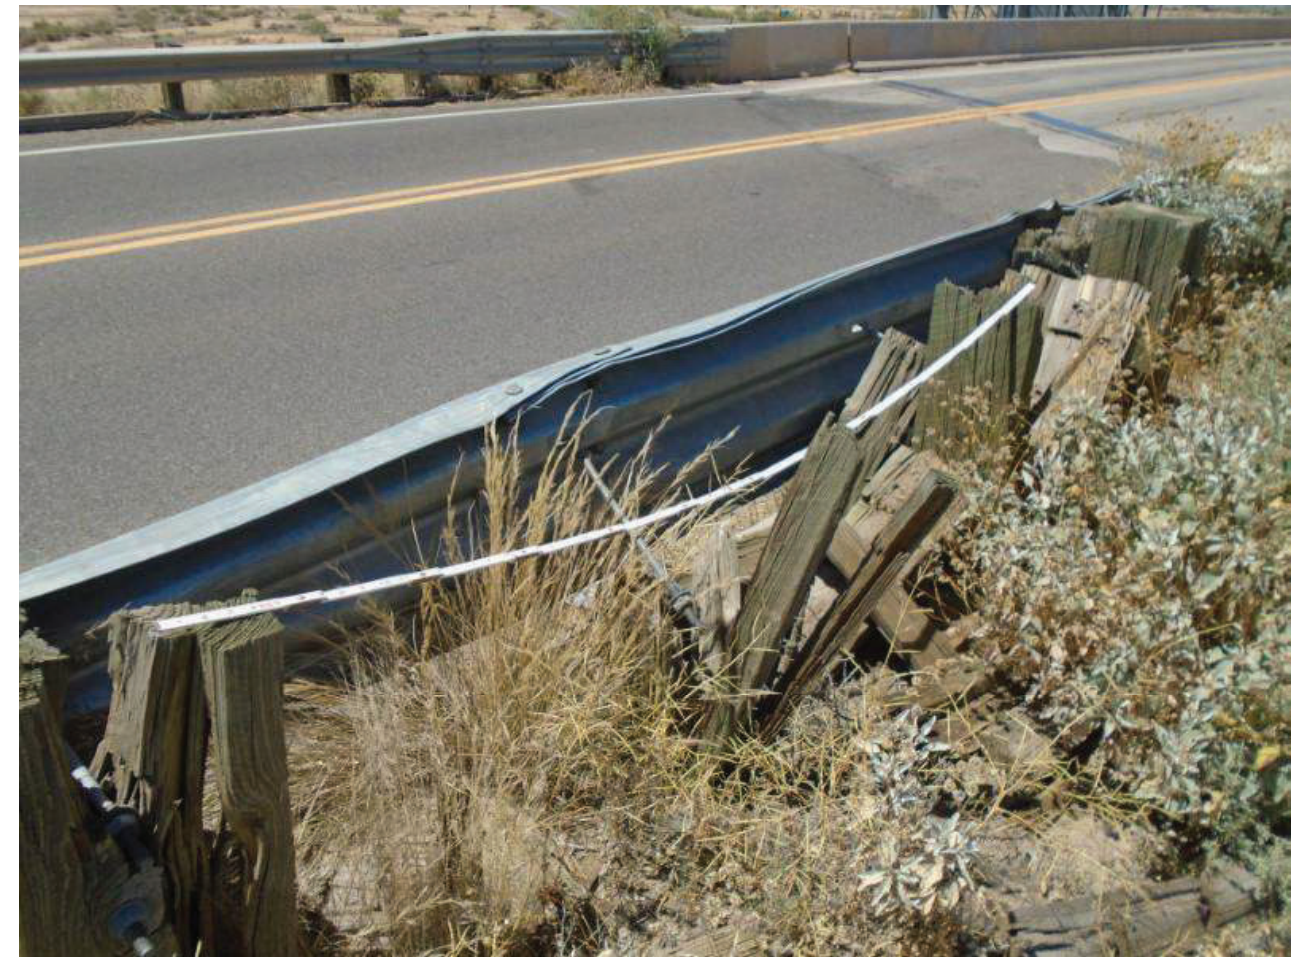
File Name : 01214-2020-05-31-Photo-9.JPG
 Description : Impact Damage, SE Approach Transition, LN

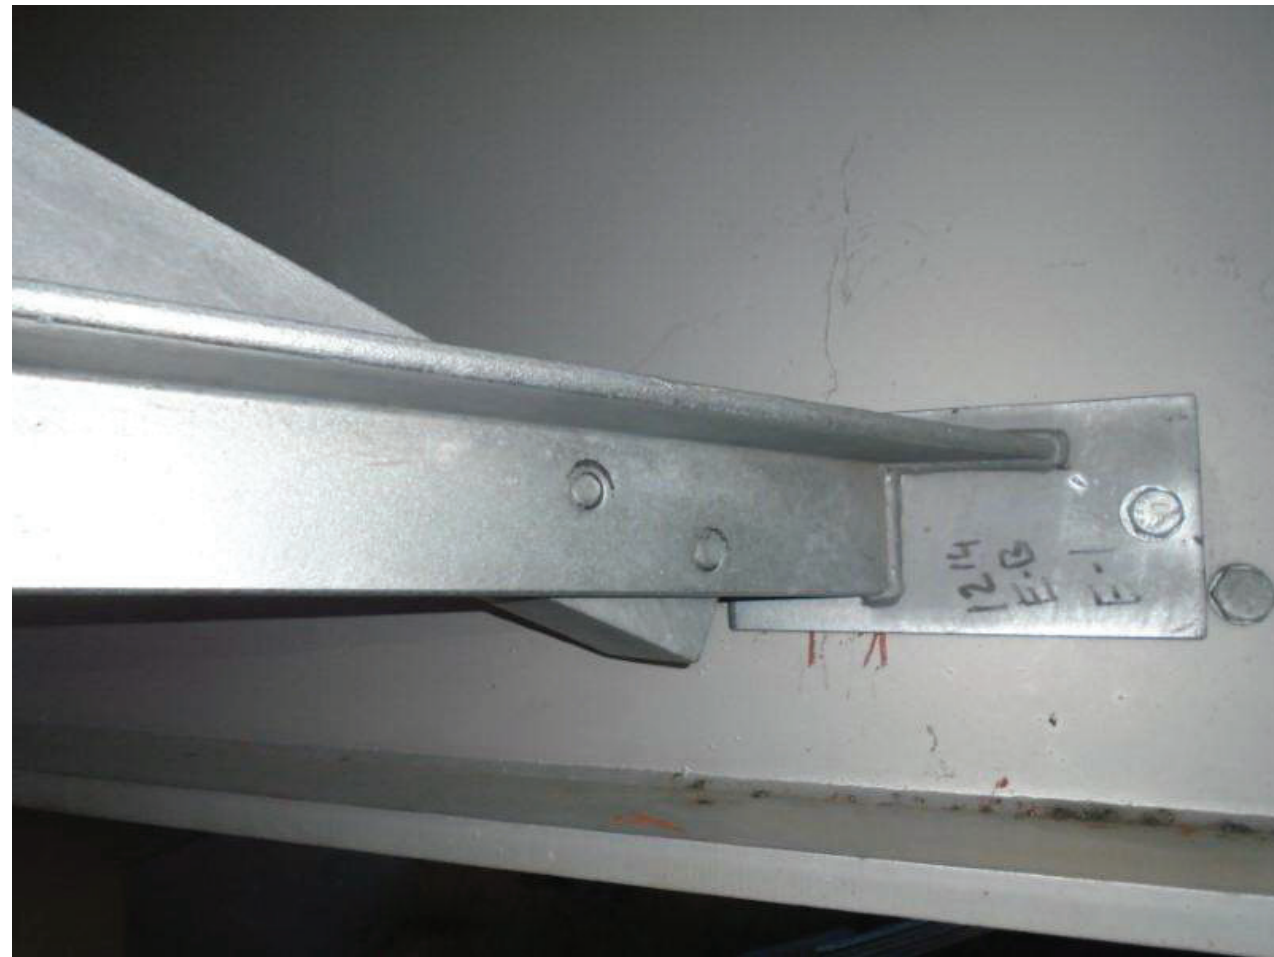
File Name : 01214-2020-05-31-Photo-24.JPG
 Description : Loose Connection, Wrong Way Sign Support, Span 3, LSW

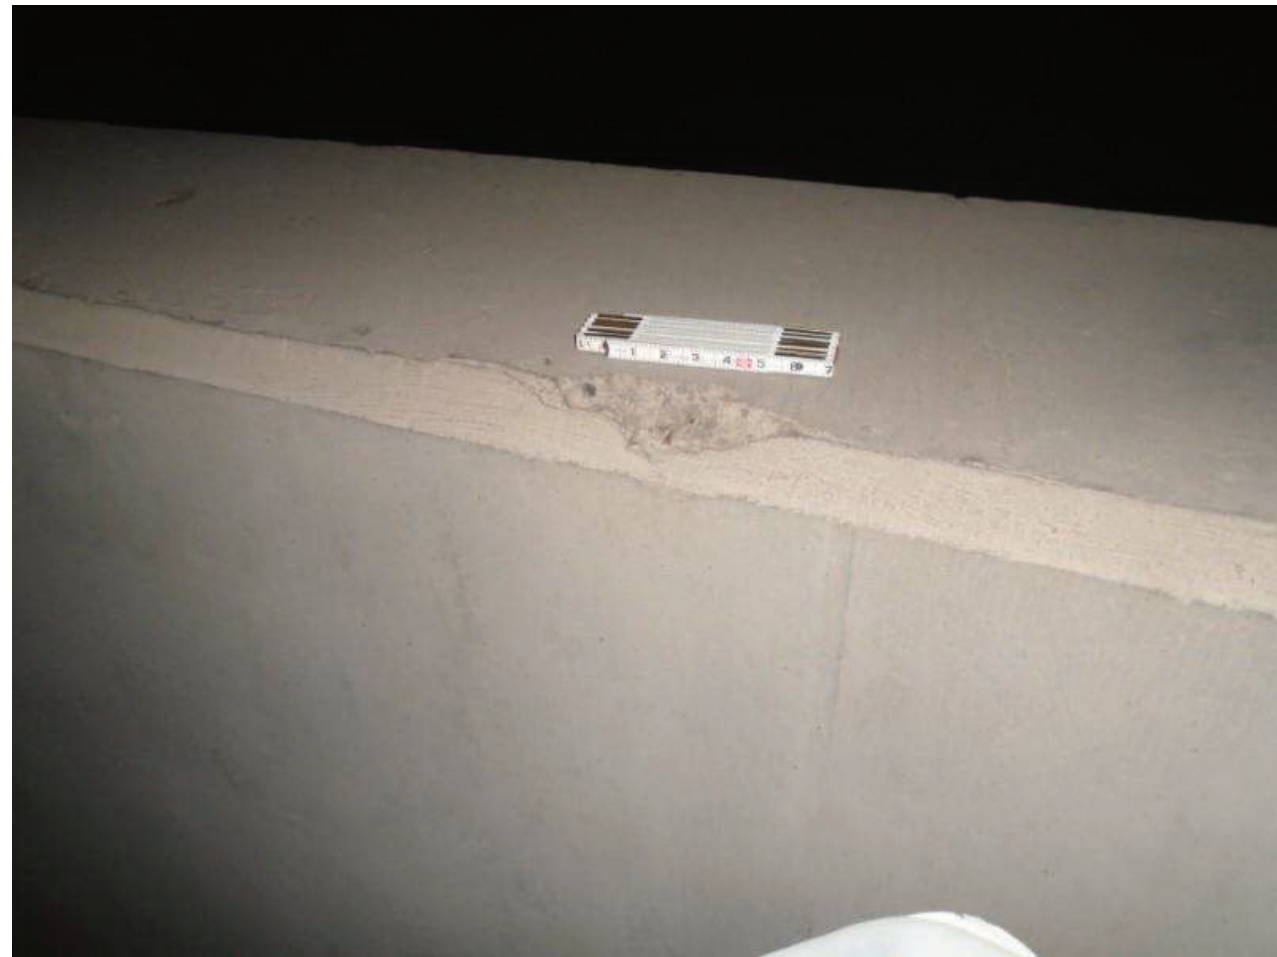
File Name : 01214-2020-05-31-Photo-26.JPG
 Description : Edge Spall, Pier 1 Cap, Bay 2, South Side, LN

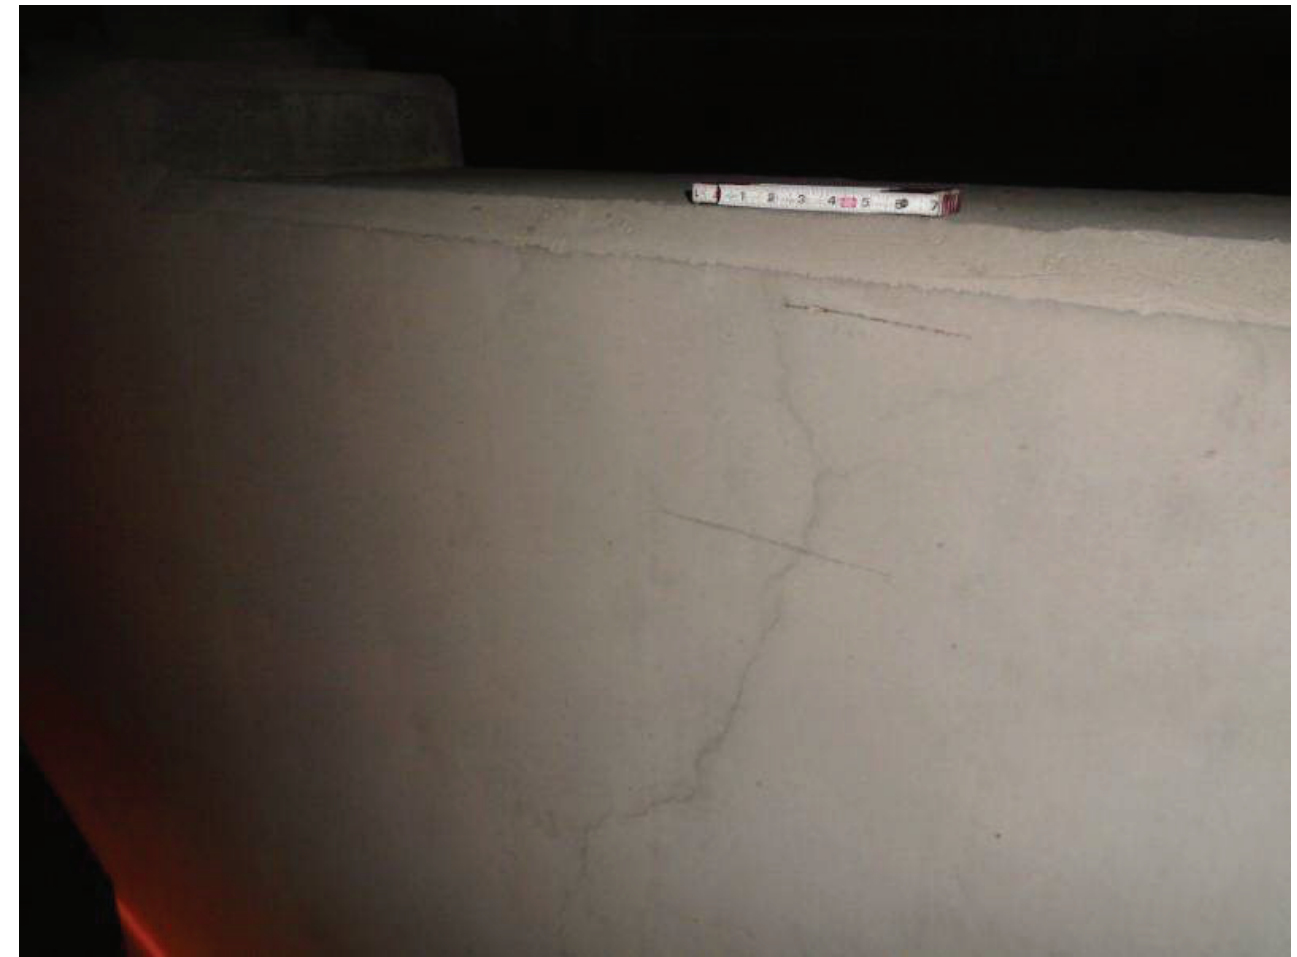
File Name : 01214-2020-05-31-Photo-27.JPG
 Description : Typical Pier Cap Cracks

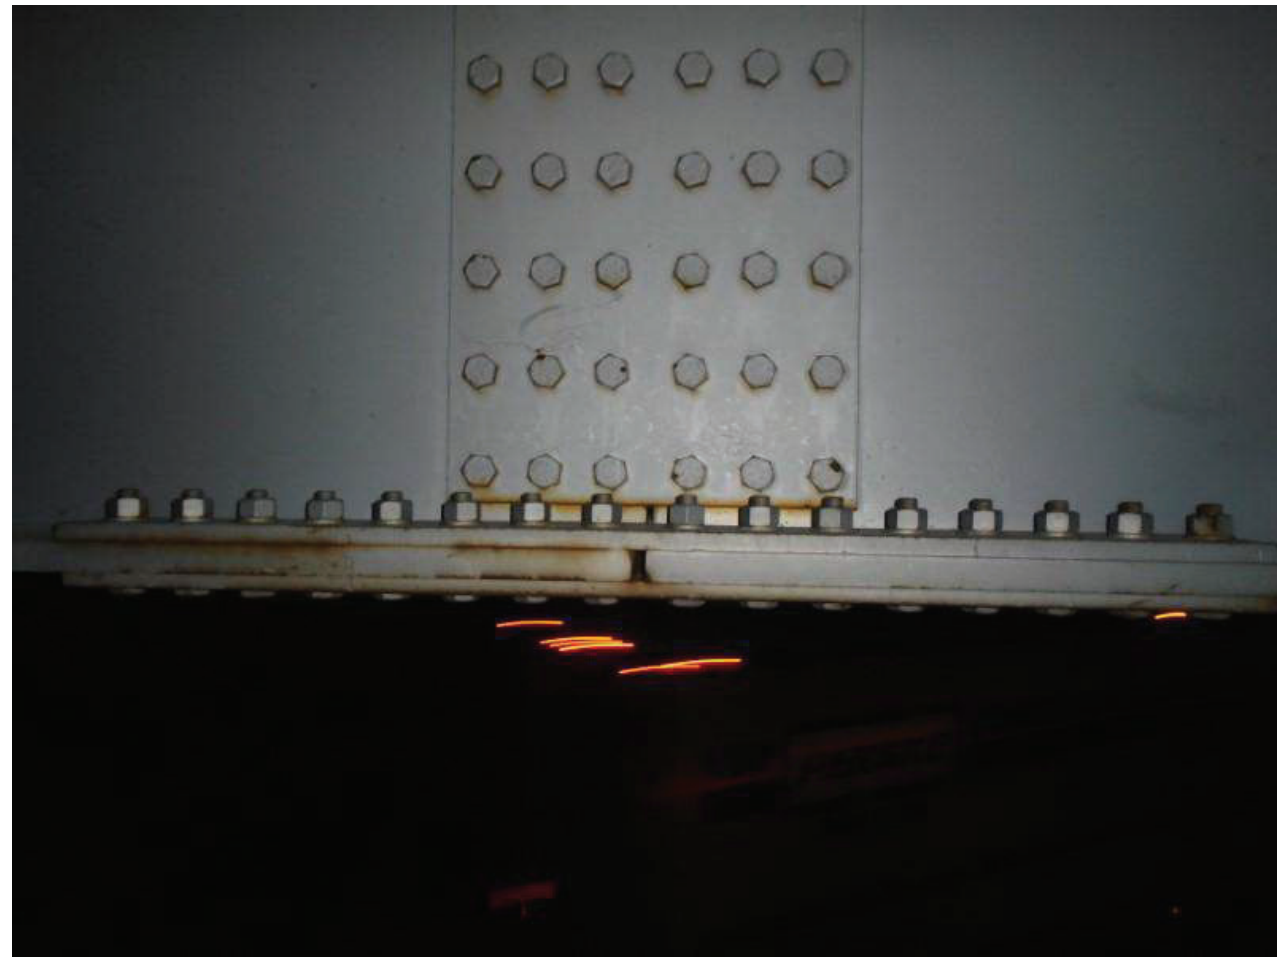
File Name : 01215-2020-05-31-Photo-18.JPG
 Description : Splice Plate Corrosion, Span 4, Girder 4, LSE

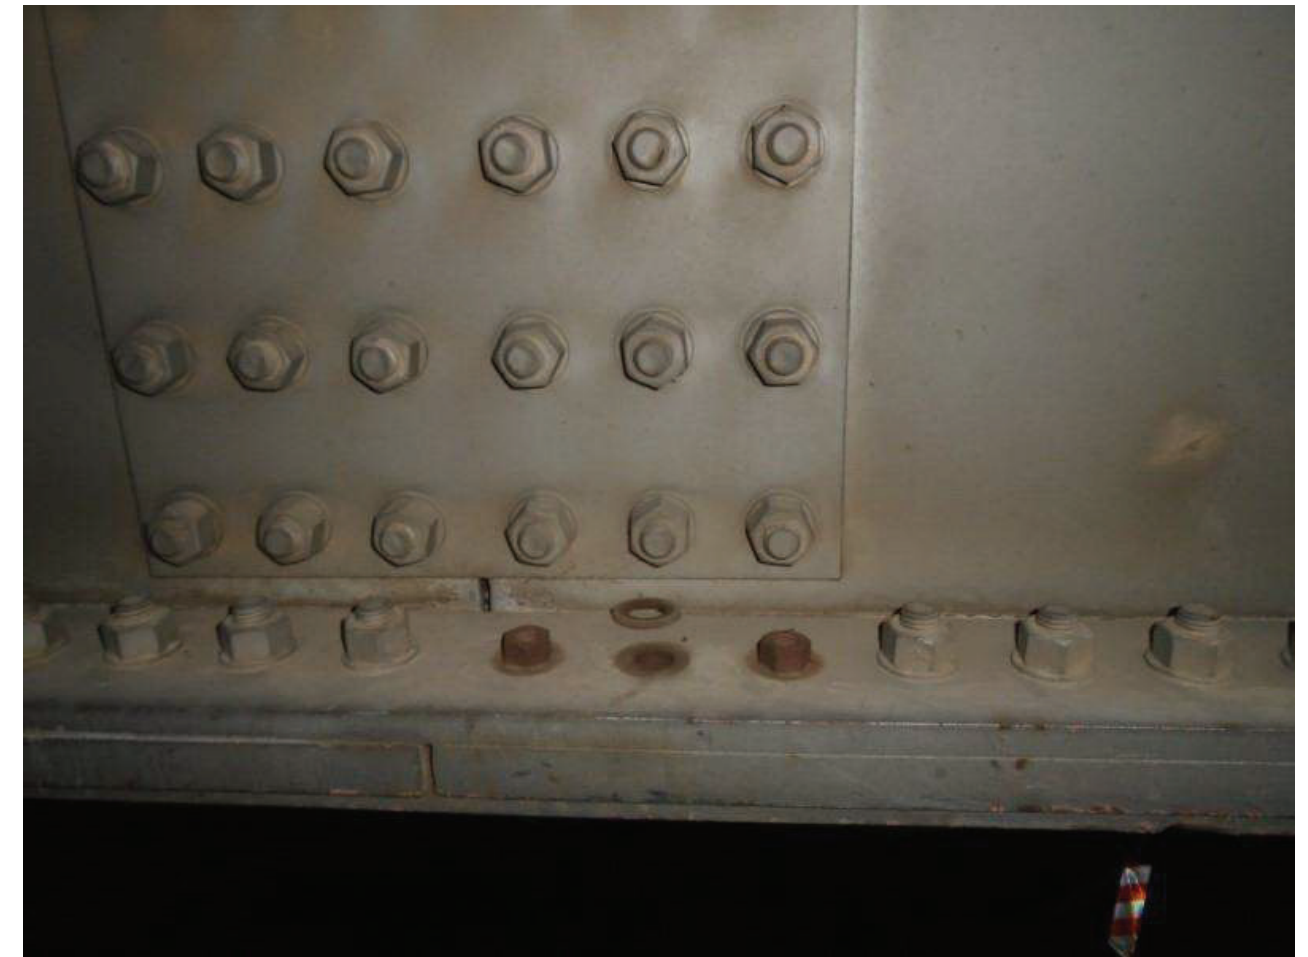
File Name : 01215-2020-05-31-Photo-25.JPG
 Description : Missing Bolt, Span 2, Girder 4, South Splice Plate, LE

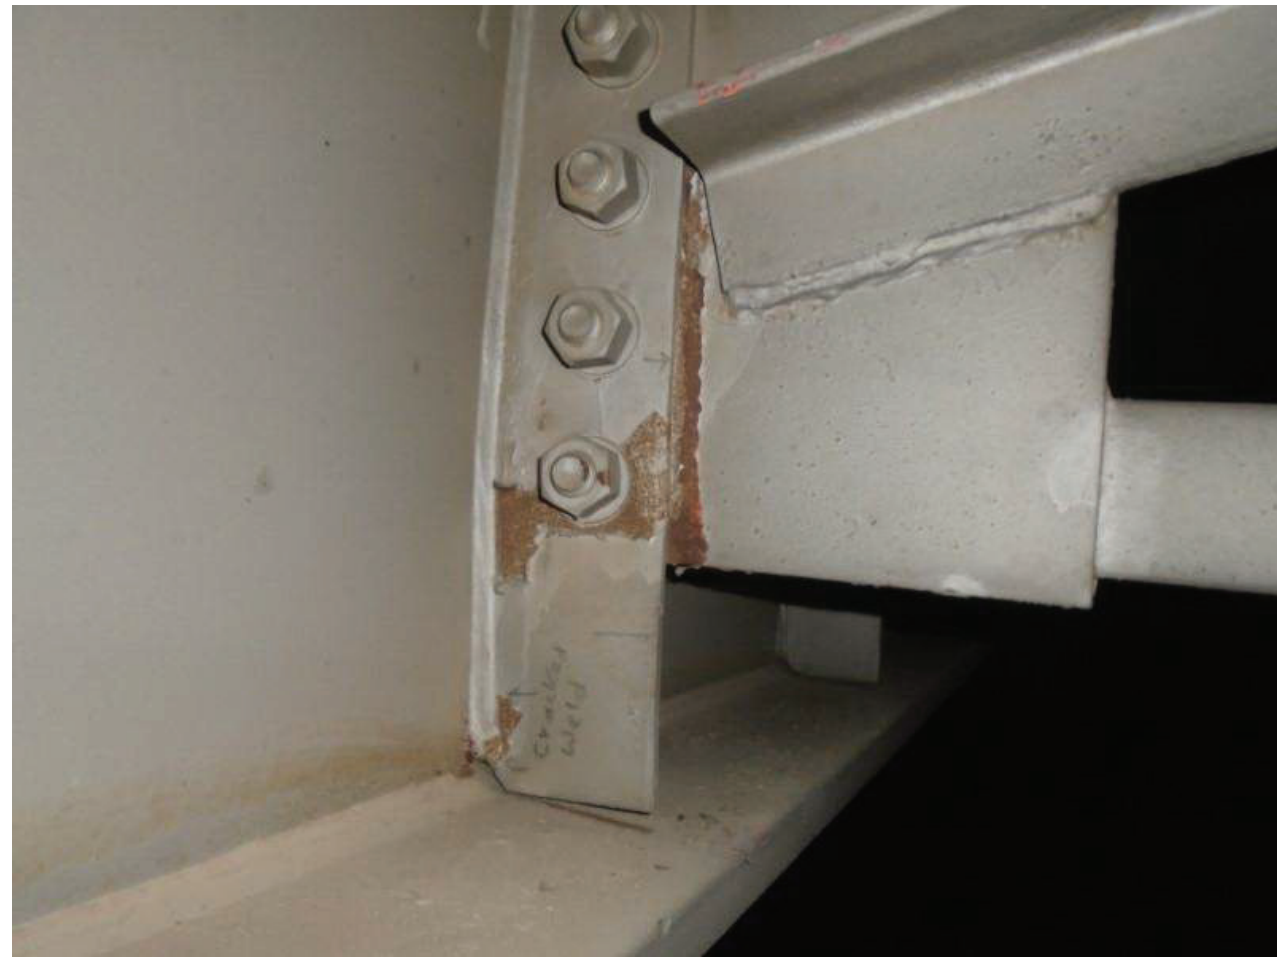
File Name : 01216-2020-05-31-Photo-21.JPG
 Description : Cracked Weld, Span 2, Girder 1, Diaphragm 1, LSW

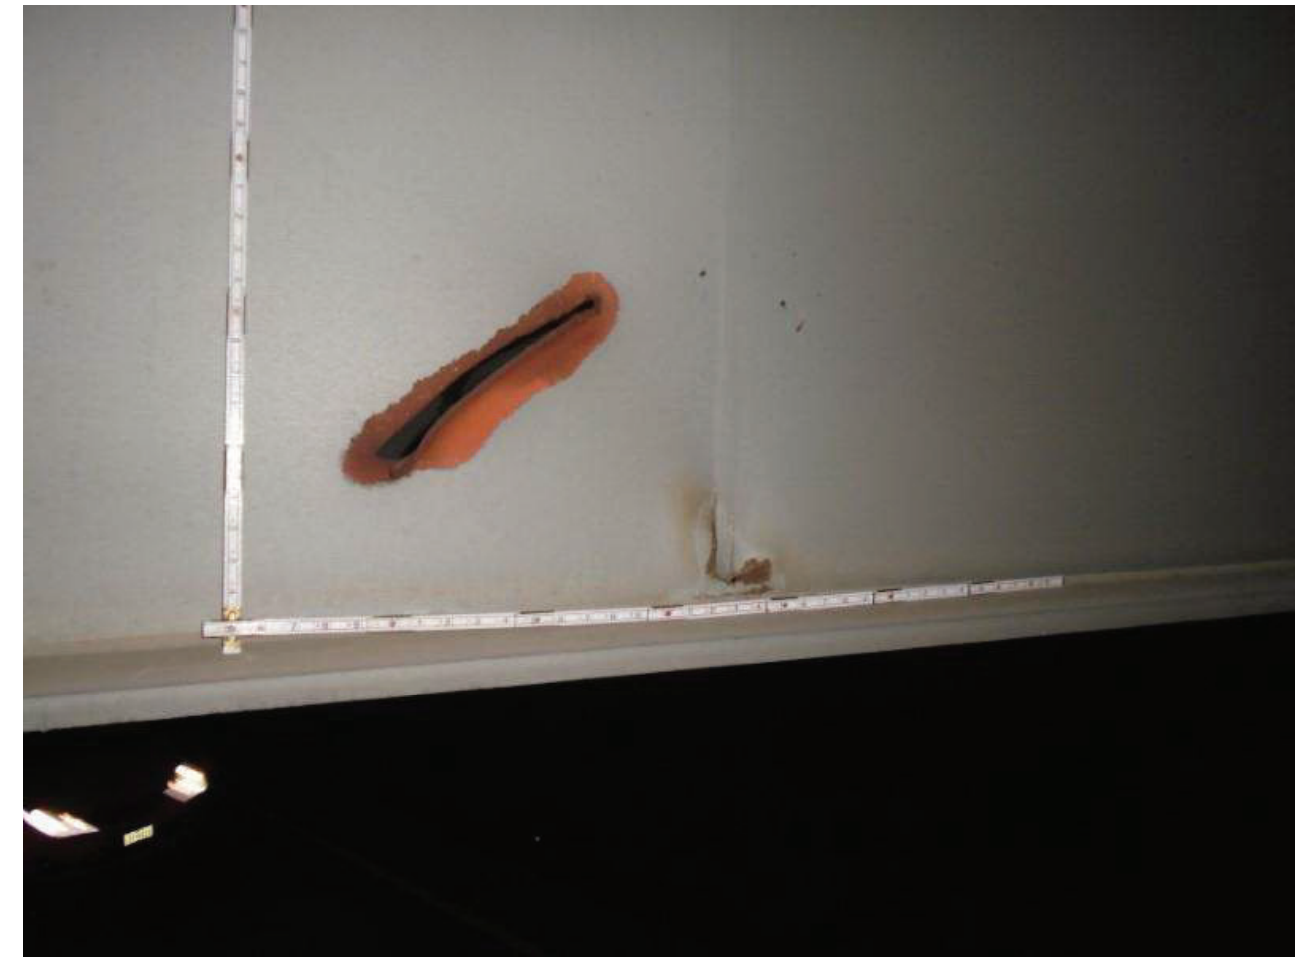
File Name : 01216-2020-05-31-Photo-22.JPG
 Description : Impact Damage, Span 2, Girder 2, Diaphragm 1, LS

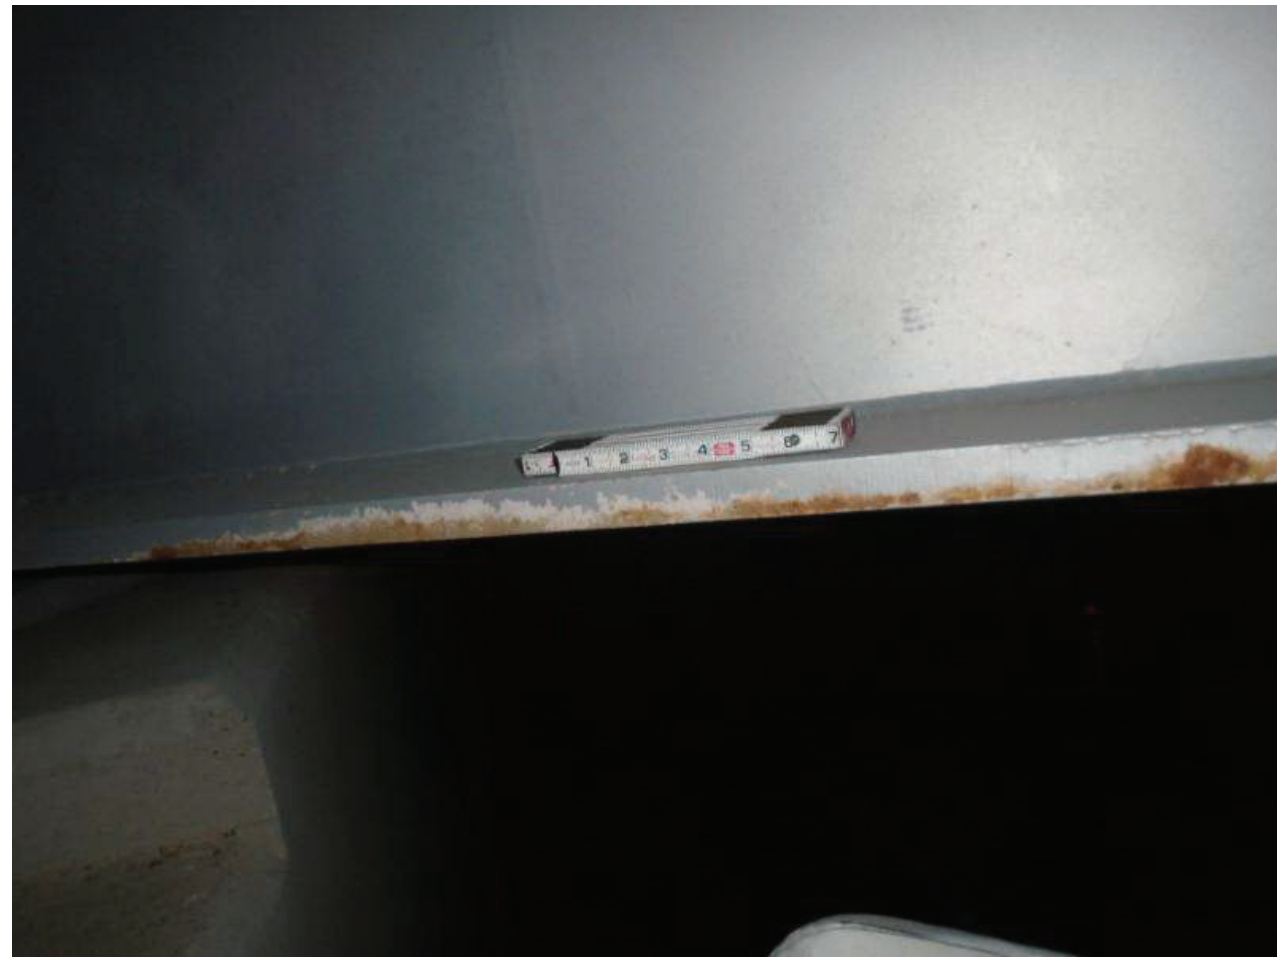
File Name : 01216-2020-05-31-Photo-29.JPG
 Description : Failing Paint, Span 3, Girder 1, Near Pier 3, LN

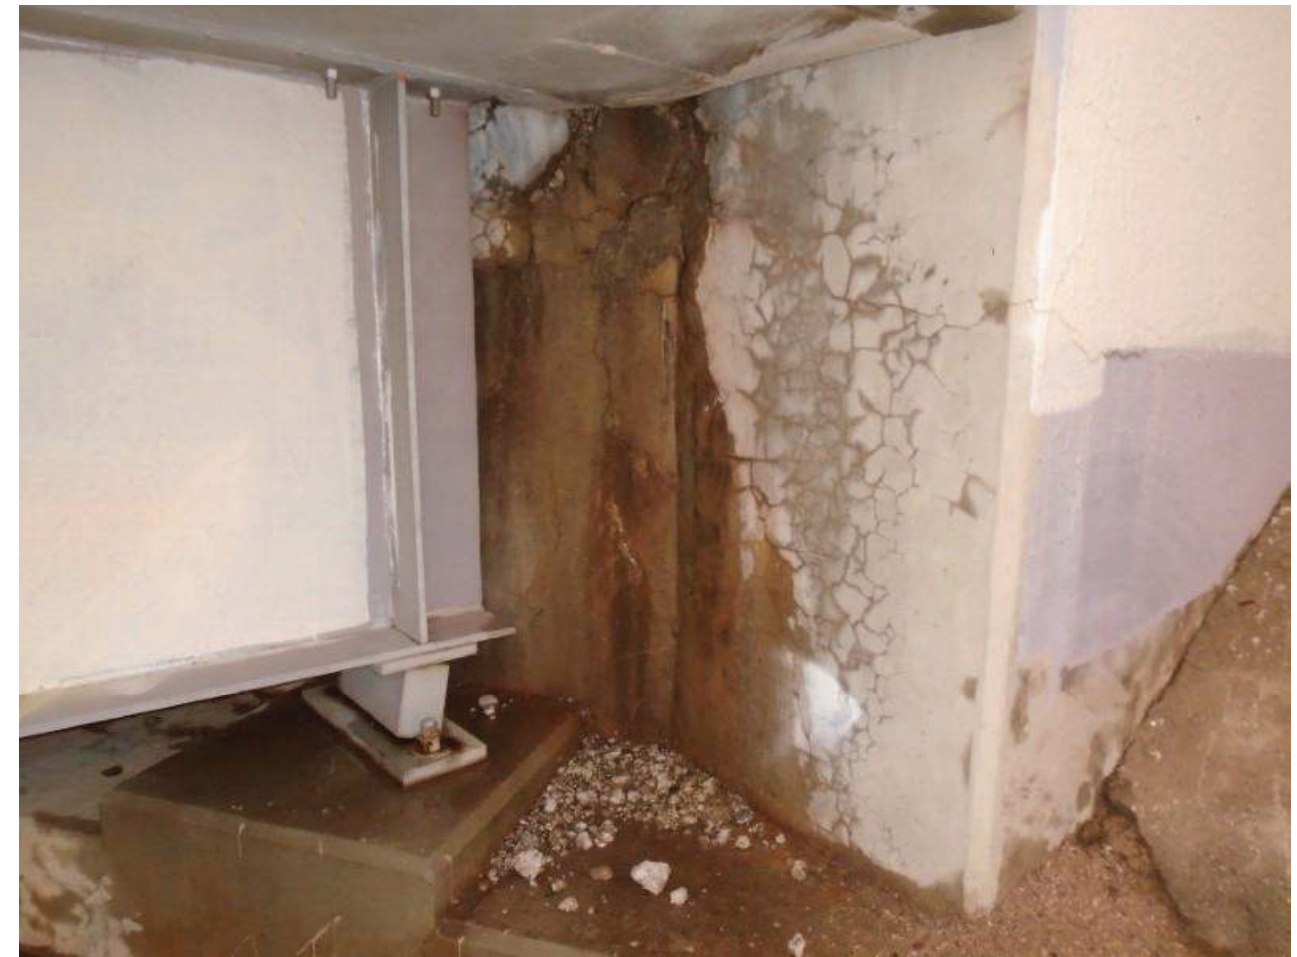
File Name : 01216-2020-05-31-Photo-30.JPG
 Description : Spalls & Map Cracks, Southeast Abutment Backwall, LNE

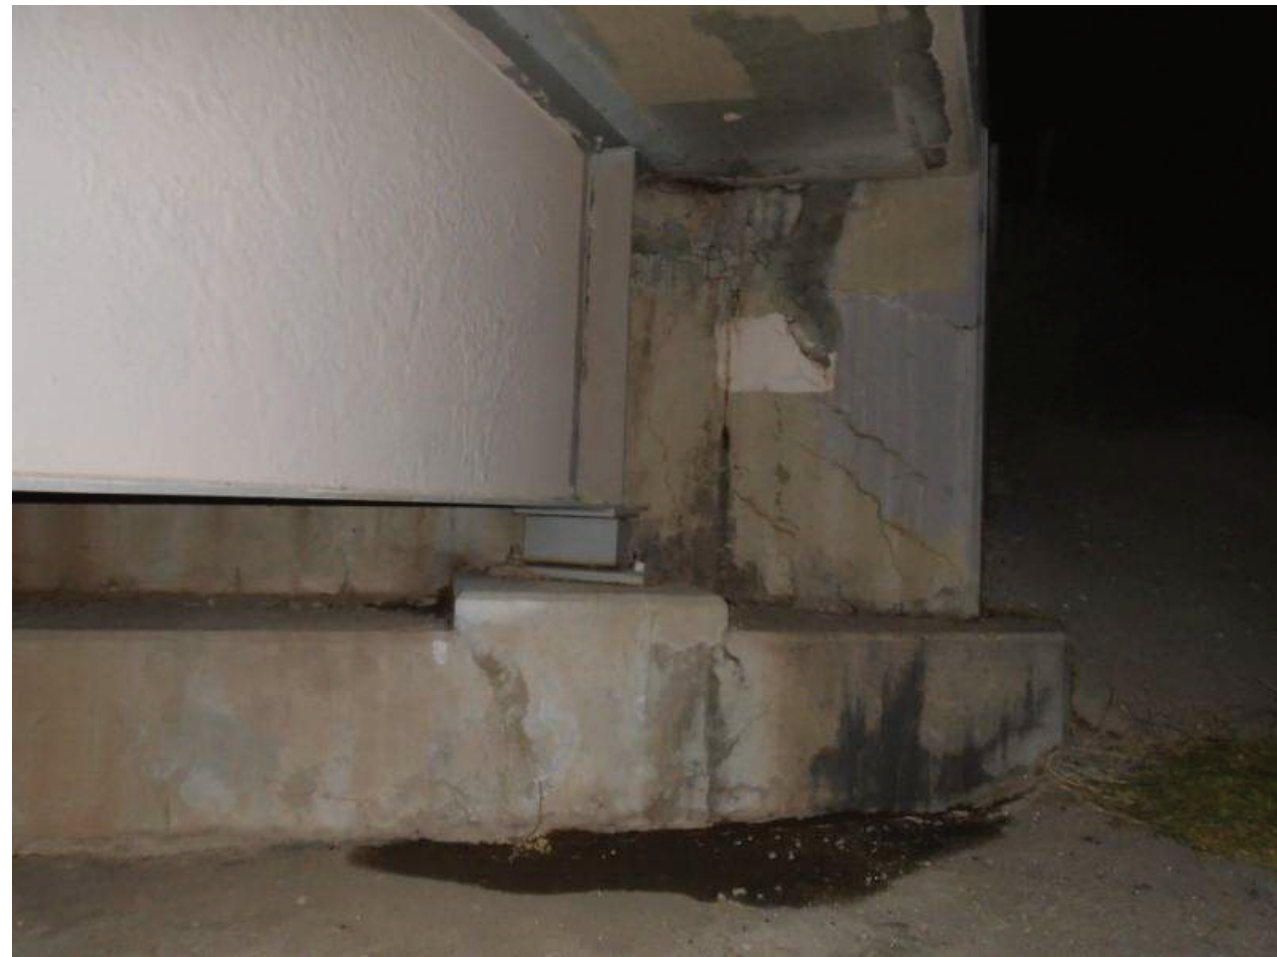
File Name : 01216-2020-05-31-Photo-31.JPG
 Description : Spalls & Map Cracks, Southwest Abutment Backwall, LW

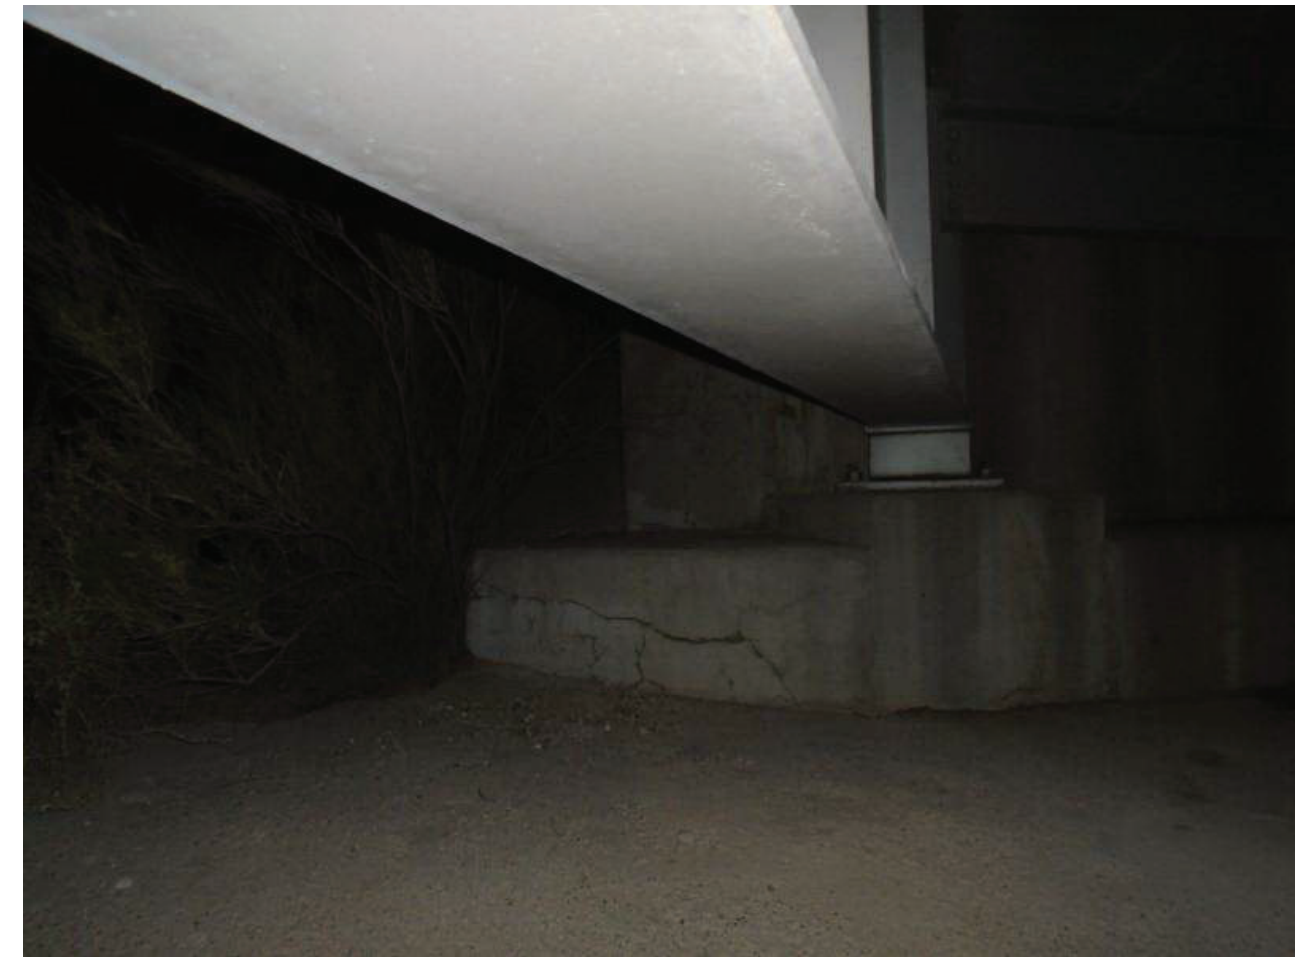
File Name : 01216-2020-05-31-Photo-32.JPG
 Description : Wide Crack, Northwest Abutment Backwall, LW

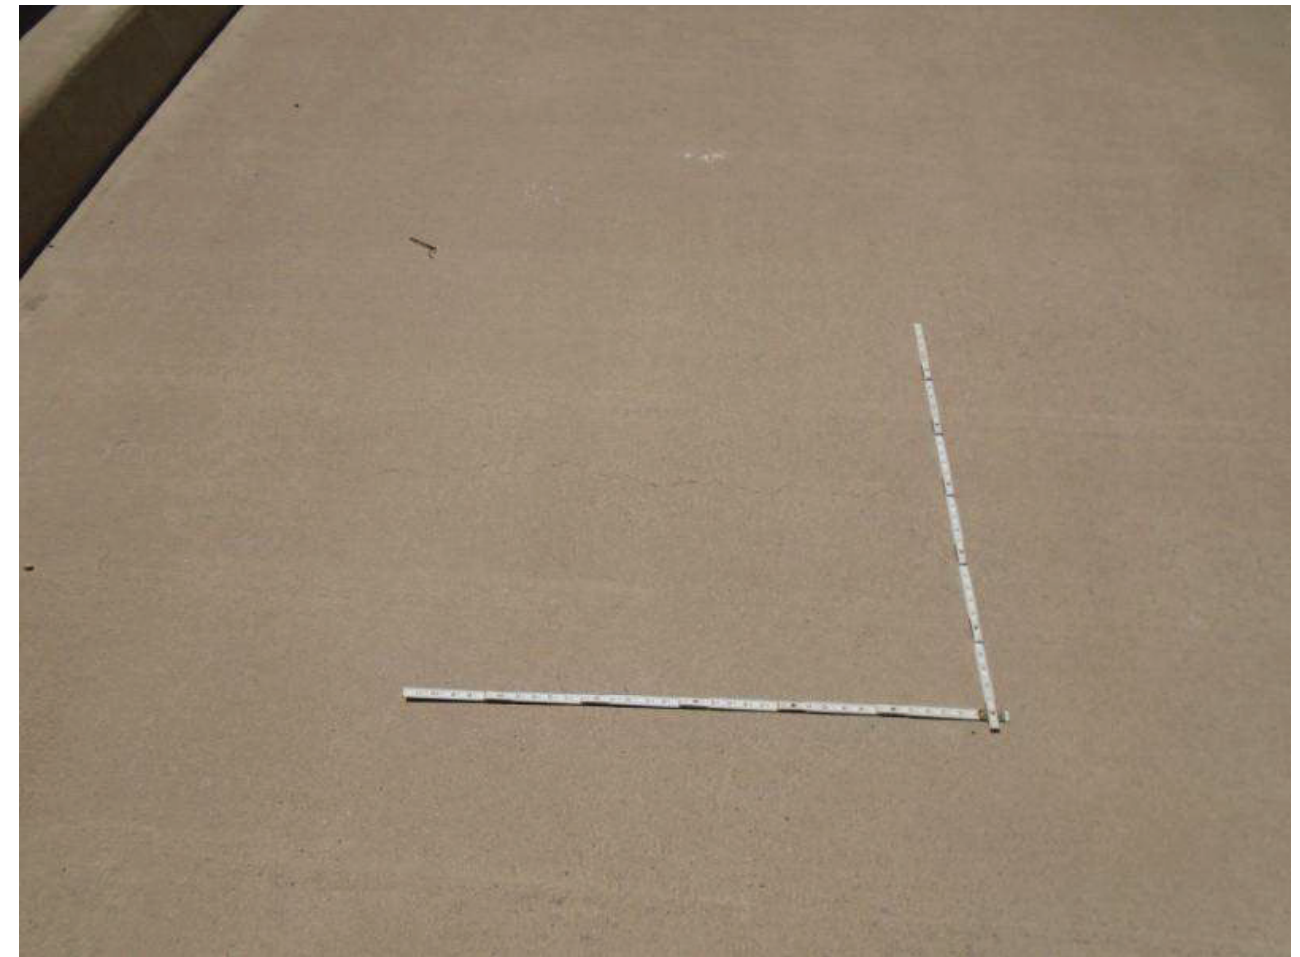
File Name : 01150-2020-05-31-Photo-6.JPG
 Description : Typical Deck Cracking

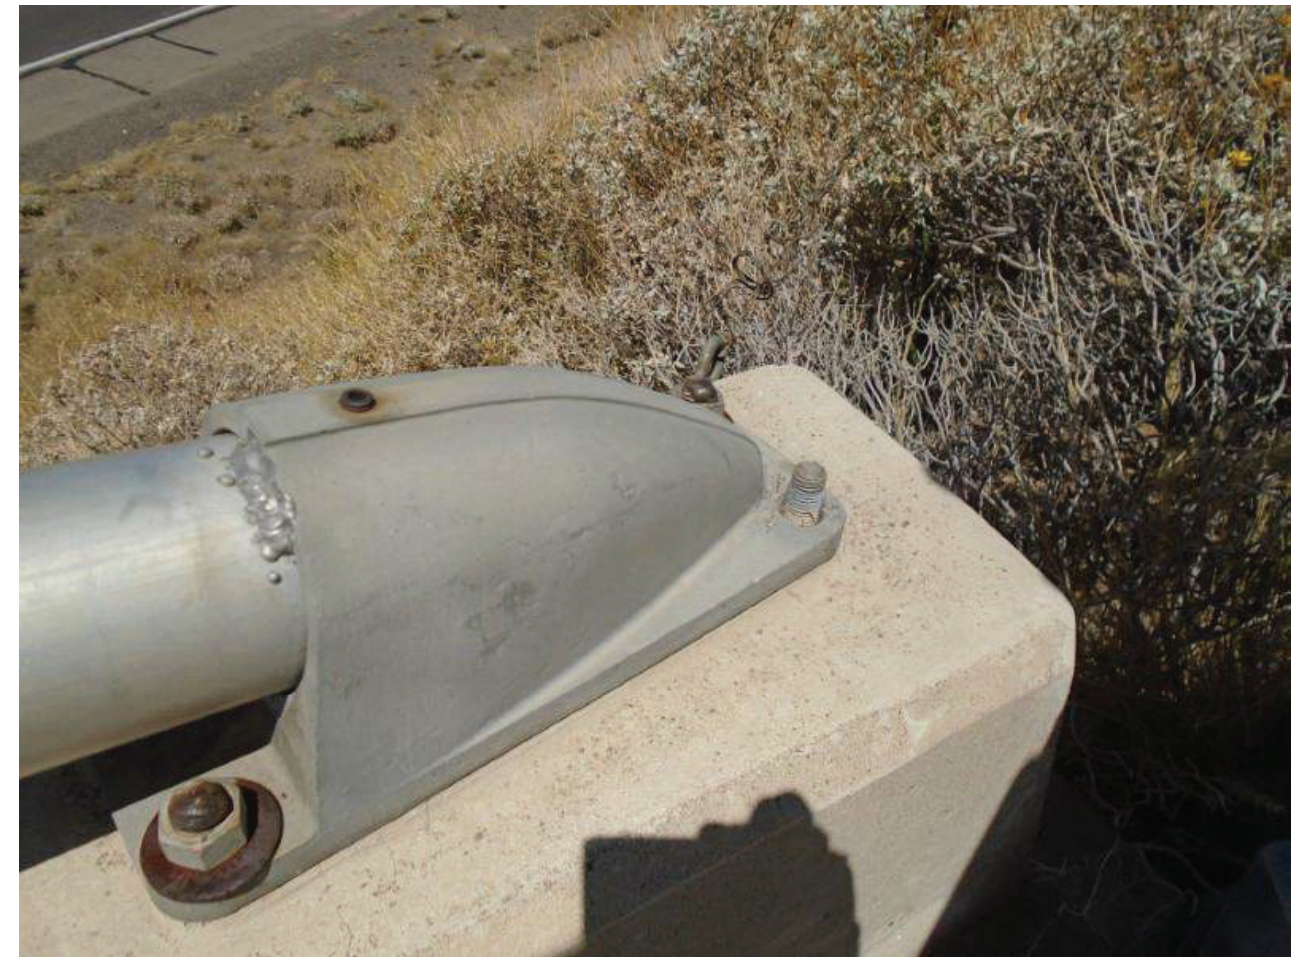
File Name : 01150-2020-05-31-Photo-8.JPG
 Description : Typical Missing Nuts, End of Metal Railing

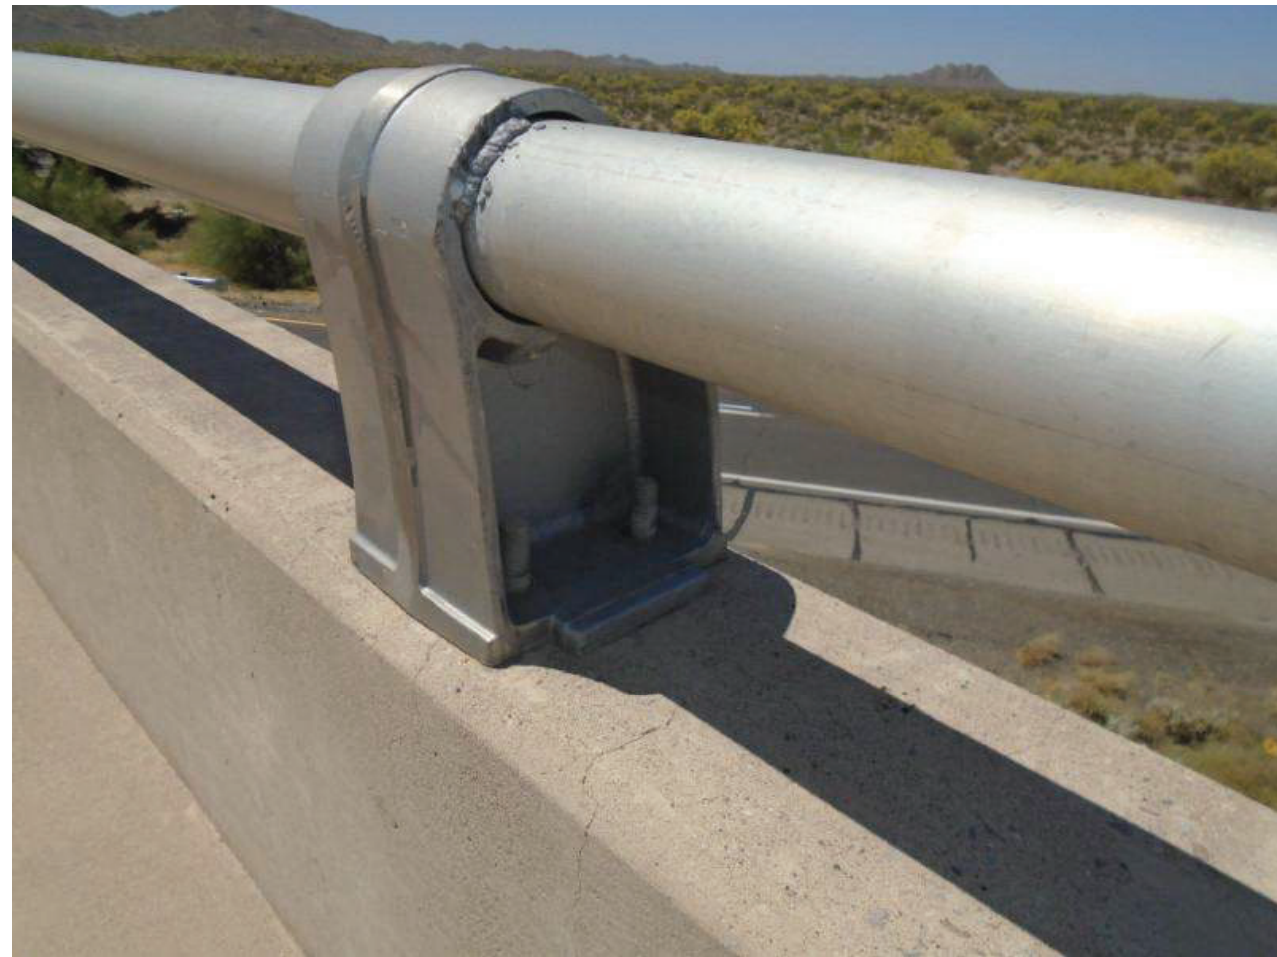
File Name : 01150-2020-05-31-Photo-9.JPG
 Description : Typical Missing Nuts, Intermediate Metal Railing Support

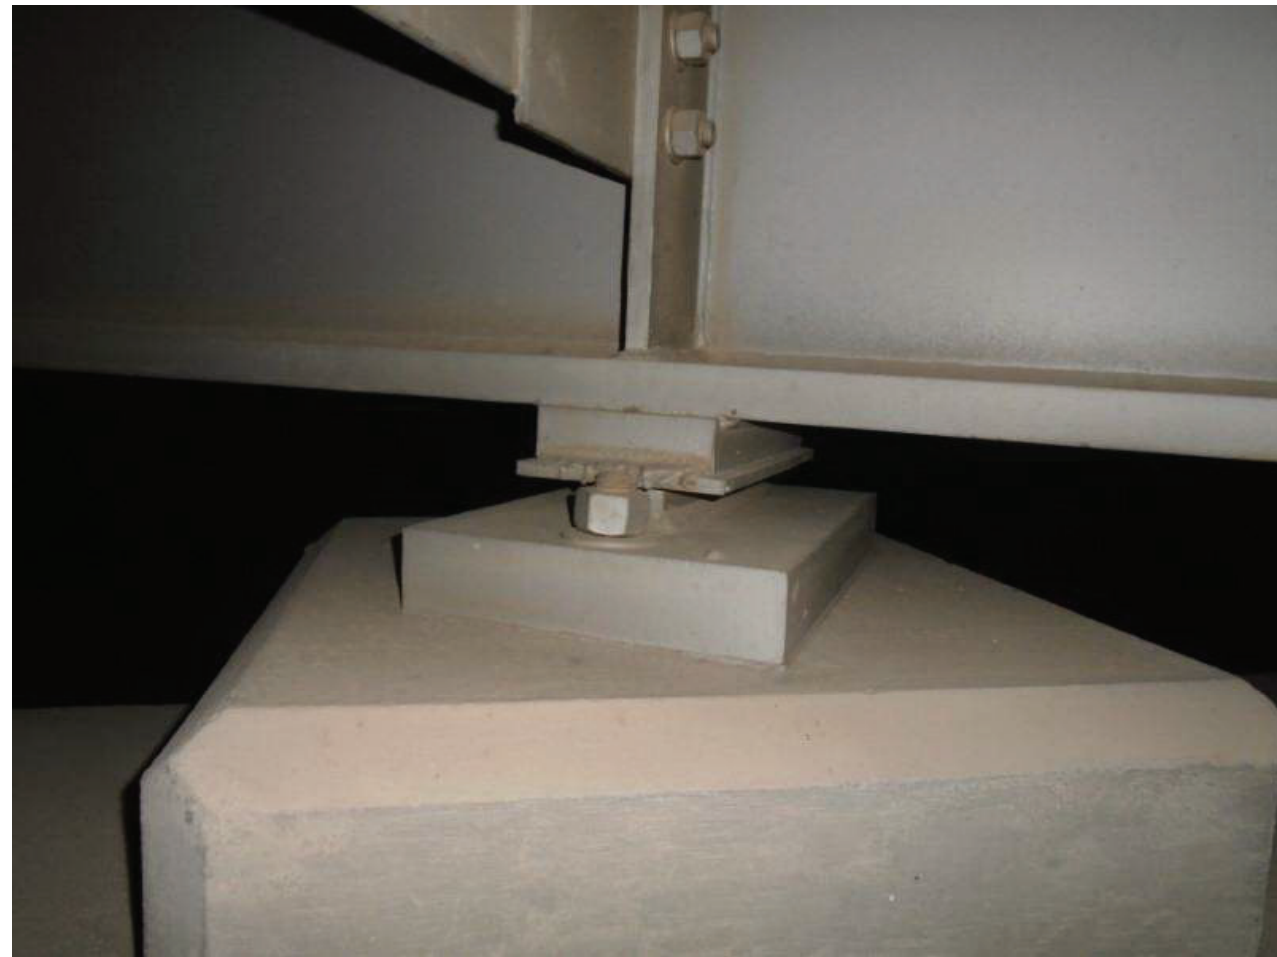
File Name : 01150-2020-05-31-Photo-13.JPG
 Description : Pier 3, Typical Bearing Condition, LSW
