I-10 | LOOP 202 TO SR-387
WILD HORSE PASS CORRIDOR

Draft Design Concept Report Appendix Volume

Interstate 10 Corridor: State Route 202L
to State Route 387

*ADOT Project Nos. F0252 01L and F0252 02L
Federal Aid No. 010-C(222)S*

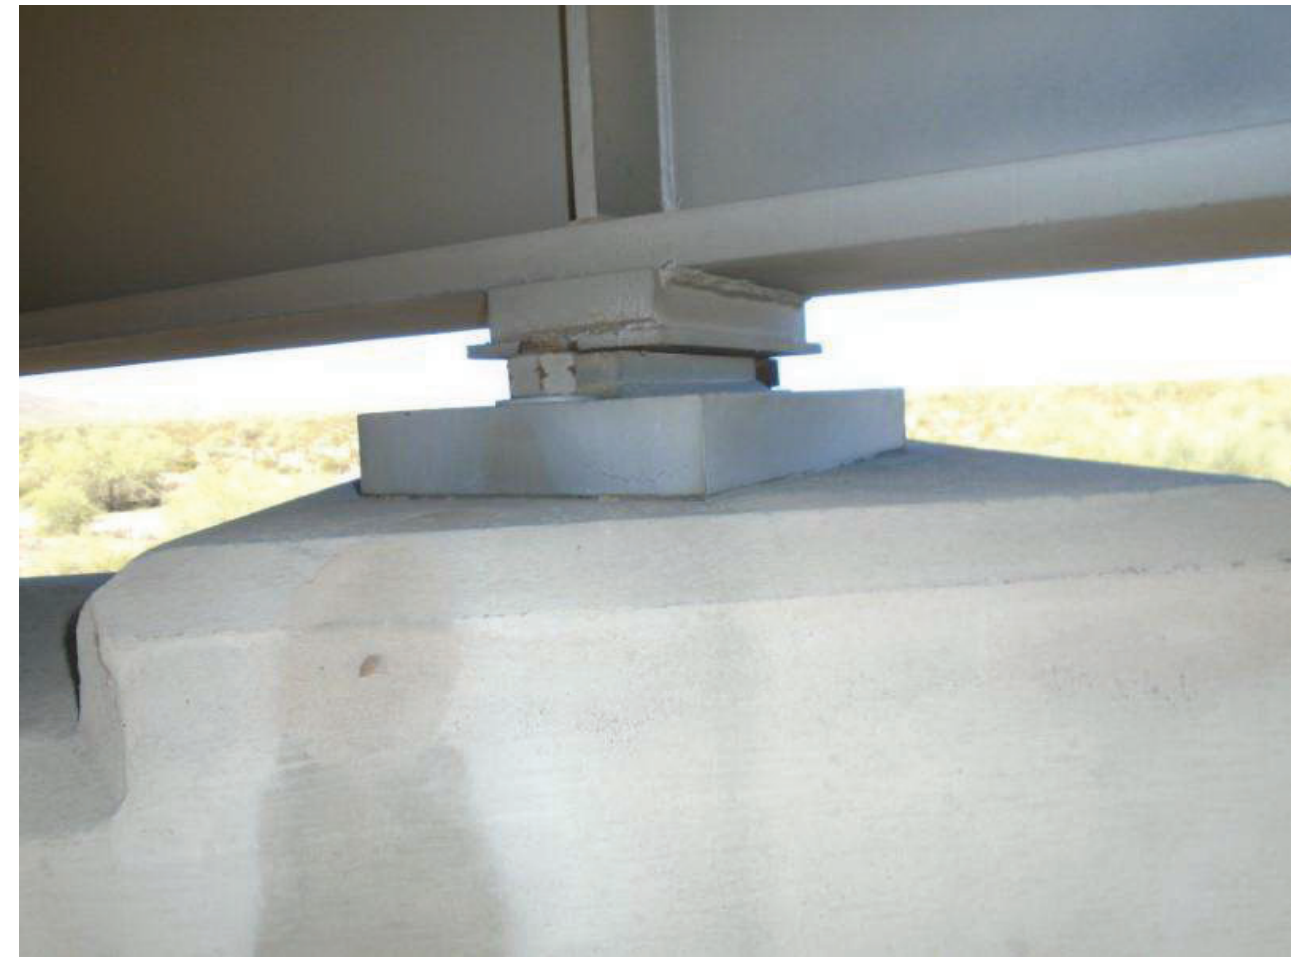
File Name : 01150-2020-05-31-Photo-14.JPG
 Description : Pier 2, Typical Bearing Condition, LSW

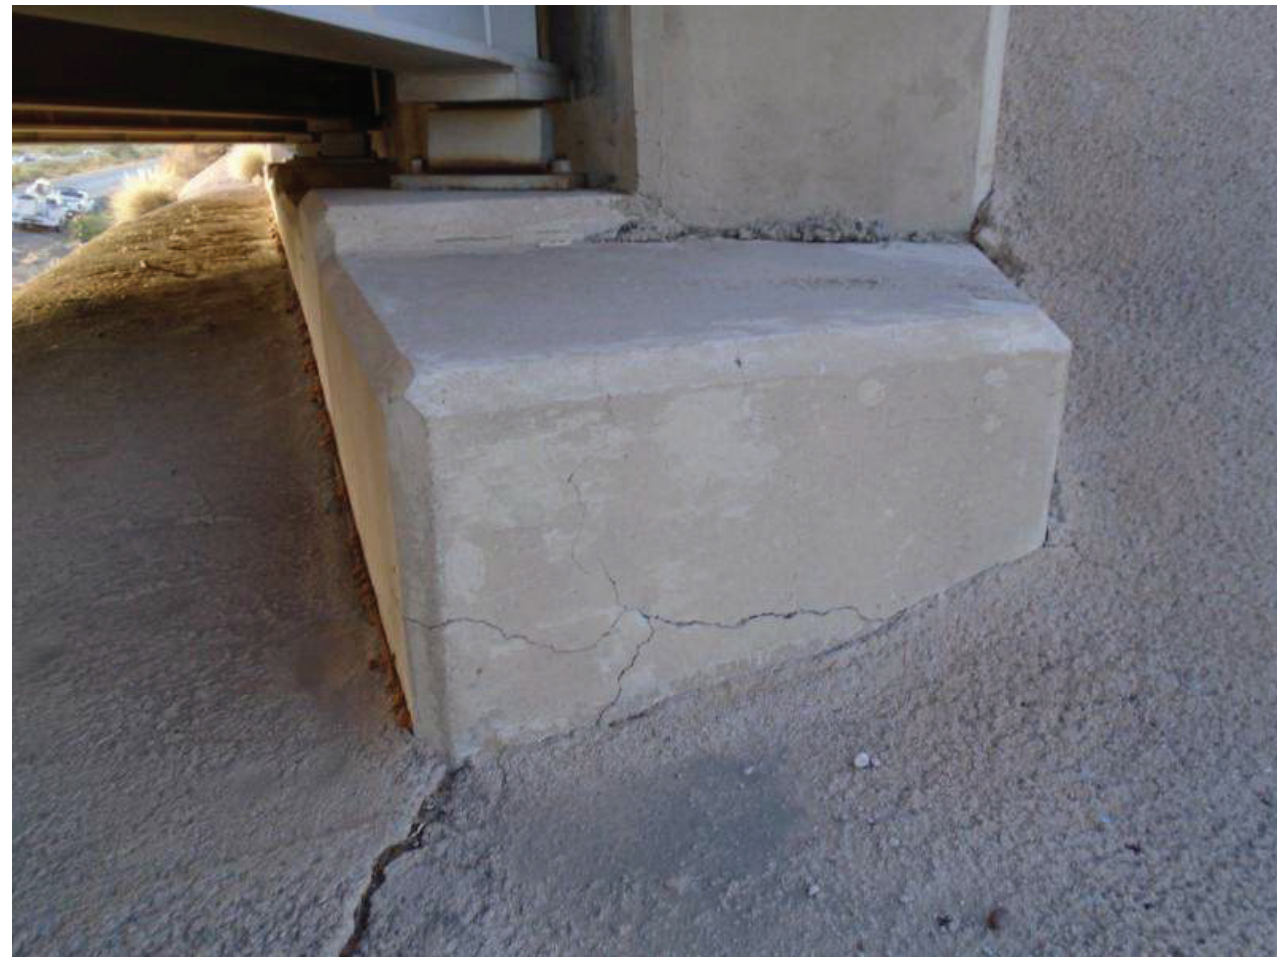
File Name : 01150-2020-05-31-Photo-19.JPG
 Description : Wide Map Cracks, East End of North Abutment, LNW

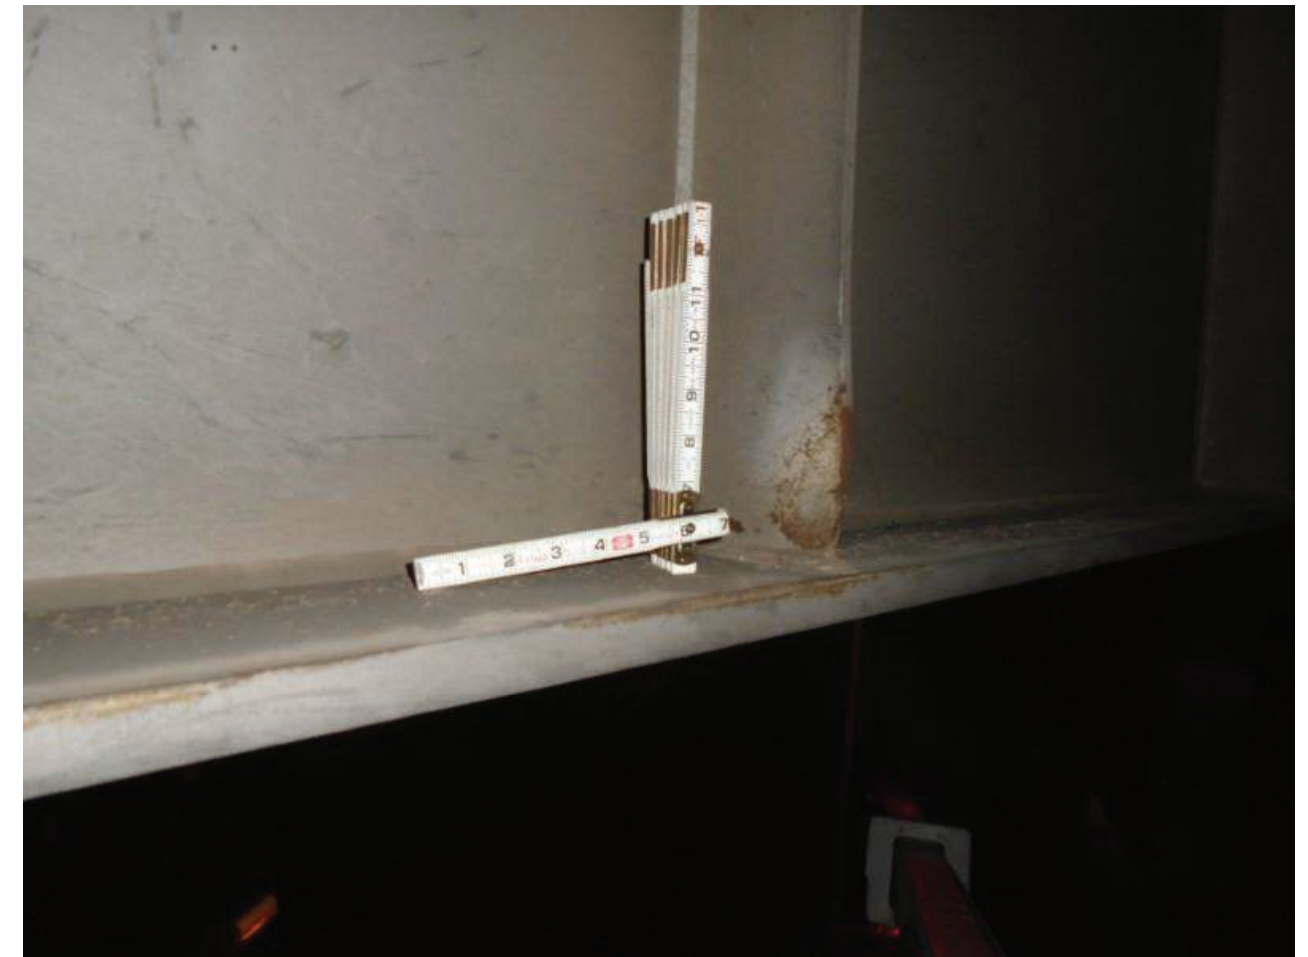
File Name : 01150-2020-05-31-Photo-24.JPG
 Description : Cracked Diaphragm Stiffener, Span 4, Girder 2, Bay 2, LW

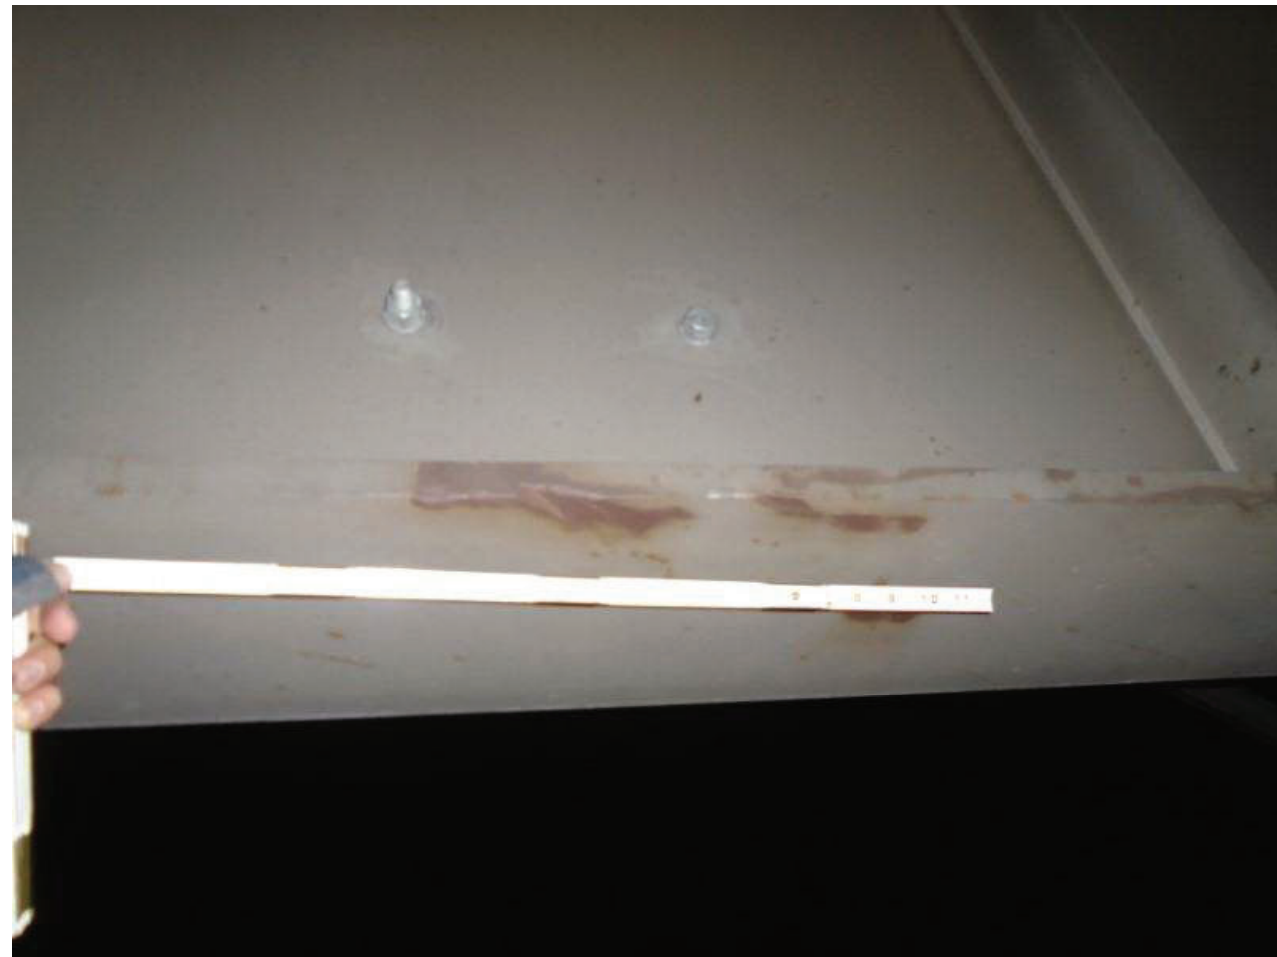
File Name : 01150-2020-05-31-Photo-25.JPG
 Description : Impact Damage, Span 2, Girder 4, Over Left Lane, LE

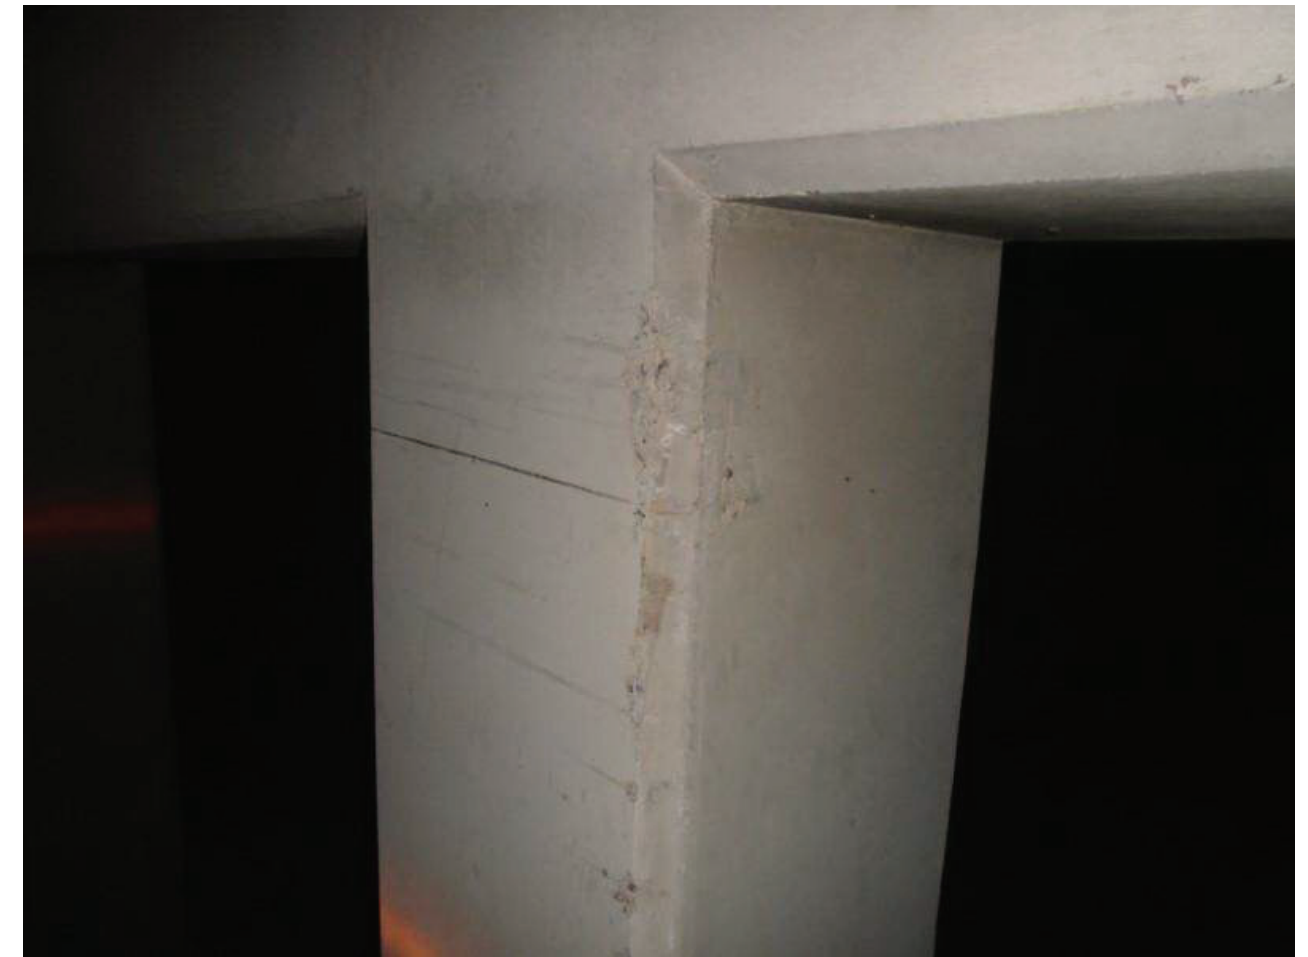
File Name : 01150-2020-05-31-Photo-26.JPG
 Description : Spall with Scrape Marks, Pier 2, Second Column from East, LE

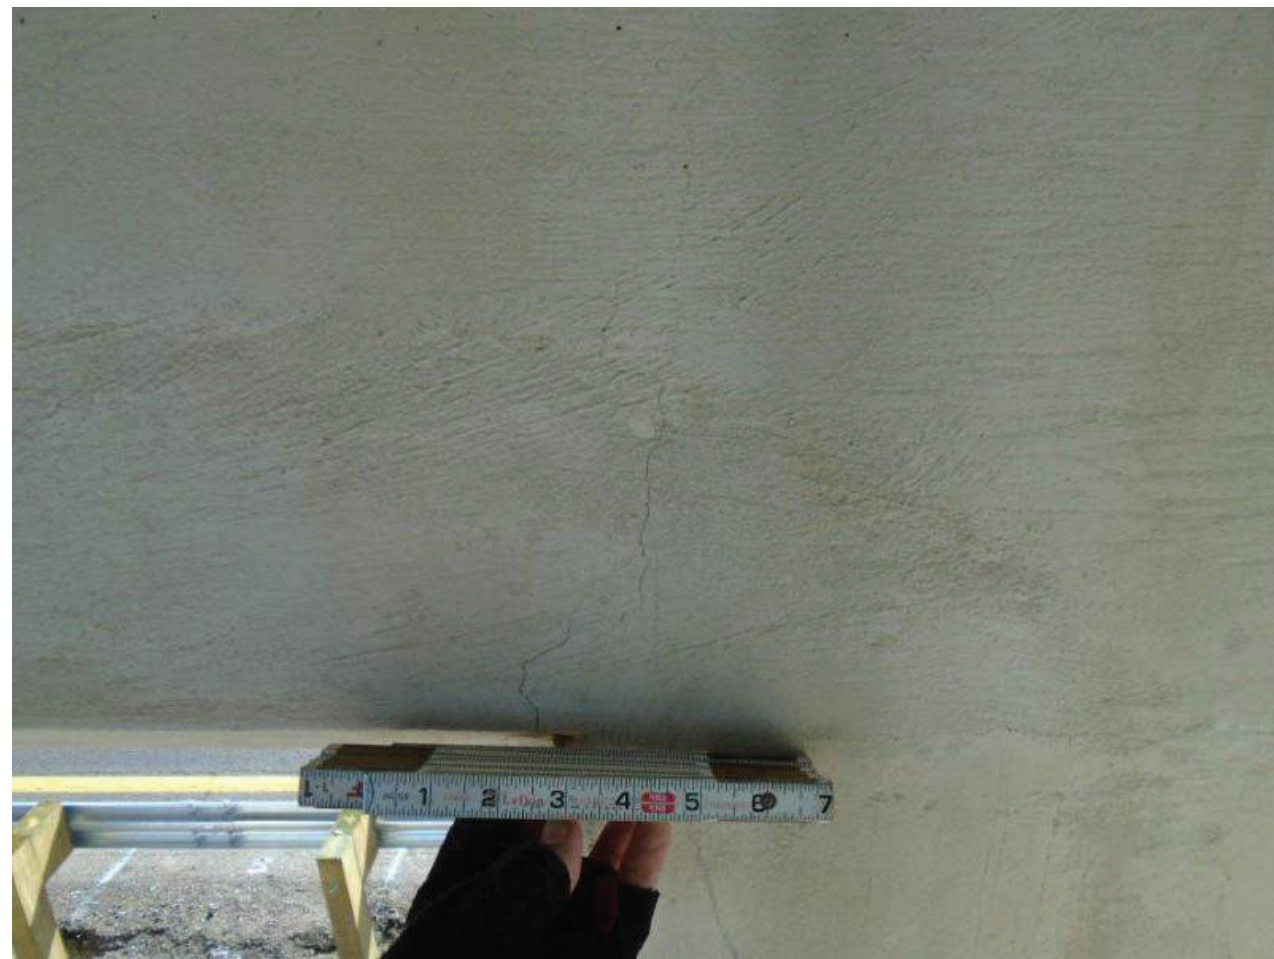
File Name : 01150-2020-05-31-Photo-27.JPG
 Description : Vertical Cracks, Pier 3 Cap, at Column 4, LN
